PENNSYLVANIA HERITAGE AREAS AFRICAN AMERICAN CEMETERY PILOT PROJECT

LINDLEY HILL AME ZION CHURCH CEMETERY PRESERVATION PLAN Downingtown, Chester County, Pennsylvania

RGA Technical Report 2022-341PA

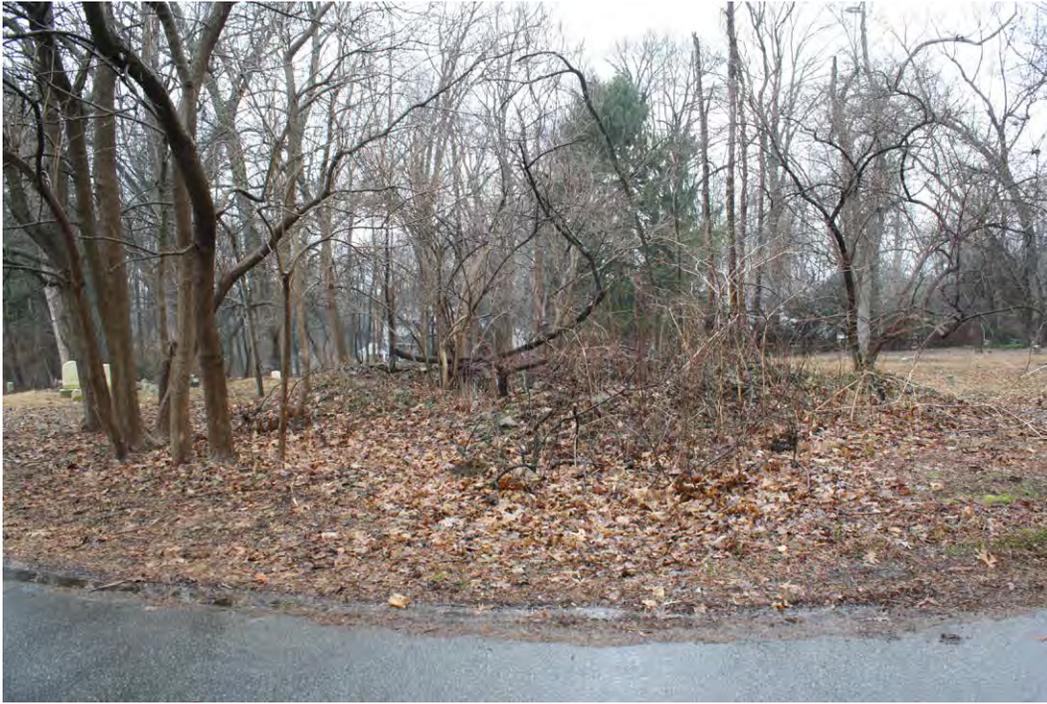
Figure 2.1: The foundation of Zion AME Church, southeast of the Lindley Hill Cemetery.
Photo view: Northwest.; Photographer: Jason Harpe; Date: January 19, 2023.

Stewards and volunteers should clear vegetation and debris in and around the church foundation by hand. They should use garden tools to cut small saplings and weeds in and around the foundation so as not to disturb any intact foundation stones. They can remove trees with a chain saw or by hand saw, where feasible, and leave foundation stones as is while making every effort not to disarticulate any intact structural remnants.

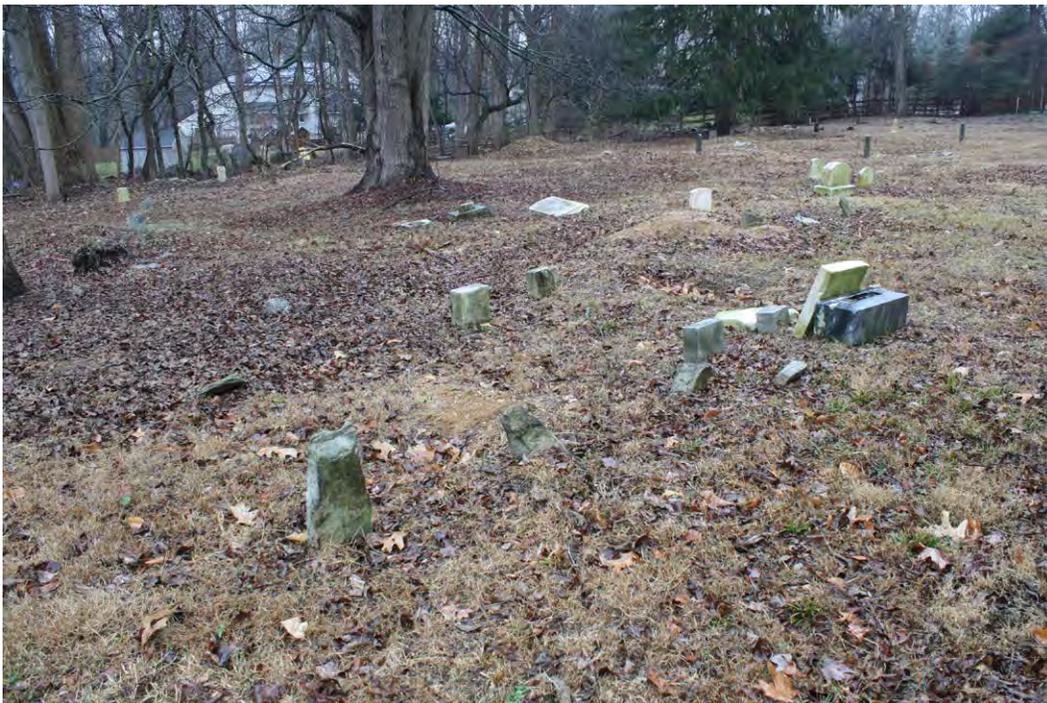
Figure 2.6: Gravemarkers near the cemetery's southern edge.
Photo view: Northwest; Photographer: Jason Harpe; Date: January 19, 2023.

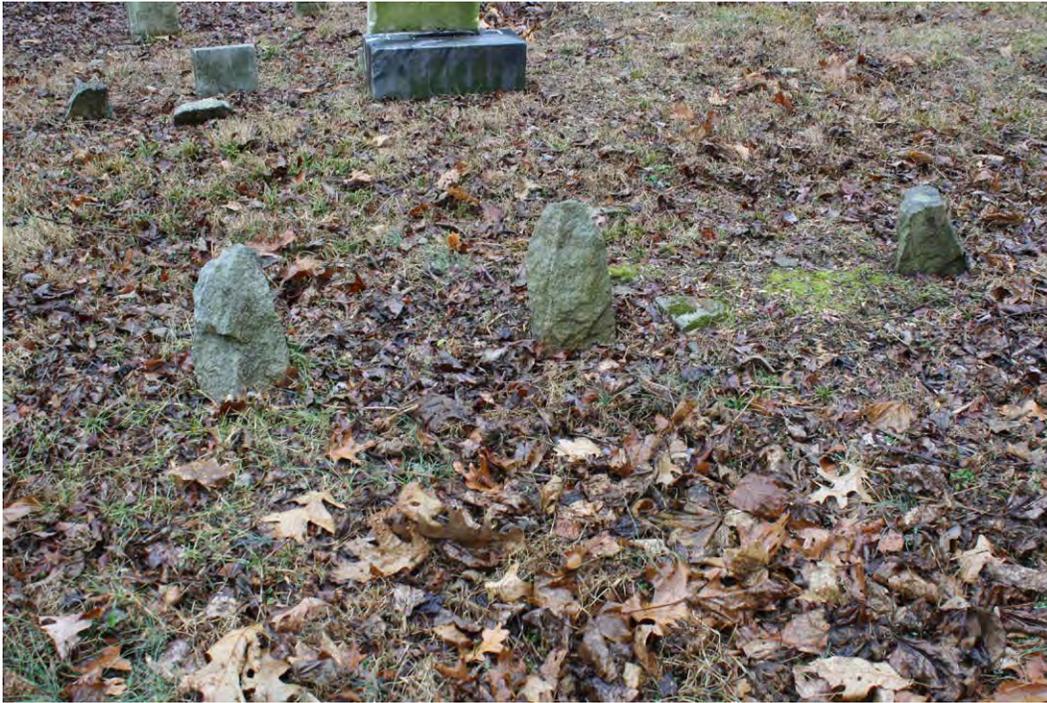
Figure 2.16: Unmarked fieldstones near Lindley Hill Cemetery's southern edge.
Photo view: West; Photographer: Jason Harpe; Date: January 19, 2023.

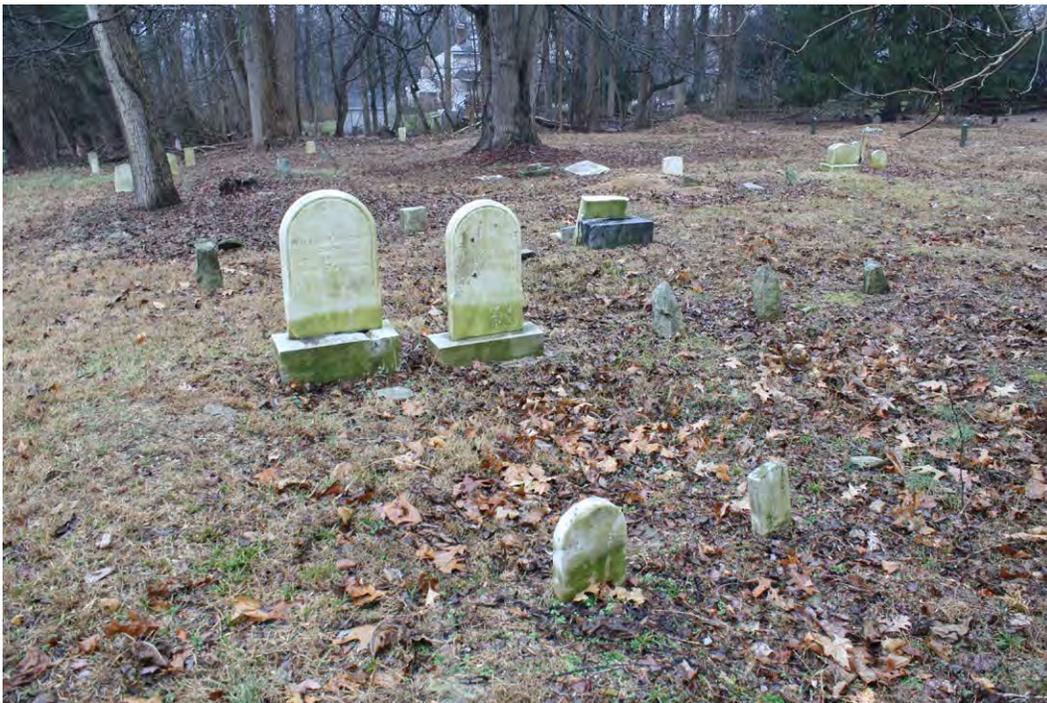
Figure 2.17: Gravemarkers near Lindley Hill Cemetery's southern edge.
Photo view: West; Photographer: Jason Harpe; Date: January 19, 2023.

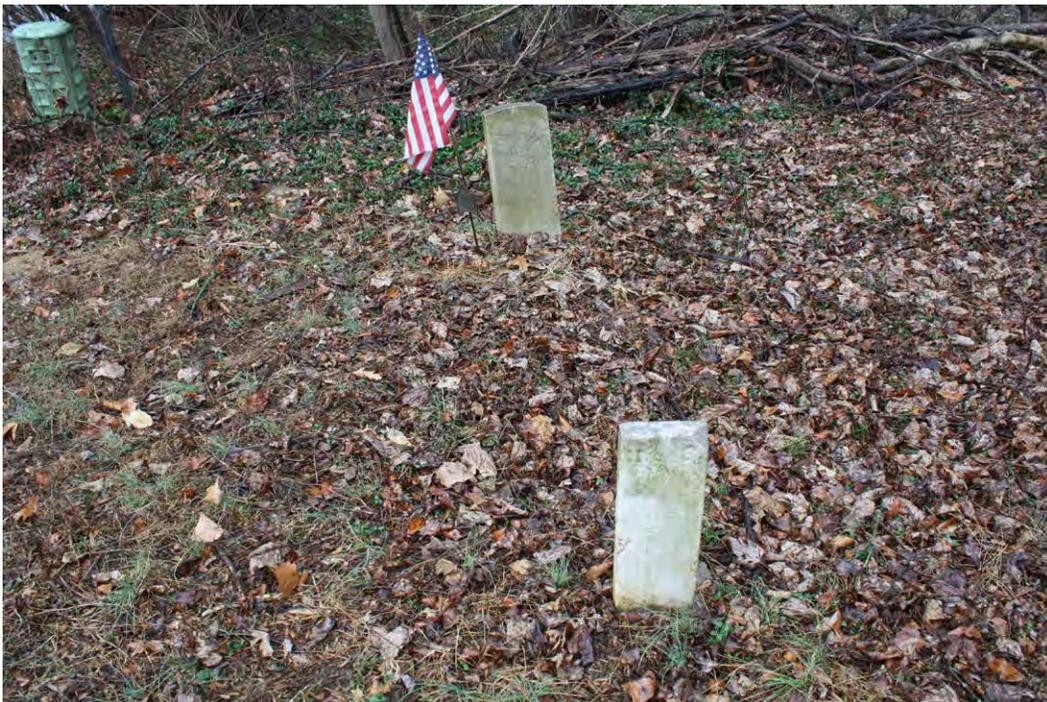
Figure 2.19: Marble headstone and footstone for Hugh Brown who served the Union war effort during the Civil War as a member of the Third United States Colored Troops.
Photo view: West; Photographer: Jason Harpe; Date: January 19, 2023.

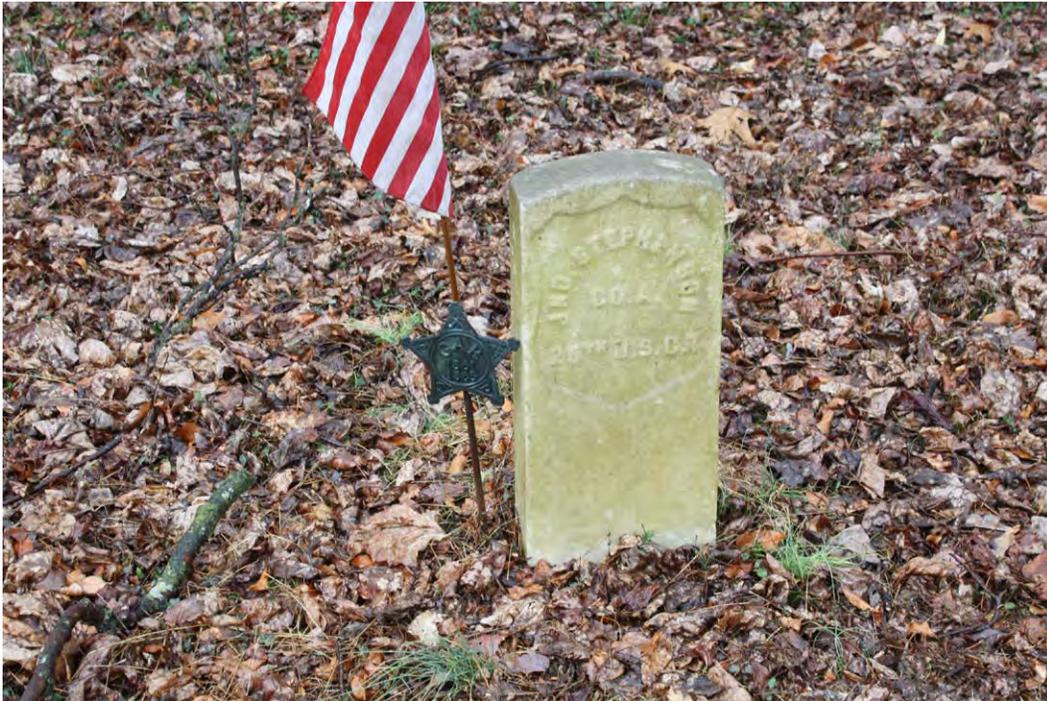
Figure 2.20: Marble headstone for John Stephenson who served the Union war effort during the Civil War as a member of Company A, 25th United States Colored Troops. Photo view: West; Photographer: Jason Harpe; Date: January 19, 2023.

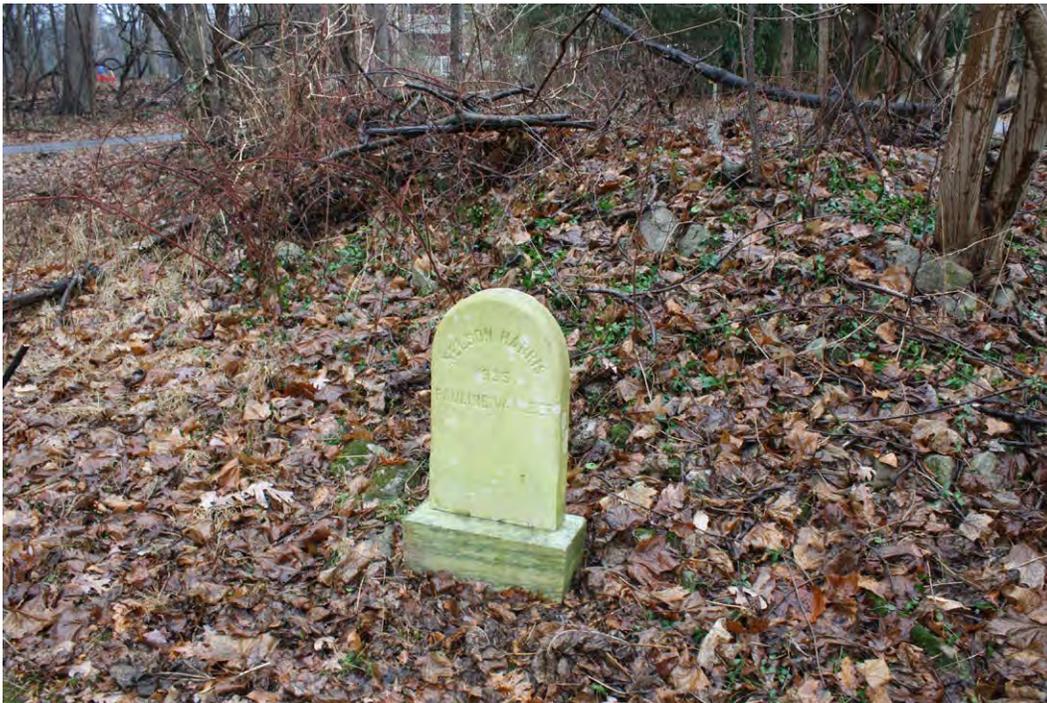
Figure 2.23: Marble die-on-base gravemarker for Nelson Harris and Pauline VanLeer (1935)
near the foundation of the Zion AME Church.
Photo view: East; Photographer: Jason Harpe; Date: January 19, 2023.

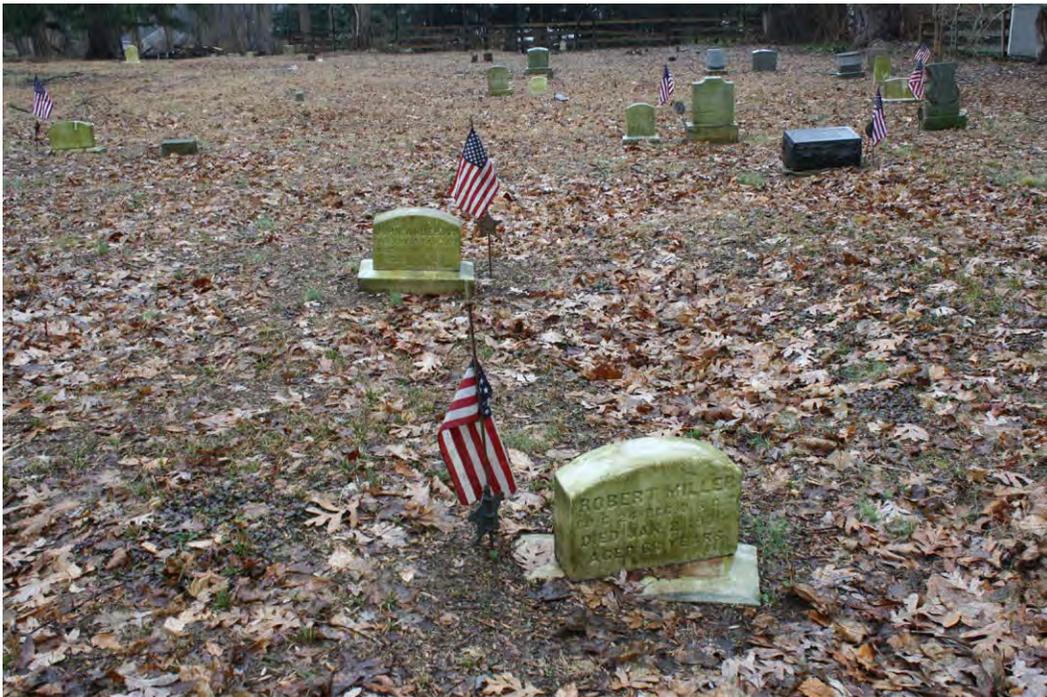
Figure 2.25: Marble die-on-base gravemarkers for John Anderson who served the Union war effort as a member of Company B, 6th Regiment, United States Colored Troops (d. 1903), and Robert Miller who served as a member of Company C, 24th Regiment, United States Colored Troops (d. 1905).

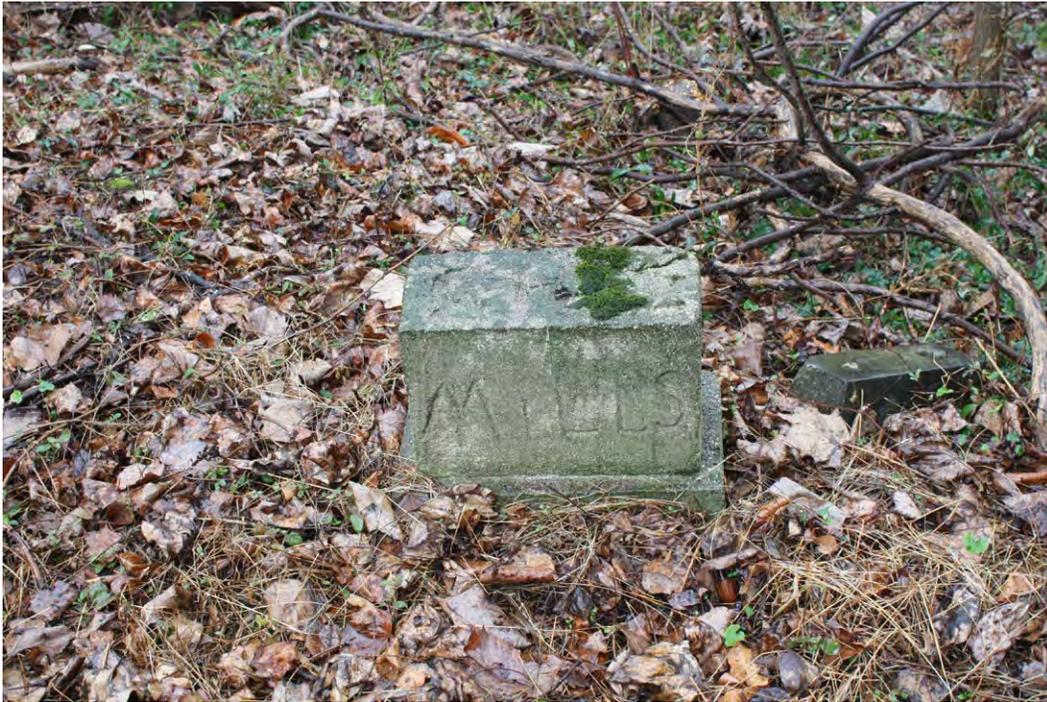
Figure 2.30: Cast concrete die-on-base gravemarker inscribed “Mills”.
Photo view: West; Photographer: Jason Harpe; Date: January 19, 2023.

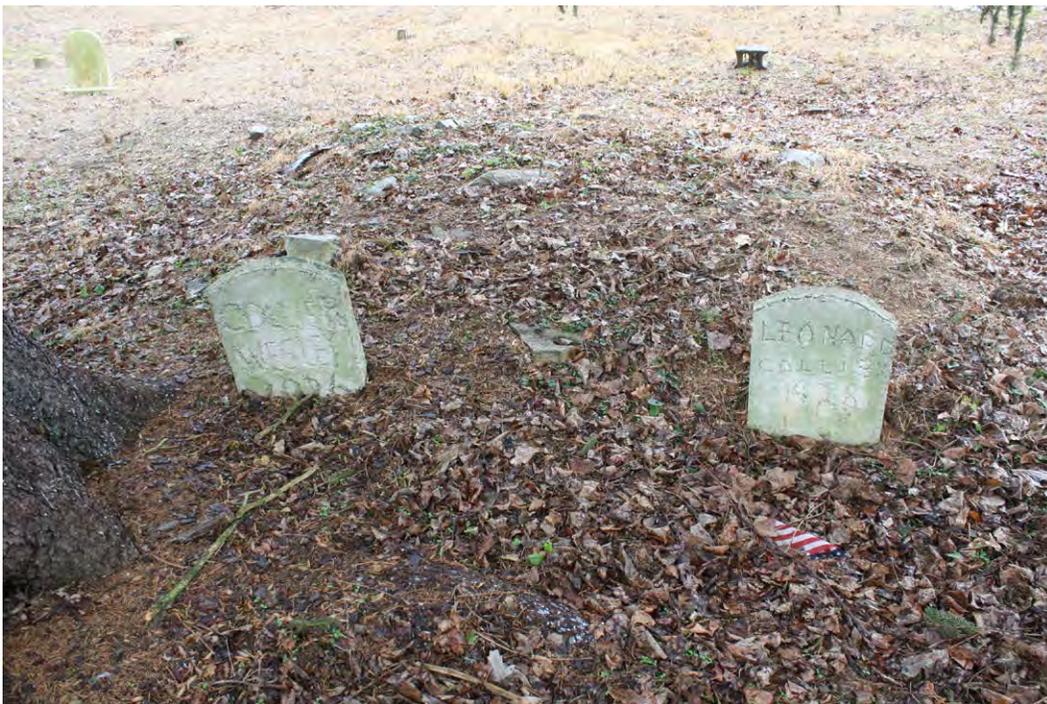
Figure 2.31: Cast concrete gravemarkers for Wesley Collier (d. 1921) and Leonard Collier (d. 1928).
Photo view: East; Photographer: Jason Harpe; Date: January 19, 2023.

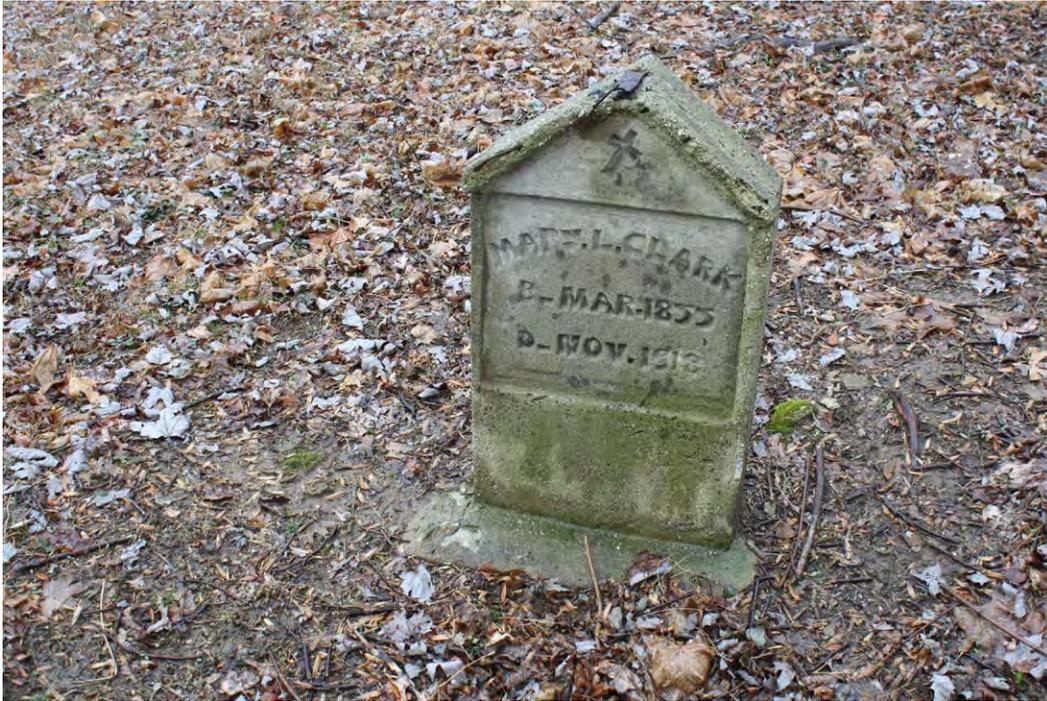
Figure 2.32: Cast concrete gravemarker for Mary L. Clark (1855–1918).
Photo view: West; Photographer: Jason Harpe; Date: January 19, 2023.

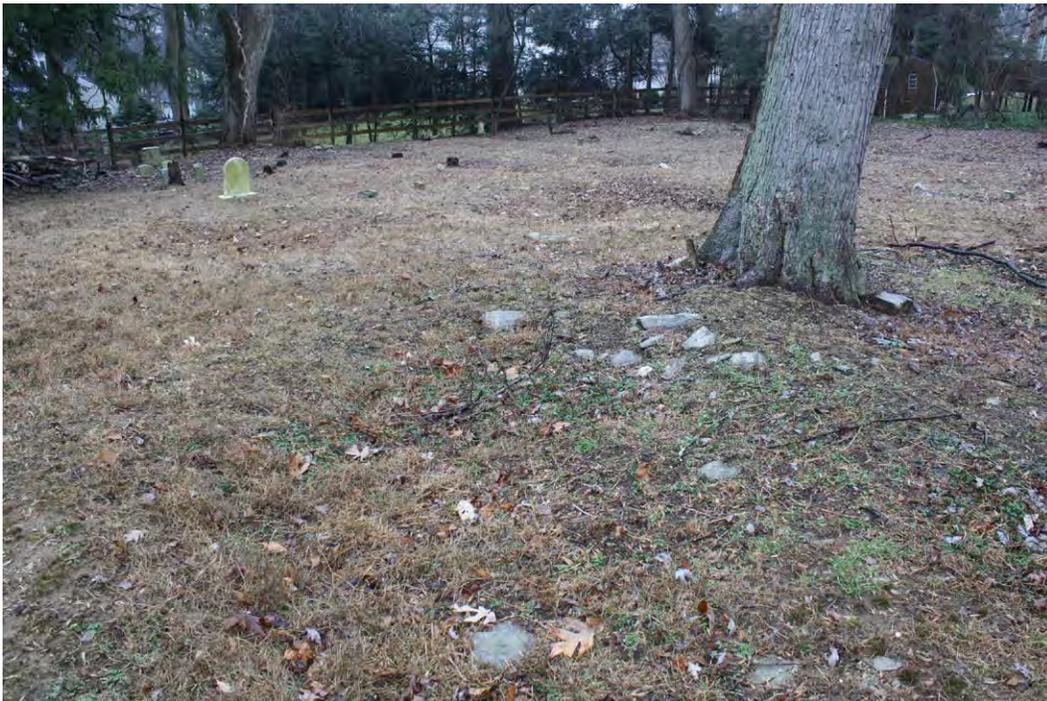
Figure 2.33: View of potential gravemarkers or burial plot enclosures
near the middle of the cemetery.
Photo view: Northwest; Photographer: Jason Harpe; Date: January 19, 2023.

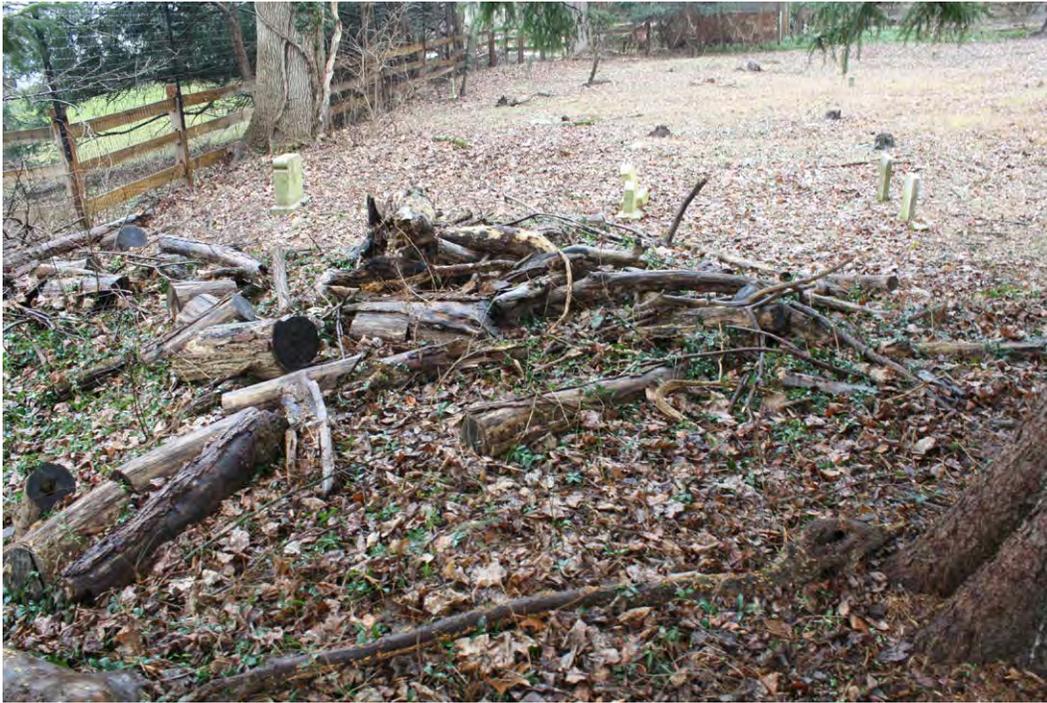
Figure 3.1: A pile of cut trees near Lindley Hill Cemetery's western edge.
Photo view: North; Photographer: Jason Harpe; Date: January 19, 2023.

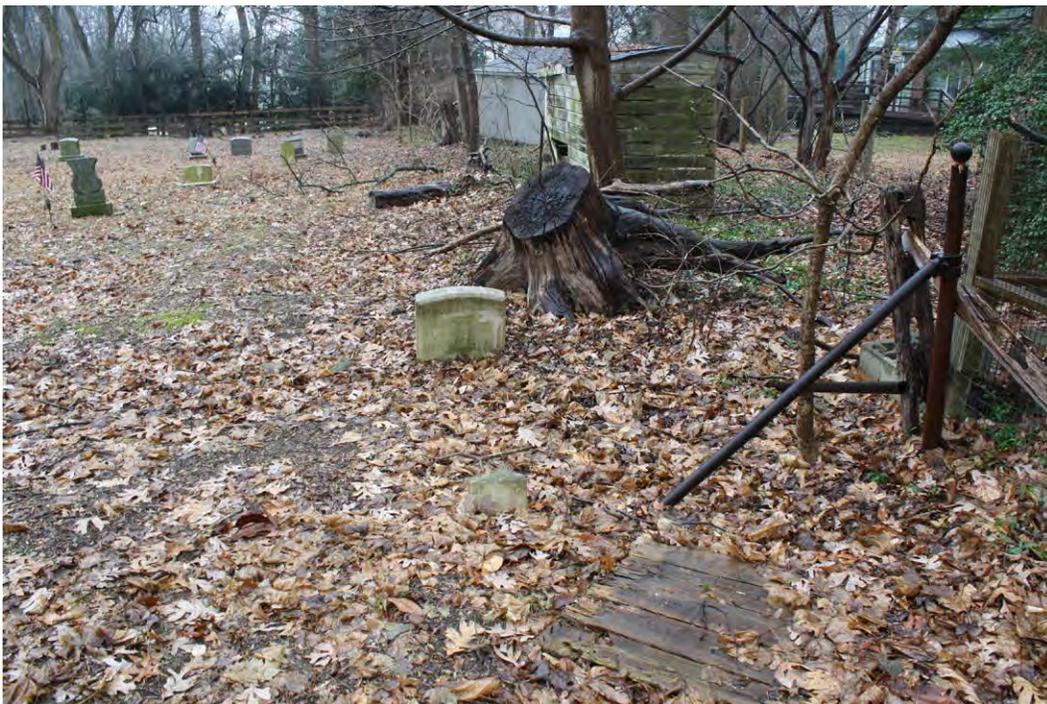
Figure 3.2: View of Lindley Hill Cemetery's northern edge.
Photo view: West; Photographer: Jason Harpe; Date: January 19, 2023.

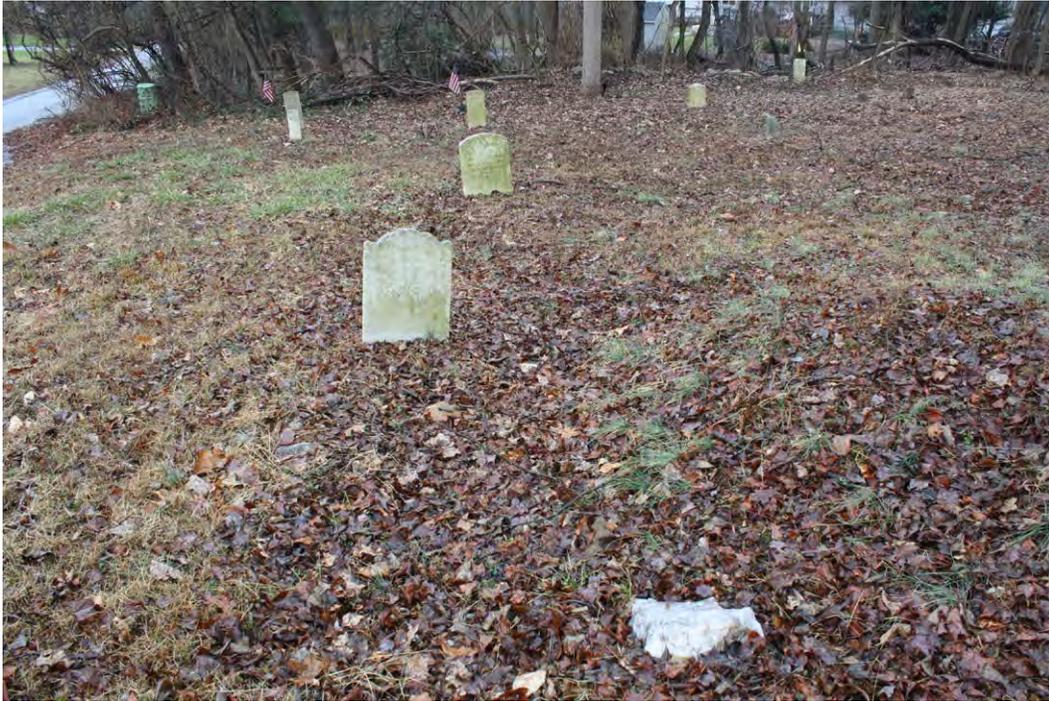
Figure 3.3: Damaged and leaning gravemarkers near Lindley Hill Cemetery's southern edge.
Photo view: West; Photographer: Jason Harpe; Date: January 19, 2023.

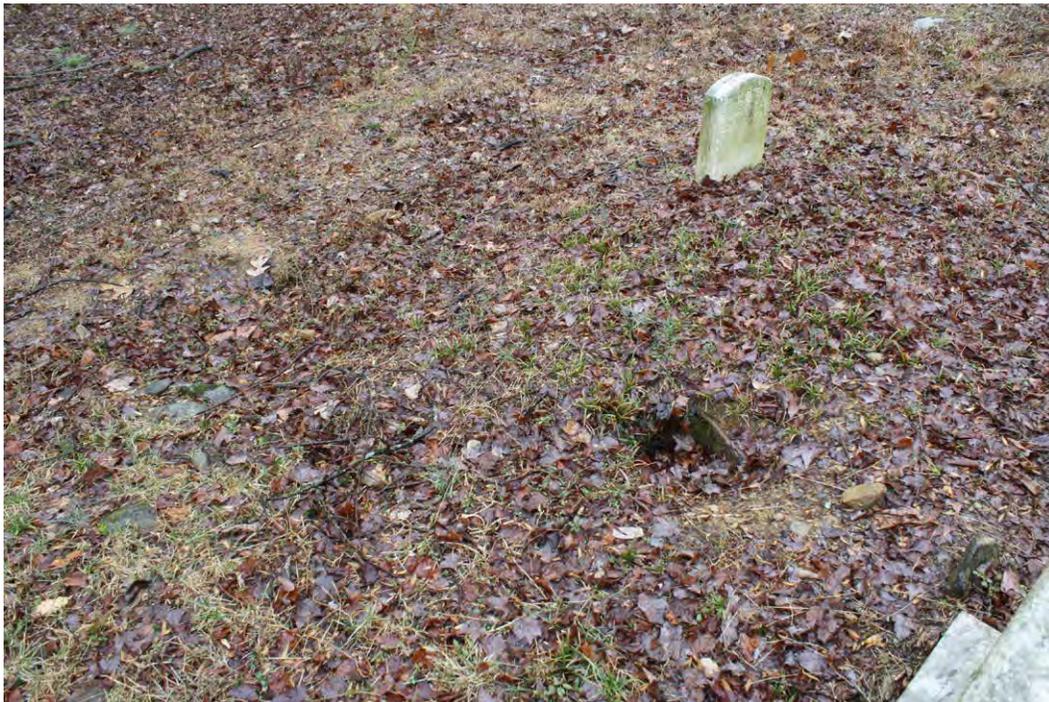
Lindley Hill Cemetery has uneven ground and depressions that may be associated with burials. Some of the depressions are very consistent with a slight caving in or sinking of the earth that is attributable to the decomposition of a coffin to the point of collapsing, but other depressions could result from other types of ground disturbance such as deteriorating tree roots, erosion, water runoff, or activities associated with Zion AME Church and its congregation. Pastor Ivy Berry and the cemetery stewards have expressed concerns over the depressions being a safety hazard and proposed to remedy the situation by grading to fill in the depressions. Pastor Berry and the cemetery stewards should avoid grading of any type in the cemetery and need to conduct a ground-penetrating radar (GPR) survey in the cemetery before considering backfilling potential grave depressions. If Pastor Berry and the cemetery stewards decide to backfill the depressions, they should first mark the head of the burial with a memorial stone. RGA can provide photographic examples of memorial stones used by other cemetery stewards to mark the locations of unidentified decedents.

Figure 3.4: Sunken gravemarkers at burial plots at the Lindley Hill Cemetery.
Photo view: West; Photographer: Jason Harpe; Date: January 19, 2023.

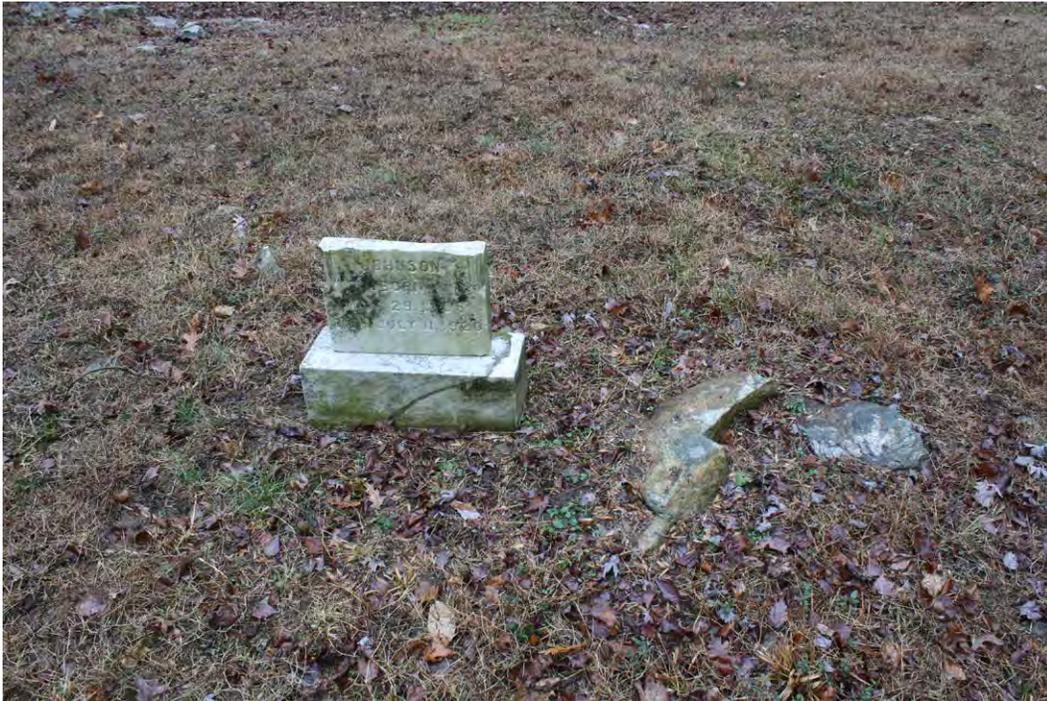
Figure 3.5: A damaged marble tab-in-socket gravemarker at the Lindley Hill Cemetery.
Photo view: West; Photographer: Jason Harpe; Date: January 19, 2023.

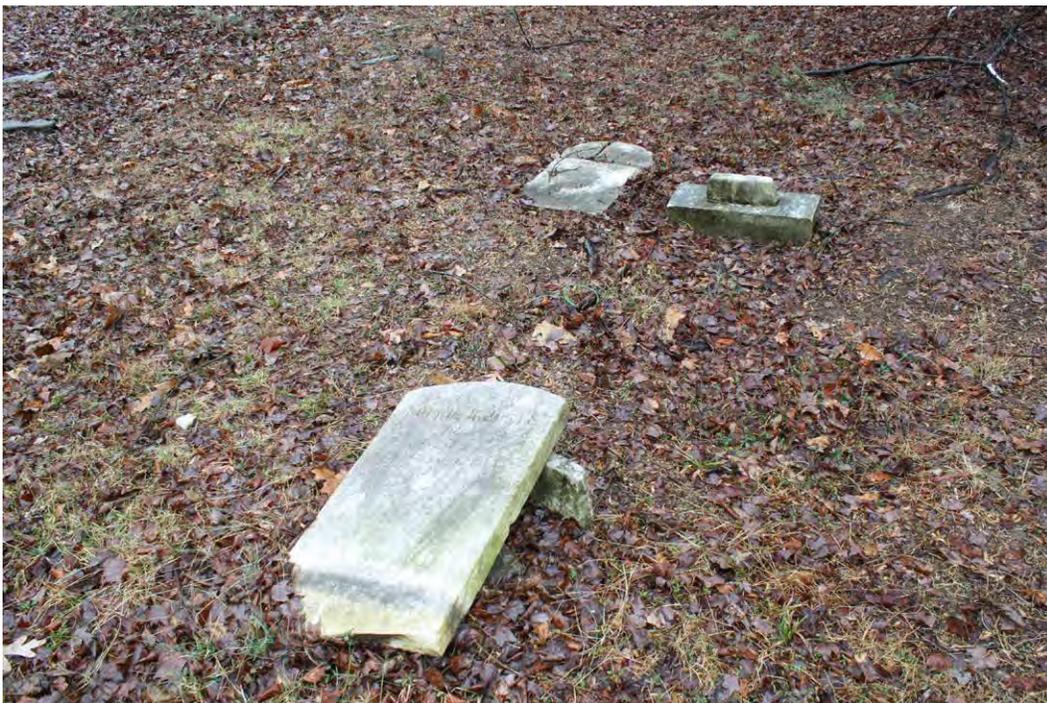
Figure 3.6: Damaged marble ground-supported tablet and tab-in-socket gravemarkers
at the Lindley Hill Cemetery.

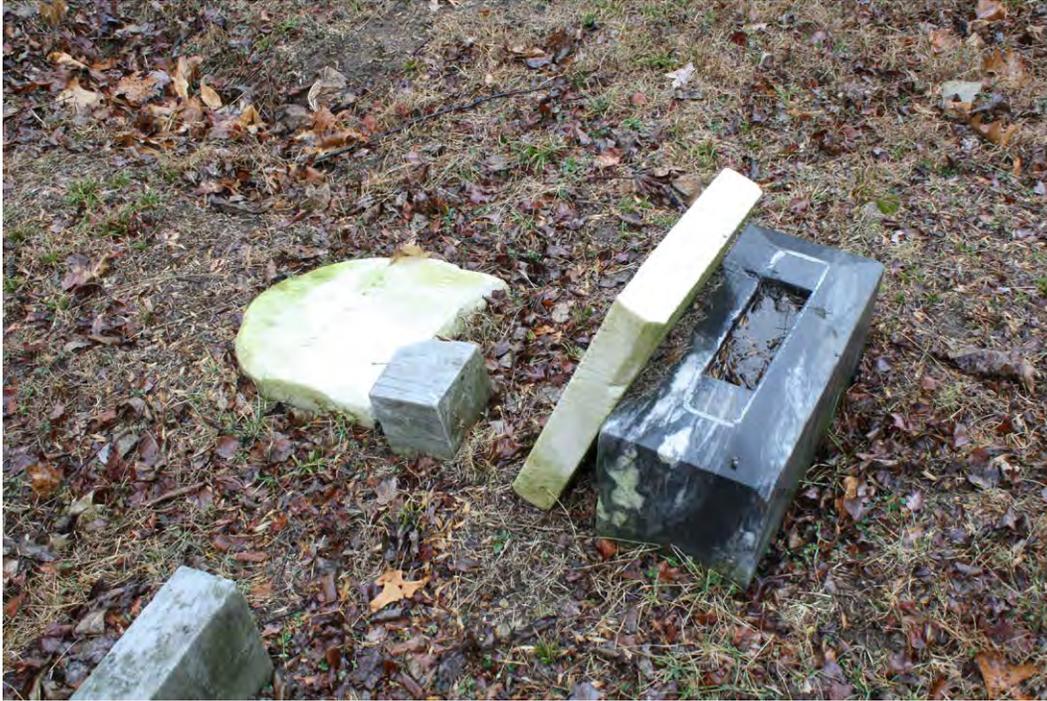
Figure 3.7: Damaged marble tablet with a granite base at the Lindley Hill Cemetery.
Photo view: West; Photographer: Jason Harpe; Date: January 19, 2023.

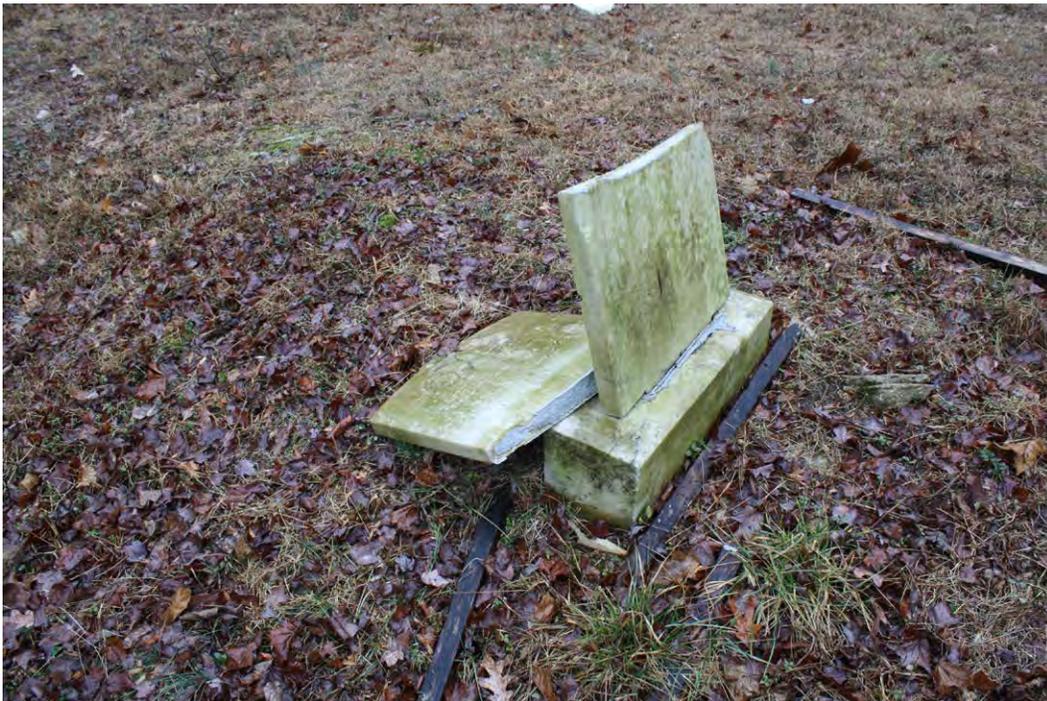
Figure 3.8: Damaged marble tab-in-socket with previous inappropriate repairs
at the Lindley Hill Cemetery.
Photo view: Northwest; Photographer: Jason Harpe; Date: January 19, 2023.

Some gravemarkers at Lindley Hill Cemetery have inappropriate previous repairs. The cemetery stewards or conservators should remove to the greatest extent possible any adhesives from previous repairs without damaging the historic material. The cemetery stewards or conservators should not attempt the removal of previous inappropriate repair materials if it would result in even greater risks to the gravemarker and its mating surfaces. The rules of “do no harm” and “do that which is reversible” always apply to the repair of damaged gravemarkers and should apply to any future repairs to damaged gravemarkers in the Lindley Hill Cemetery. No materials chosen for the repair of the damaged gravemarkers should cause damage to the primary or secondary stone components.

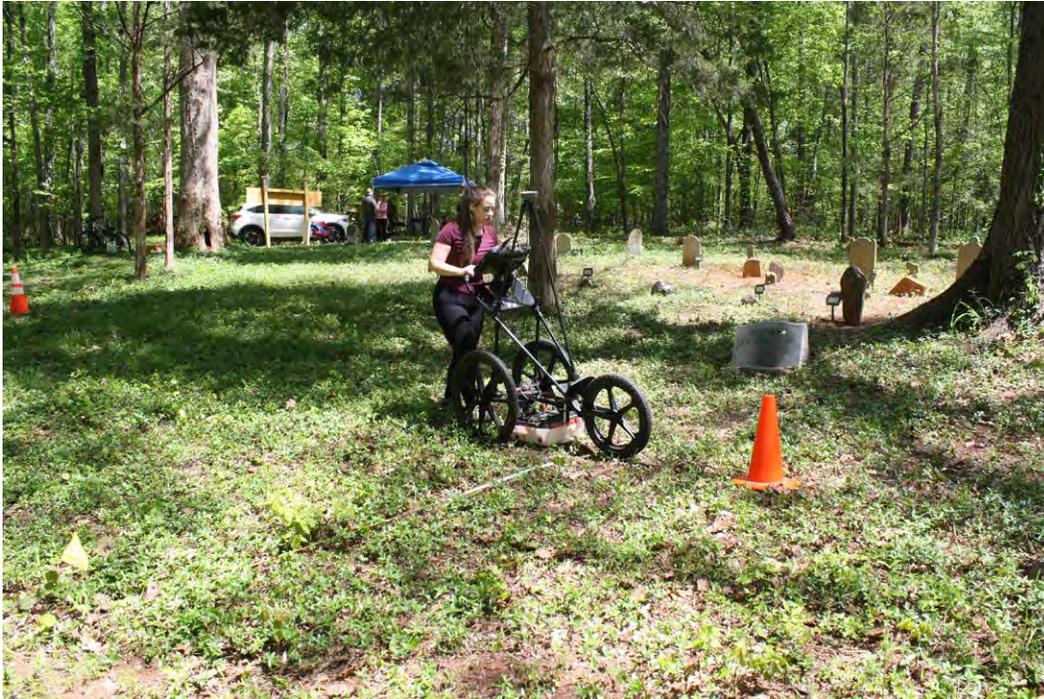
The objective of the GPR survey is to identify the location of marked graves and potential unmarked burials within the limits of the survey area. A GPR survey can identify belowground features, such as grave shafts or coffins, without disturbing the ground surface, and provide the location of marked graves and potential unmarked burial anomalies. Field conditions, such as tree roots, debris, and rocks could affect the results of the survey. Contrast in soils is important for detecting subsurface anomalies such as burials. Over time, distinctions in the soil may be diminished. Since contrast in soils is reduced over time, older burials may be difficult to identify through survey without post-processing (Figures 4.3–4.4).

Figure 4.3: Cayla Cannon, RGA's Geophysical Specialist, conducting a ground-penetrating radar (GPR) survey at the Kiser-Huffstetler Cemetery in Lincolnton, North Carolina.
Photographer: Jason Harpe.

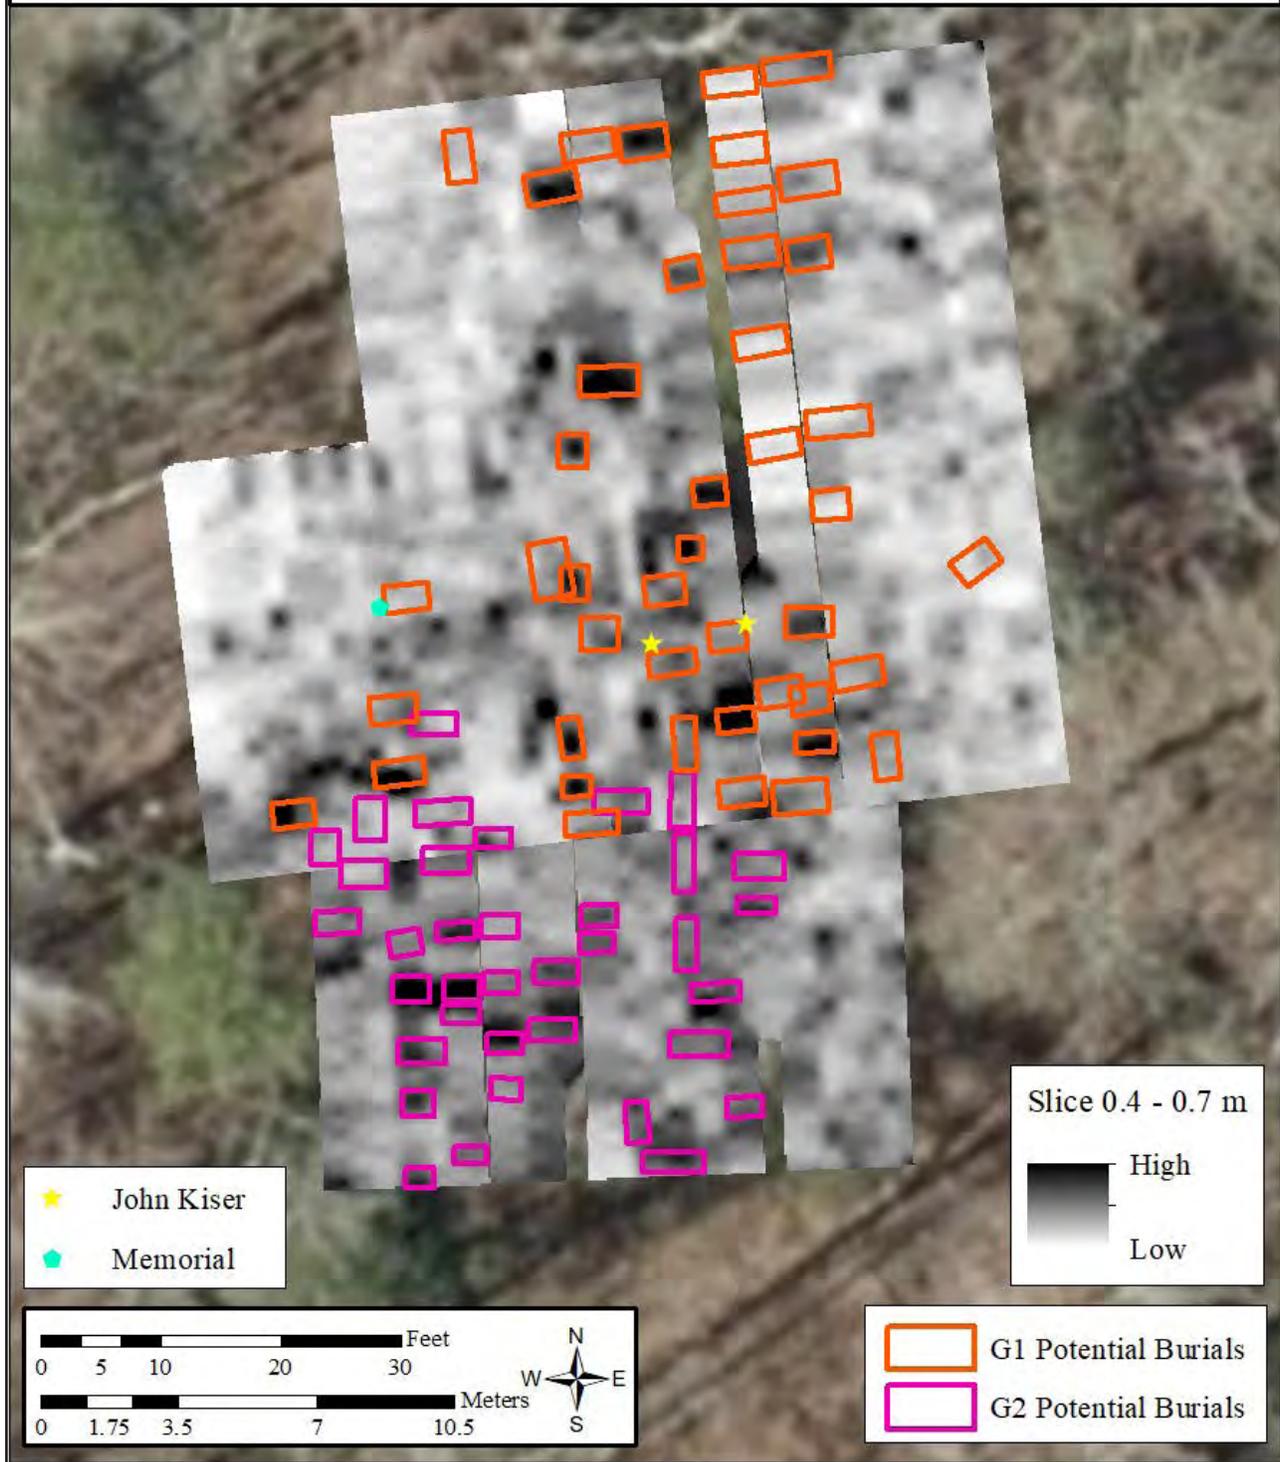
Figure 4.4: A total of 80 potential burials were identified through post processing during the GPR survey of the Kiser-Huffstetler Cemetery. This number includes 44 potential marked and 36 potential unmarked burial anomalies. This graphic shows potential burials in Grids 1 and 2 on a time slice map at 0.4 to 0.7 meters below the surface.

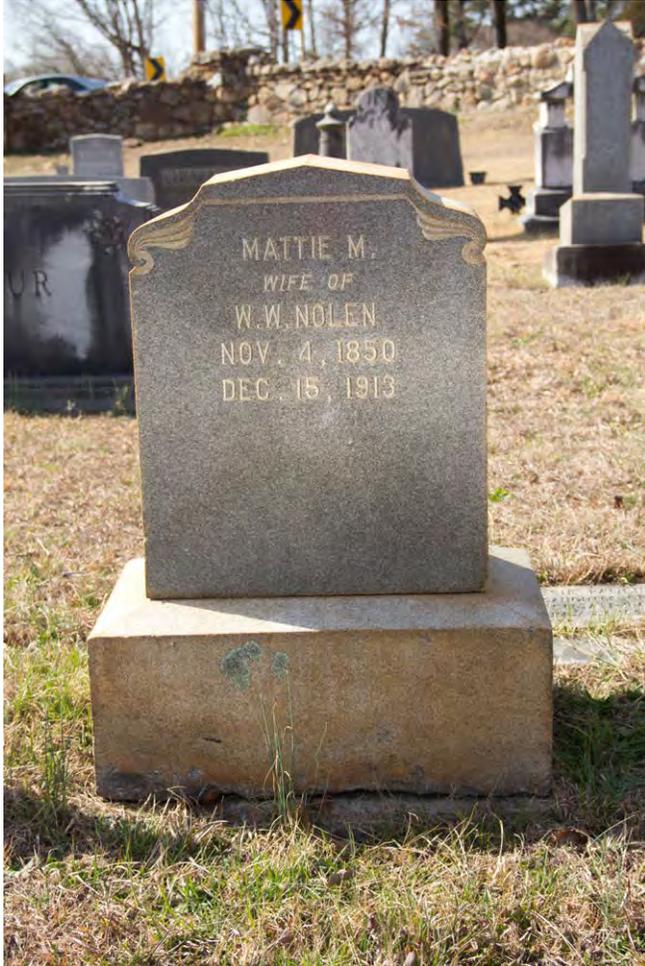
Figure 4.7: A granite die-on-base gravemarker for Mattie M. Nolen (1850–1913), Long Creek Presbyterian Church Cemetery, Bessemer City, Gaston County, North Carolina. The photographer lit the gravemarker with a reflector.
Photographer: Jason Harpe.

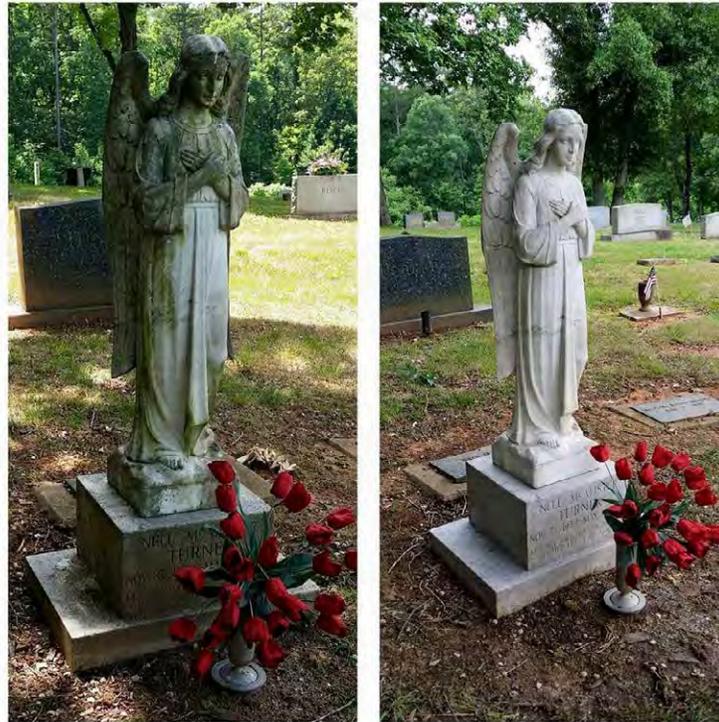
Figure 4.15: Before-and-after photographs of a marble angel in Lincolnton, North Carolina after being cleaned with D/2 Biological Solution.
Photographer: Jason Harpe.

Solution or equivalent biocidal product can be applied and allowed to dwell without rinsing as often as once every year (Figures 4.14–4.17).

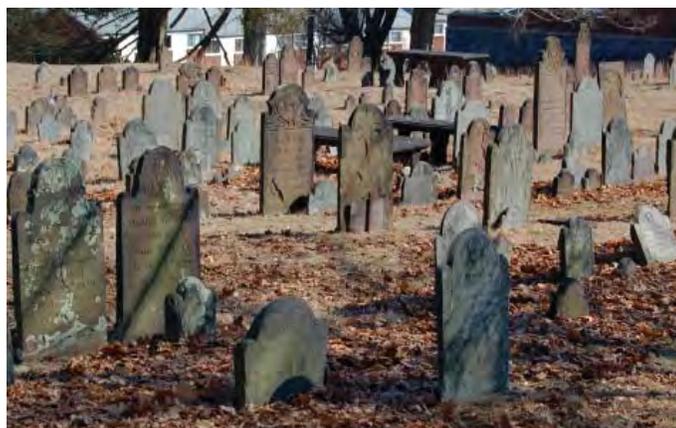
Figure 1. Sandstone and slate grave markers in the Ancient Burying Ground in New London, CT, display a variety of weathering conditions. Markers in the cemetery date from the mid-17th to the early 19th centuries. Photo: Jason Church.

While cemeteries are often considered to be perpetual, their most prominent feature—the grave markers—are not. They weather, naturally decay, often are poorly maintained and repaired and, on occasion, are vandalized (Fig. 1). Grave markers are usually noteworthy not only for their inscriptions but also for their craftsmanship. Exceptional markers are considered works of art.

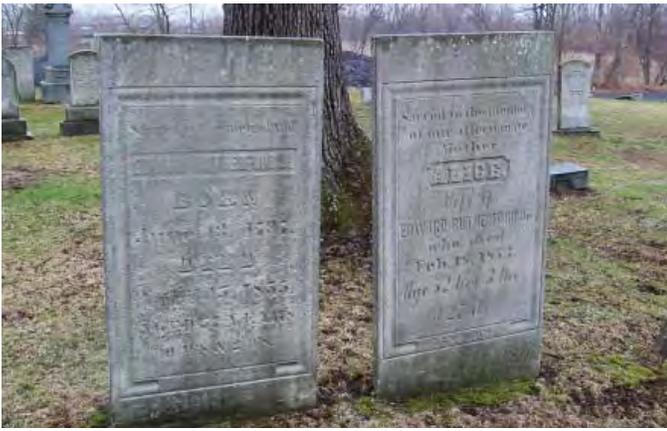
Figure 2. These mid-19th century, single-element stone grave markers in the Grove Cemetery in Bath, NY, are set in a vertical position. Photo: Jason Church.

The great variety in the types of grave markers is a fascinating aspect of the study and appreciation of historic cemeteries. Three broad categories can be used to describe grave markers—(1) single-element, (2) multiple-element, and (3) structures. Single-element grave markers are stone, cast iron, or wood elements that are set in a vertical position or placed as a horizontal slab on the ground (Fig. 2). Early examples of this simplest type of grave markers are field stone and basic wooden or wrought iron crosses, with the name of the deceased person scratched into or engraved on the marker. Often, these rudimentary grave markers are overlooked, significantly deteriorated, or lost. Vertical stone slabs and large stone ledgers laid horizontally over the gravesite are more sophisticated examples of this type.

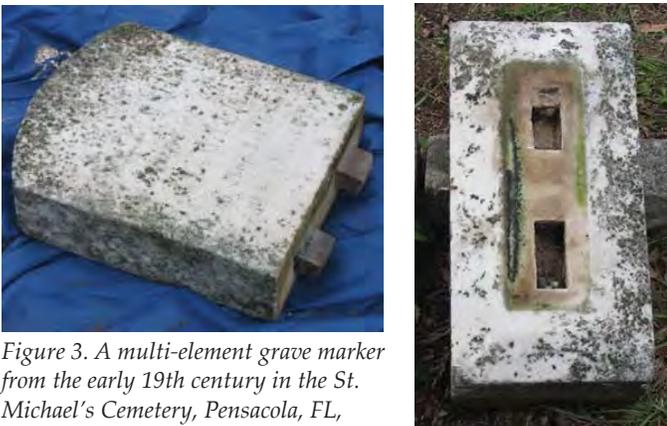
Figure 3. A multi-element grave marker from the early 19th century in the St. Michael’s Cemetery, Pensacola, FL, consists of a vertical element with tabs (left image) into a slotted base (right image). Photo: Fran Gale.

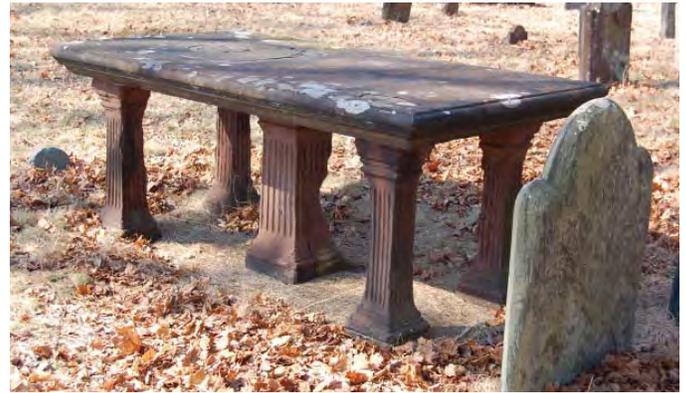
Figure 4. This sandstone table tomb, located in Cedar Grove Cemetery, New London, CT, is an engineered grave marker structure consisting of a horizontal stone tablet supported by four vertical table “legs” with and a central column,. Photo: Jason Church.

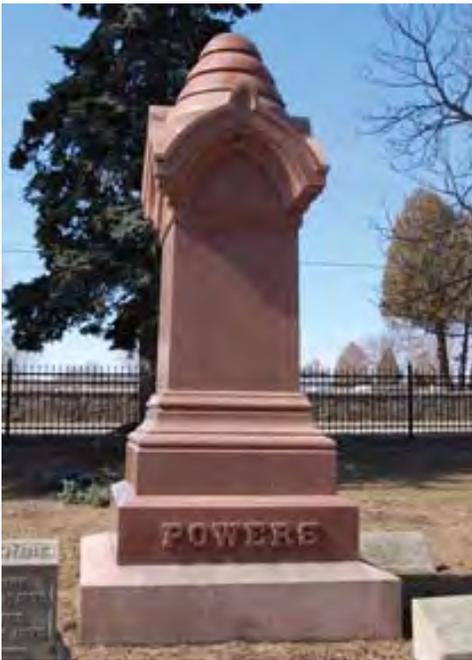
Figure 5. A variety of colors of natural stone are found in historic cemeteries, such as this pink granite marker in the Cedar Grove Cemetery, New London, CT. Photo: Jason Church.

Stone is a naturally occurring material with a wide range of properties and is available in a variety of colors (Fig. 5). Geologists classify stone according to the way in which it was formed with the three categories being igneous, sedimentary and metamorphic rock. Stone found in cemeteries is predominantly quarried, though the use of field stones is not uncommon. The mineralogy and chemical composition of stones vary. Some are composed primarily of silicate minerals; granites, sandstones, slate, and schist are examples. Other stones contain calcium carbonate with marble and limestone in this group. Mineralogy, chemical composition, and physical structure of the stone influence weathering and
