PENNSYLVANIA HERITAGE AREAS AFRICAN AMERICAN CEMETERY PILOT PROJECT

LINDLEY HILL AME ZION CHURCH CEMETERY PRESERVATION PLAN Downingtown, Chester County, Pennsylvania

RGA Technical Report 2022-341PA

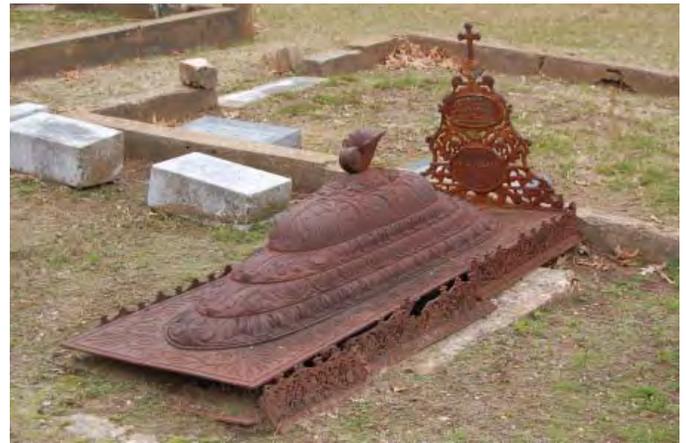
Figure 6. Decorative cast-iron grave markers like this late-19th century one in Oakland Cemetery in Shreveport, LA, are produced by heating the iron alloy and casting the liquid metal into a mold. Photo: Jason Church.

Metals are solid materials that are typically hard, malleable, fusible, ductile, and often shiny when new (Fig. 6). A metal alloy is a mixture or solid solution of two or more metals. Metals are easily worked and can be melted or fused, hammered into thin sheets, or drawn into wires. Different metals have varying physical

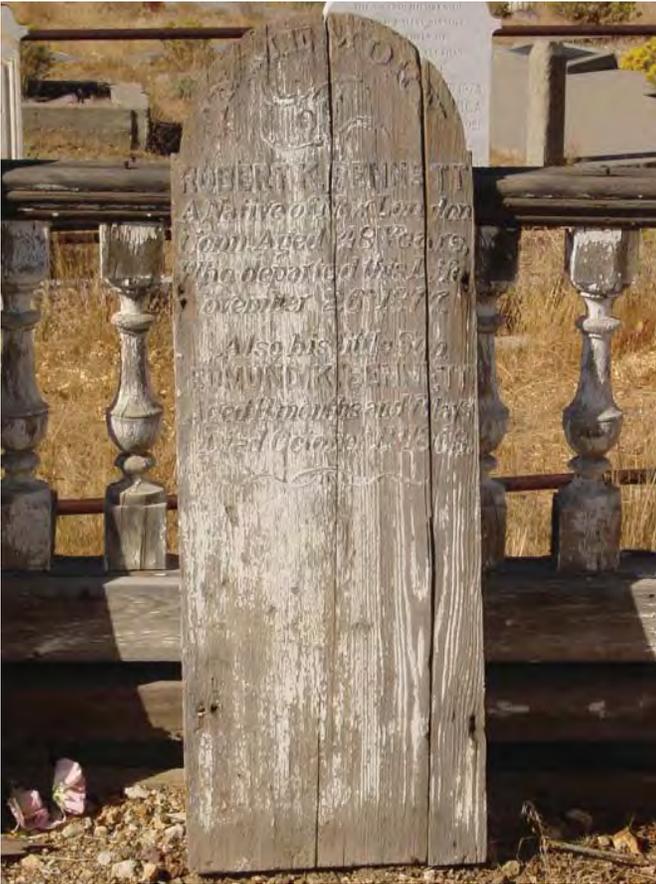
Figure 7. As shown by this 1877 marker in Silver Terrace Cemetery, Virginia City, NV, exposure to sunlight can damage wood grave markers, making the wood more susceptible to water damage and cracking. Photo: Jason Church.

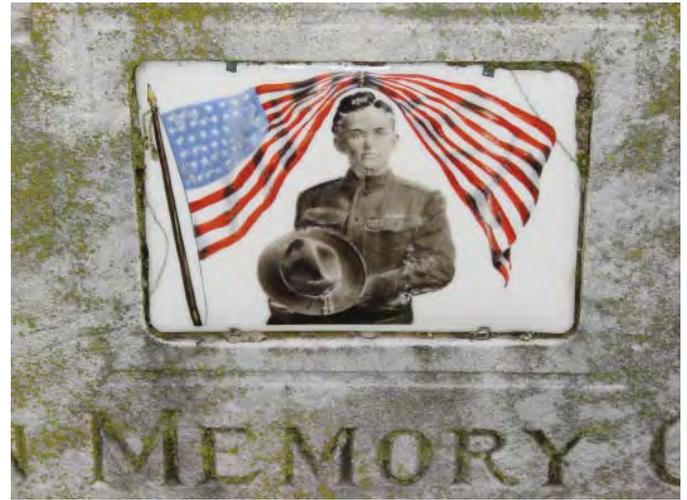
Figure 8. A fired ceramic, this cameo is set in a marble grave marker, located in Elmwood Cemetery, Memphis, TN. Different materials may require different conservation approaches. Photo: Mary Striegel.

Old cemeteries often include a wide variety of other materials not normally associated with contemporary grave markers, such as ceramics, stained glass, shells, and plastics (Fig. 8). As with masonry, metals, and wood, each has its own chemical and physical properties which affect durability and weathering. These materials

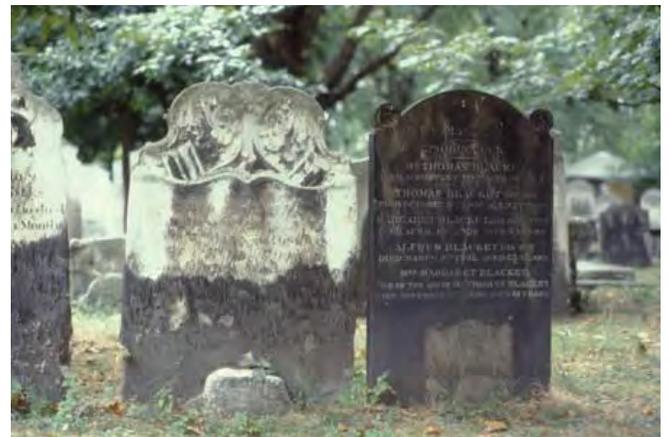
Figure 9. The limestone and sandstone grave markers in this historic cemetery have different weathering processes. On the left, the limestone shows surface loss in areas exposed to rainwater and gypsum crust formation below. The sandstone marker on the right displays uniform soiling, but surface hardening may be occurring. Photo: Fran Gale.

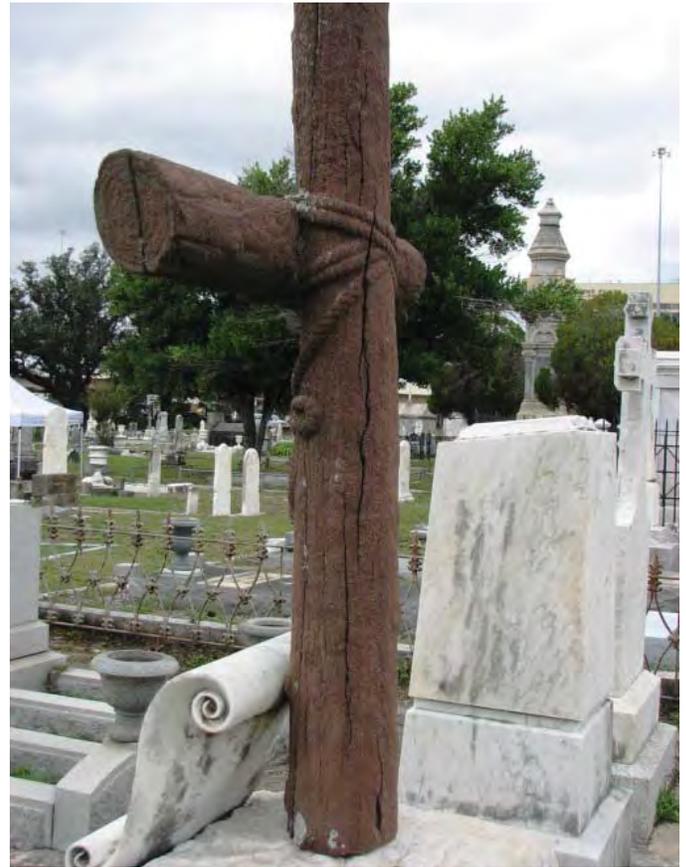
Figure 10. The sandstone cross (carved to look like wood) in this grave marker in St. Michael's Cemetery in Pensacola, FL, provides an example of inherent vice – the severe delamination affecting the sandstone has occurred along its natural bedding planes.

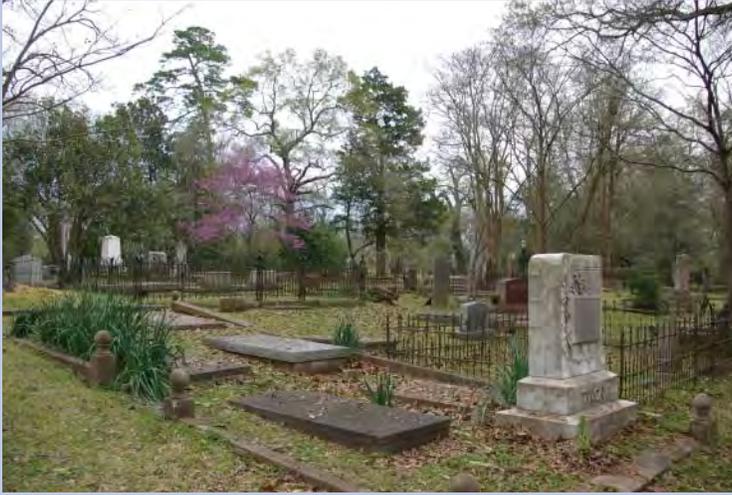
Figure A. Cemeteries are cultural landscapes made up of a variety of features. Grave markers are but one component of cemeteries that also include walkways, drives, fences, coping, trees, shrubs, and other vegetation. Each component adds to the understanding of the cemetery landscape. Photo: Debbie Dietrich Smith.

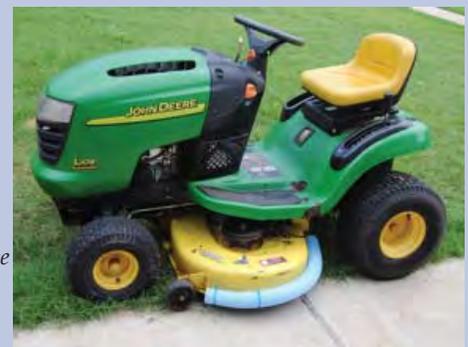
Figure B. A pool ‘noodle’ can be fitted to the deck of a lawnmower to prevent damage to grave markers. Photo: Debbie Dietrich Smith.

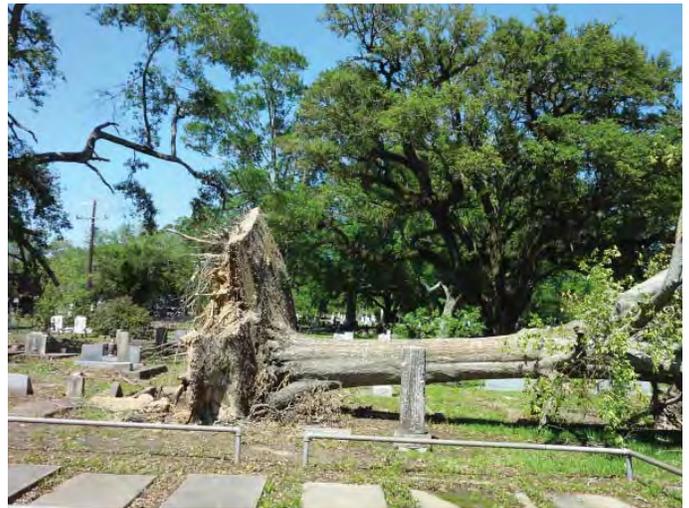
Figure 11. Woody vegetation can damage grave markers and pose a risk to visitors unless well managed and maintained. Photo: Jason Church.

Woody vegetation can damage grave markers in a variety of ways (Fig. 11). Trees, bushes, and vines can shade grave markers, extending the time that the markers are exposed to moisture. Tendrils and roots may burrow into mortar joints and openings, causing mechanical damage and large plants may lift up or shift markers. Even leaves and twigs, when allowed to collect on the ground near grave markers, can affect water drainage and evaporation (Fig. 12).

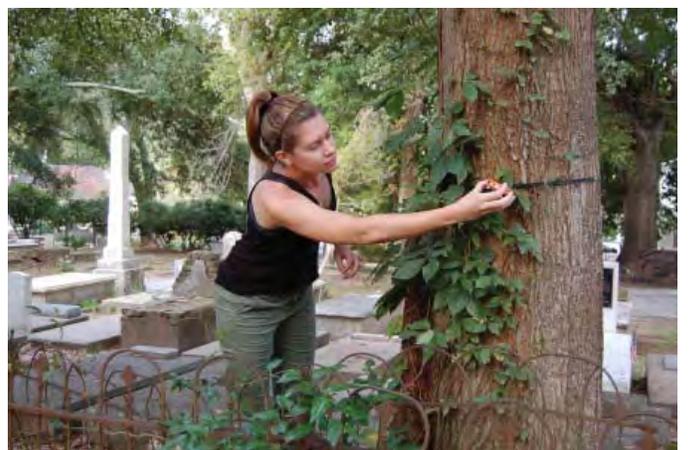
Figure 12. A cemetery professional undertakes a tree inventory in American Cemetery, Natchitoches, LA, to determine the health of trees in the cemetery. Management decisions for trimming or removal are based on the inventory. Photo: Debbie Dietrich Smith.

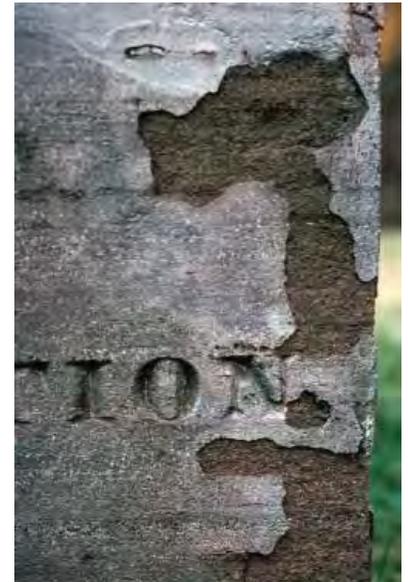
Figure 14. High-pressure water washing can damage grave markers. The photograph shows "wand marks" on the headstones produced by inappropriate pressure washing. Photo: Jason Church.

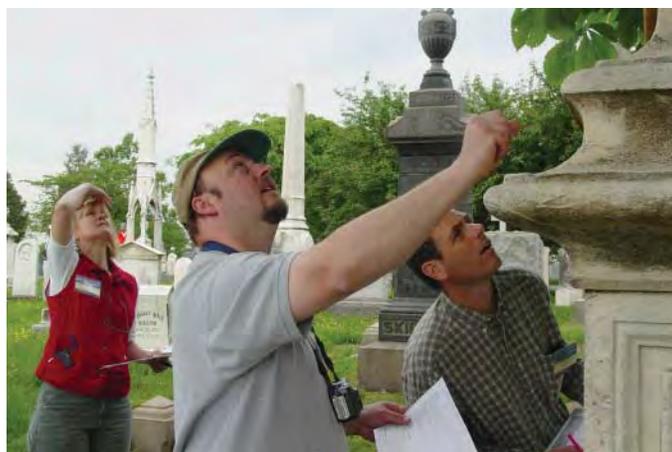
Figure 15a. Condition surveys are undertaken to document current conditions, determine safety issues, and plan both emergency stabilization and future treatment plans. There are a variety of survey forms available that can be tailored to the specific cemetery. Photo: Mary Striegel.

Depending upon the size of the cemetery and funding available, the initial assessment may be carried out by a team consisting of cemetery staff, a materials conservator, and, where necessary, an architect or structural engineer for cases involving large monuments and mausoleums (Figs. 15a and 15b). For smaller cemeteries without large monuments and mausoleums, and where funding is problematic, volunteers can be trained to prepare a condition assessment under the guidance of an experienced individual.

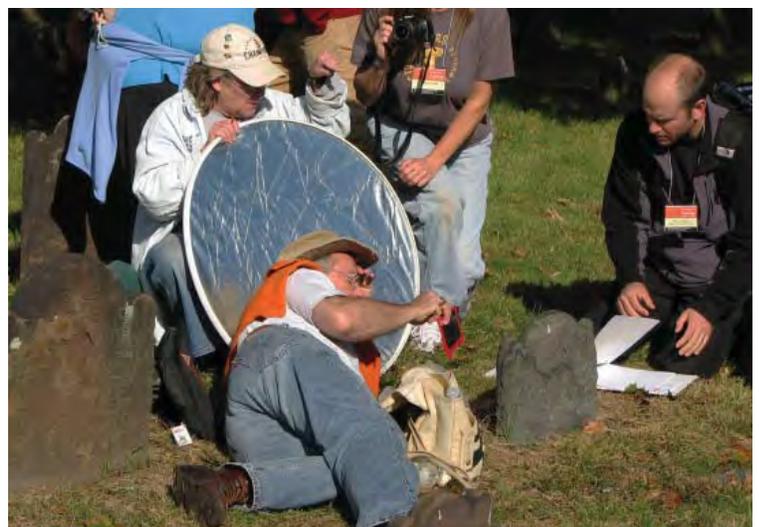
Figure 15b. Photographs are used to document the condition of the grave marker as part of a condition assessment. Photo: Fran Gale.

A tool kit for the condition assessment may include binoculars, digital camera, magnifying glass, measuring tape, clipboard, carpenter's rule, level, magnet, and flashlight. For large monuments, a ladder or aerial lift may be required. Photographs of each marker, including overall shots and close-up details, are an essential part of the documentation process. Photo logs are helpful for

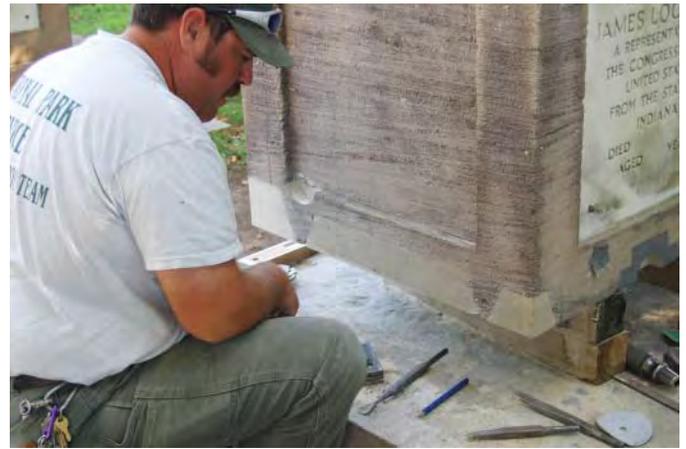
Figure 16. A professional mason works to insert a new piece of stone. Often referred to as a “dutchman”, this repair technique requires replacing the deteriorated stone section with a new finished piece of the same size and material. Photo: Jason Church.

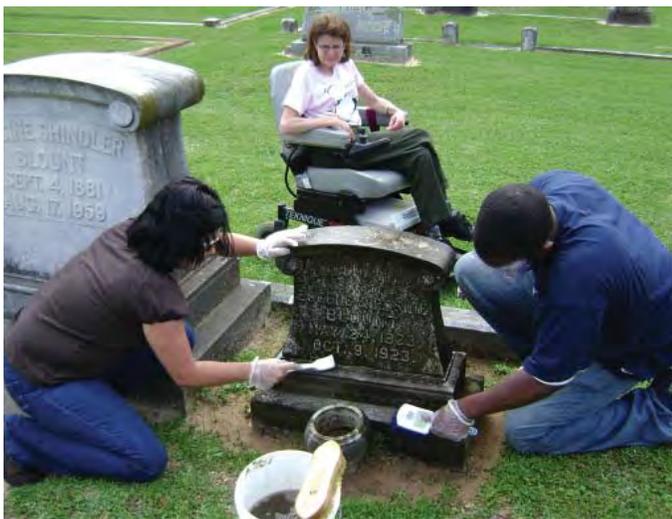
Figure 17. Volunteers can undertake cleaning of grave markers once they have received initial training. Cleaning methods may include wetting the stone, using a mild chemical cleaner, gently agitating the surface with a soft bristle brush, and thoroughly rinsing the marker with clean water. Photo: Jason Church.

Cleaning is carried out to remove soiling, staining, and contamination from grave markers (Fig. 17). Cleaning improves the visual appearance of the marker and sometimes reveals existing problems such as erosion and cracks. For various protective treatments, cleaning may be a necessary step in surface preparation. Although cleaning often is desirable and beneficial, the use of improper materials and techniques can cause great damage; when cleaning historic grave markers is undertaken, one should keep in mind the principle, “first do no harm.”

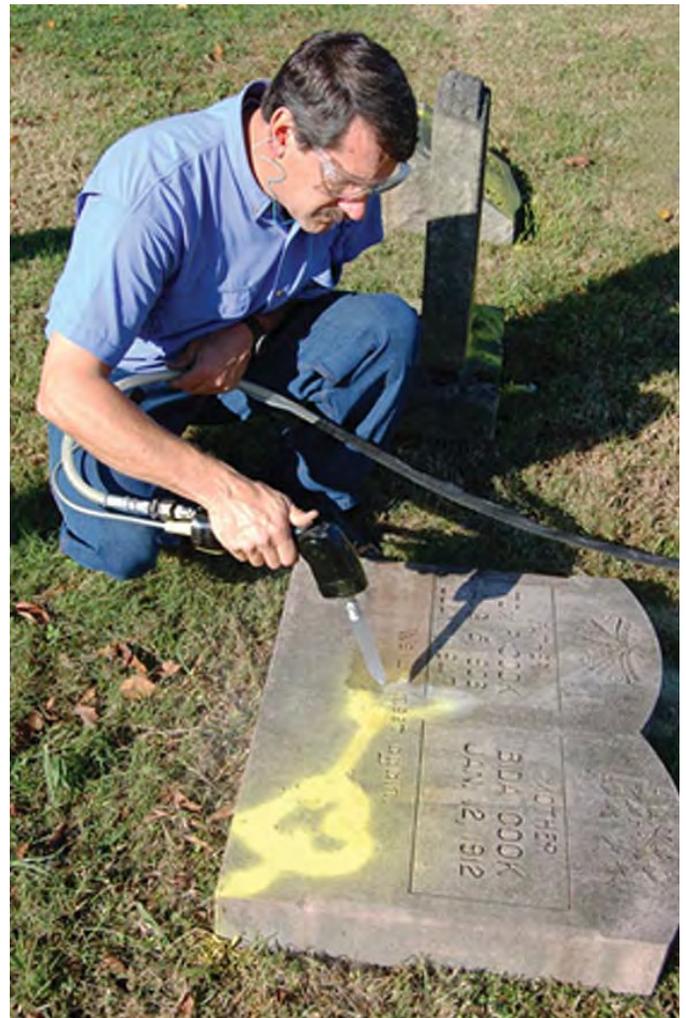
Figure 18. Graffiti is carefully removed using a low-pressure dry-ice misting instrument. Photo: Jason Church.

Markers with graffiti tend to be targets for further vandalism (Fig. 18). Timely removal helps deter future vandalism and improves the marker’s appearance.

If the graffiti is water soluble, it can be removed using water and a soft cloth or towel. Rinsing the cloth frequently helps to avoid smearing graffiti on unaffected areas. If the graffiti is not water soluble, organic solvents or commercial graffiti removal products suitable for the grave marker material are recommended. Products should be tested prior to use. General cleaning of the entire marker is a good follow-up for a more even appearance. For deep-seated graffiti, poultice cleaning (previously described) may be required to extract staining materials.

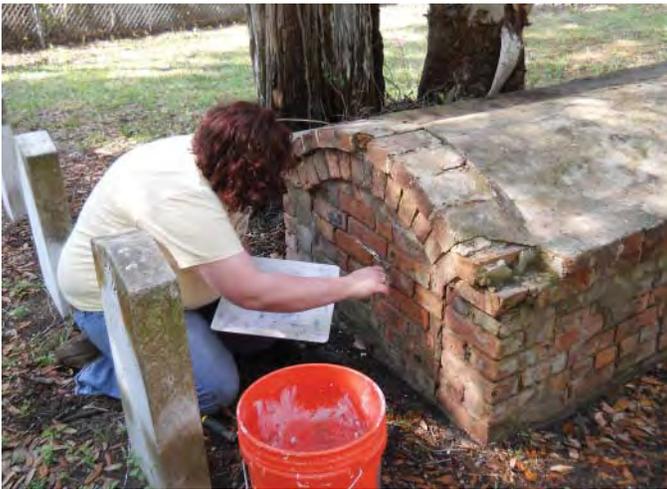
Figure 19. Masonry markers like this box tomb may require the repointing of mortar joints. It is important to use a mortar that is softer than the historic brick. In this case a conservator uses a lime putty-based mortar to repoint. Photo: Jason Church.

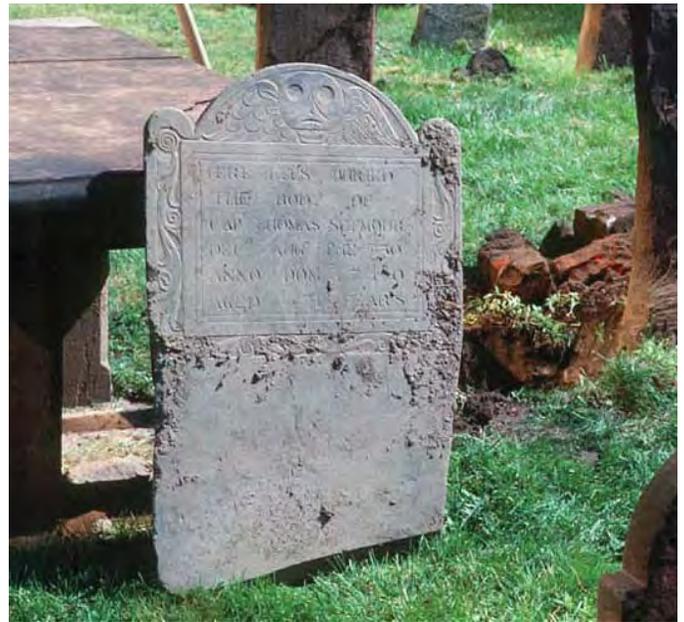
Figure 20a. This slate grave marker in the Ancient Burying Ground in Hartford, CT, is a ground-support stone. Resetting requires digging a hole that will hold the base of the stone and then compacting the soil at the bottom of the hole by hand. Photo: Fran Gale.

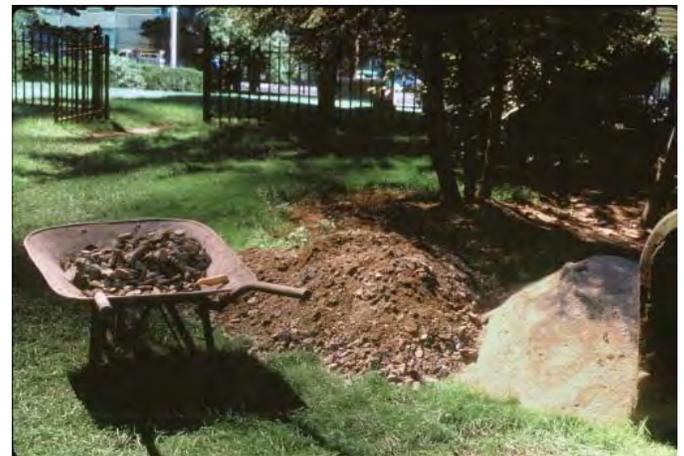
Figure 20b. To facilitate drainage, crushed stone, gravel, and sharp sand line the hole and are hand-tamped around the stone after placement. Photo: Fran Gale.

Resetting is recommended for grave markers when their foundations are unstable or out of plumb (Figs. 20a through 20c). This often complex activity involves lifting the grave marker, leveling its foundation, and returning the marker to its original upright position. Workers can be injured and the grave marker damaged if resetting is not carried out properly and safely.

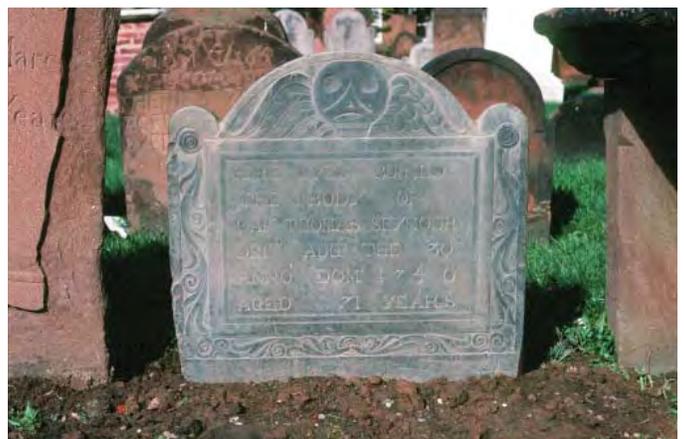
Figure 20c. The reset ground-supported grave marker should be level and plumb. Photo: Fran Gale.

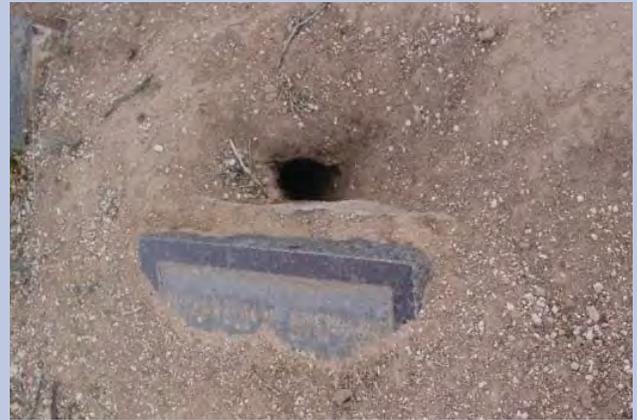
Figure C. Gophers and other burrowing animals produce uneven ground and holes that are trip and falling hazards to visitors and staff of historic cemeteries. Photo: Jason Church.

Trip and falling hazards include uneven ground, holes, open graves, toppled grave markers, fallen tree limbs, and other debris (Fig. C). Sitting, climbing, or standing on a grave marker should be avoided since the additional weight may cause

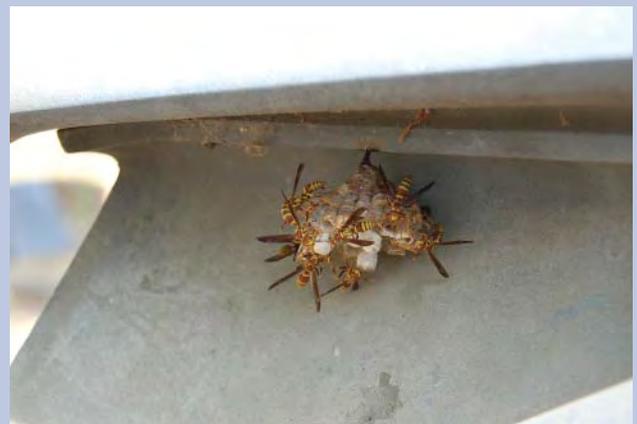
Figure D. Yellow jackets that are nesting below the projecting molding of this grave marker pose a hazard to visitors and staff because, if disturbed, they will vigorously defend their nest. Yellow jacket, paper wasp and hornet nests should be removed from grave markers by trained staff or specialists. Photo: Jason Church.

Snakes, wasps, and burrowing animals inhabit historic cemeteries (Fig. D). Snakes sun on warm stones and hide in holes and ledges, so it is important to be able to identify local venomous snakes. An appropriate venomous snake management plan should be in place, and

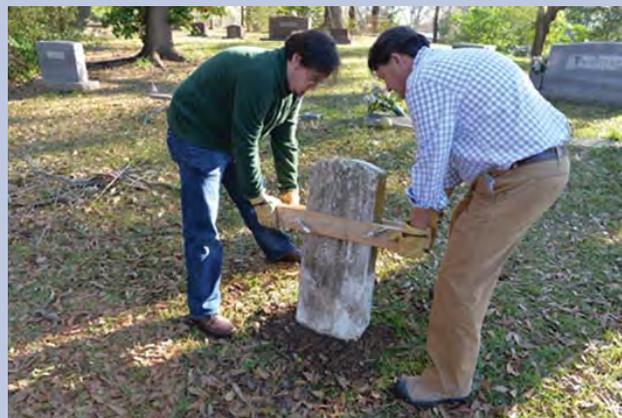
Figure E1. The simple wooden clamp system allows two people to safely lift a marble grave marker. Photo: Sarah Jackson.

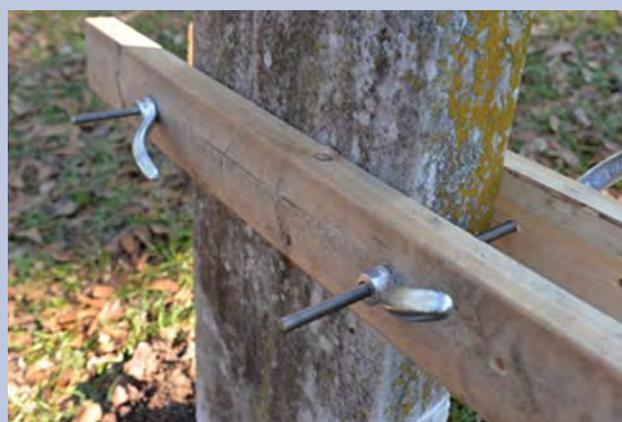
Figure E2. The clamp system is constructed from off-the-shelf wooden boards. Photo: Sarah Jackson.

lifting techniques. Lift equipment and ergonomically correct tools should be routinely used to lift heavy markers (for most people this includes markers that weight more than 50 pounds). For smaller grave markers, a simple wooden clamp system can be constructed for a two-person lift (Figs. E1 and E2).

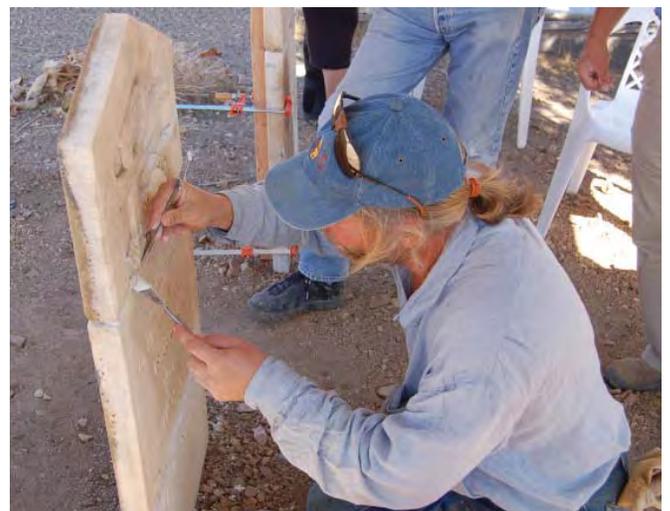
Figure 21. Cracks in a stone marker should be filled to keep water and debris out and prevent the crack from becoming larger. A patching mortar is designed to be used, in this case, with historic marble. Photo: Mary Striegel.

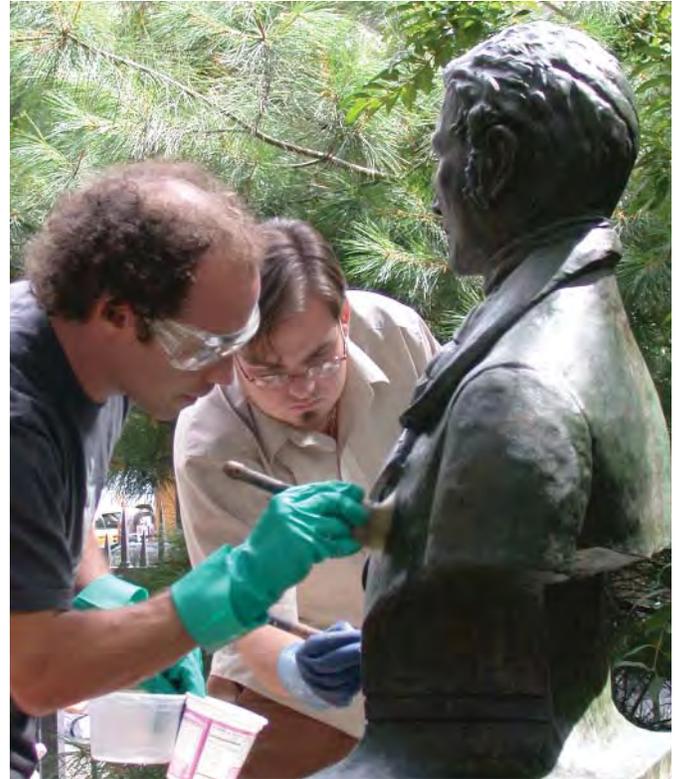
Figure 22. A protective coating must be maintained on metal elements. Wax or lacquer coatings help preserve the bronze patina and slow corrosion. Conservators apply a microcrystalline wax to this bust at St. Mark's Church in-the-Bowery, New York, NY. Photo: John Scott.

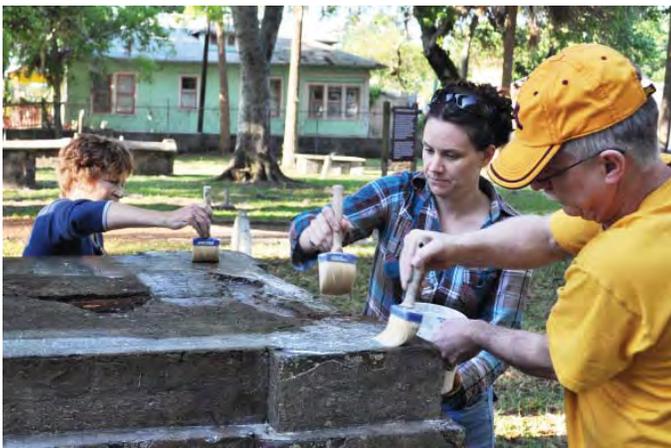
Figure 23. Limewash is a breathable coating sometimes used to protect the surface of the grave marker and provide a decorative finish. Limewash is applied by brush in five to eight thin coats (with each coat about the consistency of skim milk). The surface is allowed to slowly dry between coats. Sometimes the surface is covered by damp burlap to slow the drying process. Photo: Sarah Jackson.

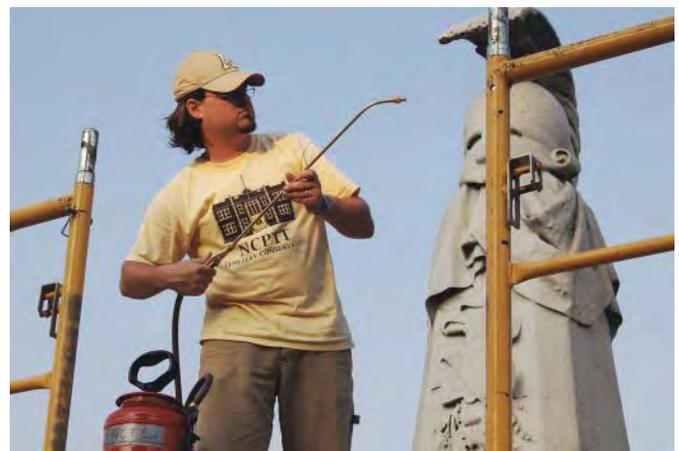
Figure 24. A severely deteriorating monument or grave marker can be treated with a stone consolidant. The treatment is usually applied using a spray system. The consolidant soaks into the stone and replaces mineral binders that hold the stone together. On-site and laboratory testing and evaluation are performed prior to using this non-reversible type of treatment. Photo: Lucas Flickinger.

When erosion is severe, consolidation treatments (e.g., ethyl silicate) have been used to replace mineral binders lost to weathering (Fig. 24). Because these treatments are not reversible, laboratory and on-site testing are essential. Application by a conservator or other experienced preservation professional is advised.
