PRESERVATION PLAN

PENNSYLVANIA AFRICAN AMERICAN CEMETERY STEWARDSHIP PROGRAM

Lincoln Cemetery
201 South 30th Street and Penbrook Avenue
Harrisburg, Dauphin County, Pennsylvania

February 2024

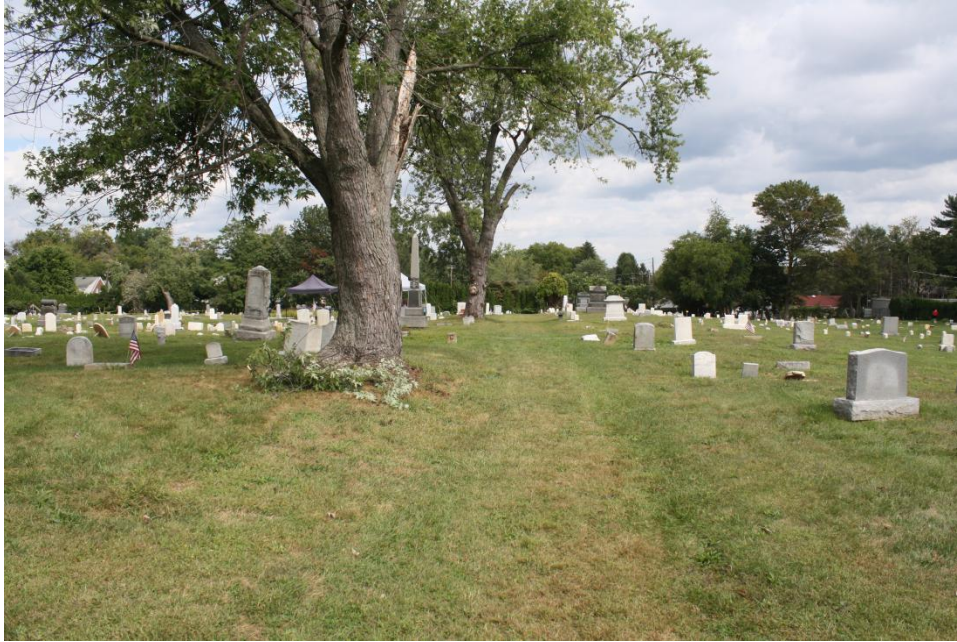
Figure 8: Grass driveway that extends west to east through Lincoln Cemetery; Photo view: East; Photographer: Jason Harpe; Date: September 18, 2023.

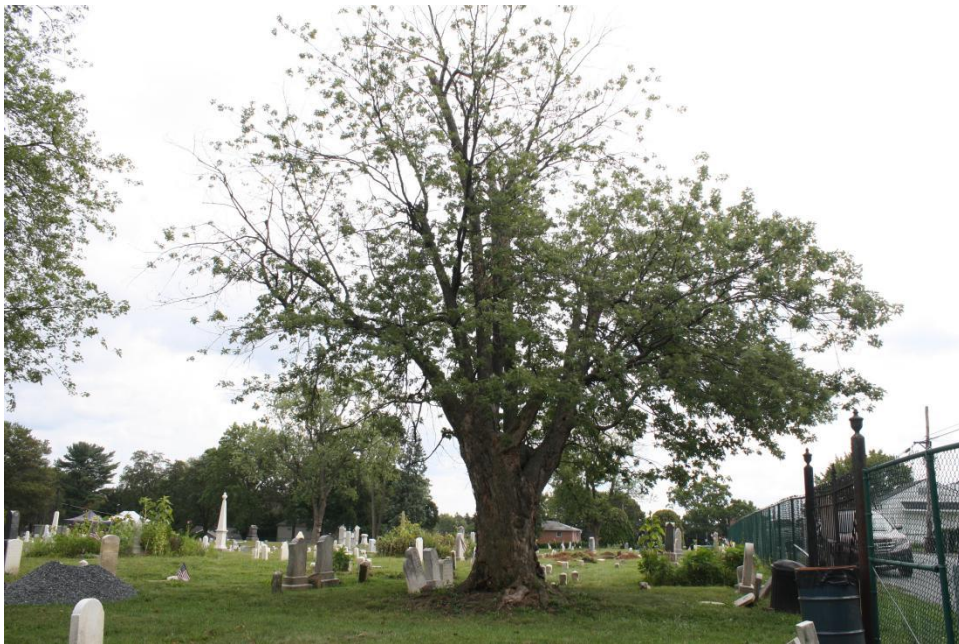
Figure 13: A large tree at Lincoln Cemetery's north elevation that should be evaluated by an arborist; Photo view: South; Photographer: Jason Harpe; Date: September 18, 2023.

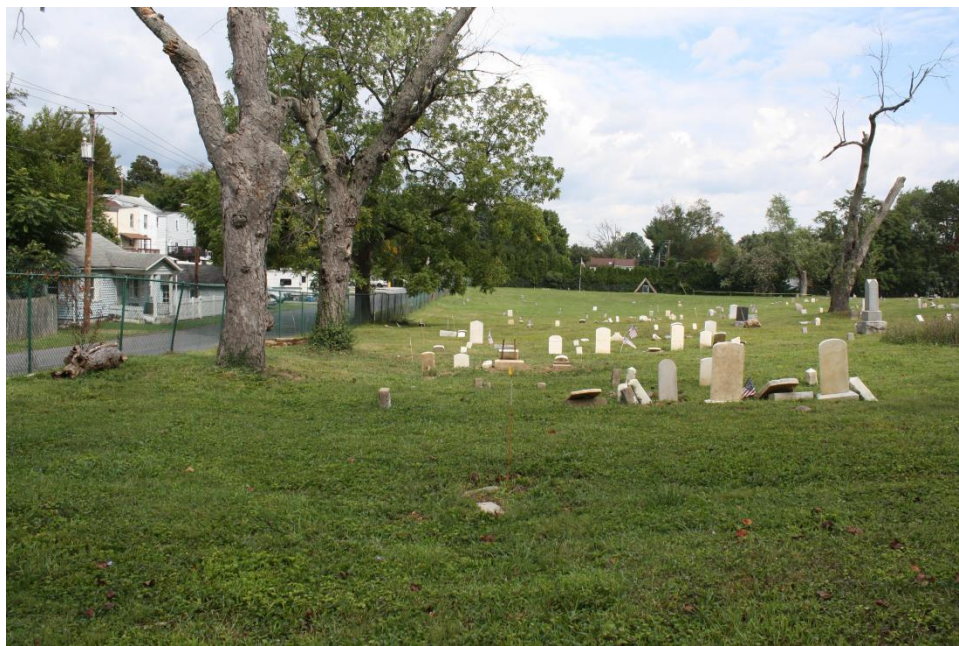
Figure 15: Large trees at Lincoln Cemetery's north elevation that should be evaluated by an arborist; Photo view: East; Photographer: Jason Harpe; Date: September 18, 2023.

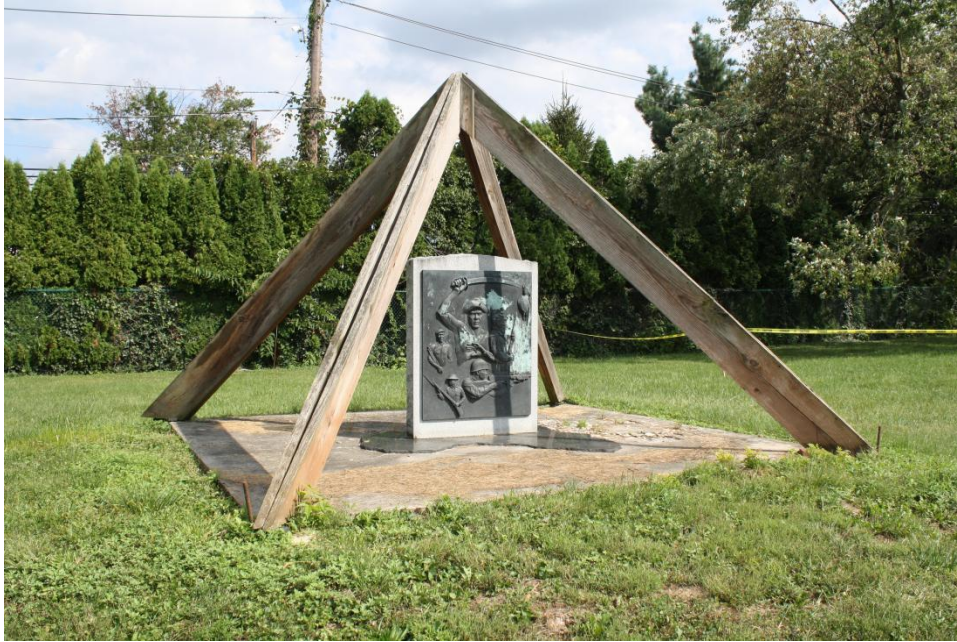
Figure 18: Granite and bronze commemorative marker for African American military veterans. The bronze plaque was completed in 1994; Photo view: East; Photographer: Jason Harpe; Date: September 18, 2023.

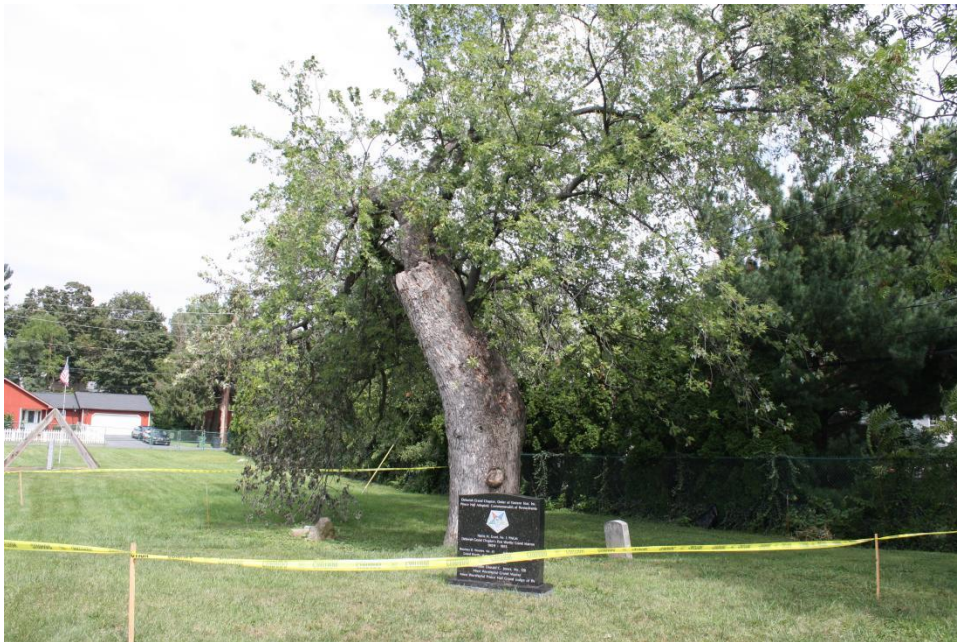
Figure 19: Dead tree near historic gravemarkers and the newly installed commemorative marker for Hattie M. Grant, the First Worthy Grand Matron of the Deborah Grand Chapter of the Order of the Eastern Star from 1909-1915; Photo view: North; Photographer: Jason Harpe; Date: September 18, 2023.

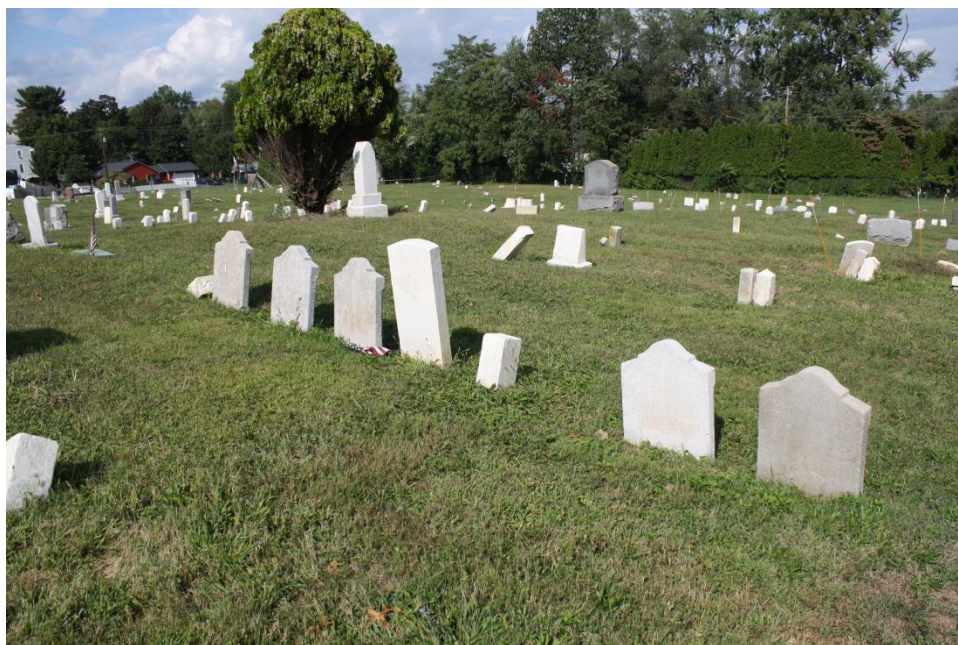
Figure 26: Marble and granite ground-supported tablets, pedestal tombs, and slant-front, tab-in-socket, and die-on-base gravemarkers; Photo view: Northeast; Photographer: Jason Harpe; Date: September 18, 2023.

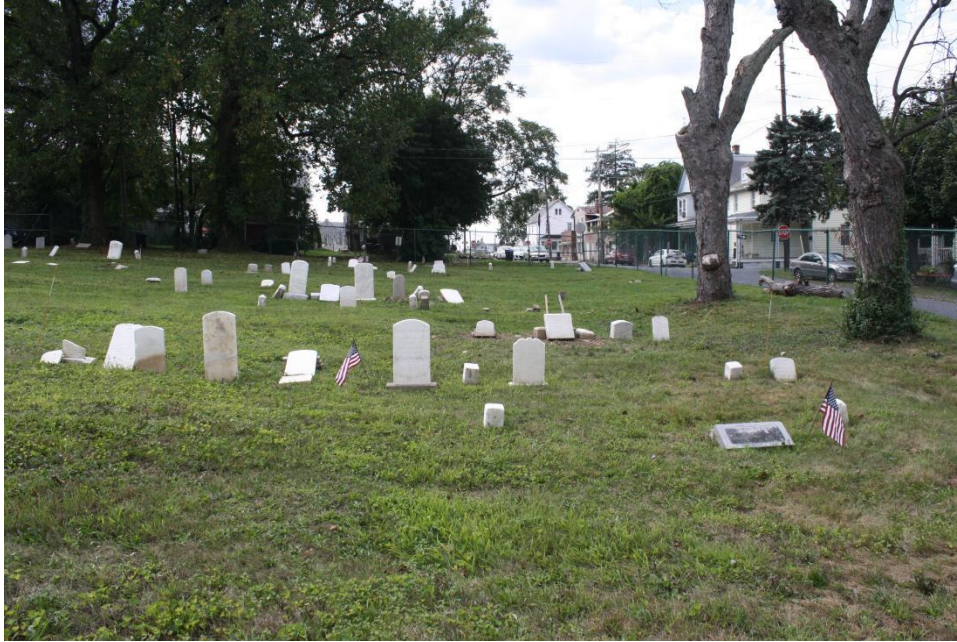
Figure 27: Ground-supported tablets and tab-in-sockets gravemarkers in varying states of disrepair; Photo view: East; Photographer: Jason Harpe; Date: September 18, 2023.

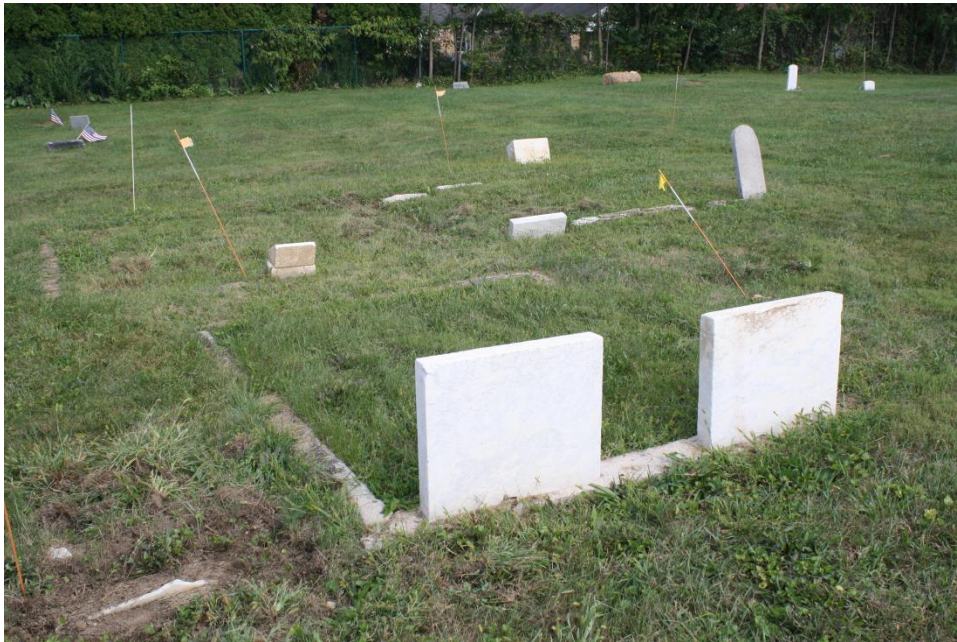
Figure 28: Marble and concrete gravemarkers and cast concrete plot enclosures near Lincoln Cemetery's east elevation; Photo view: East; Photographer: Jason Harpe; Date: September 18, 2023.

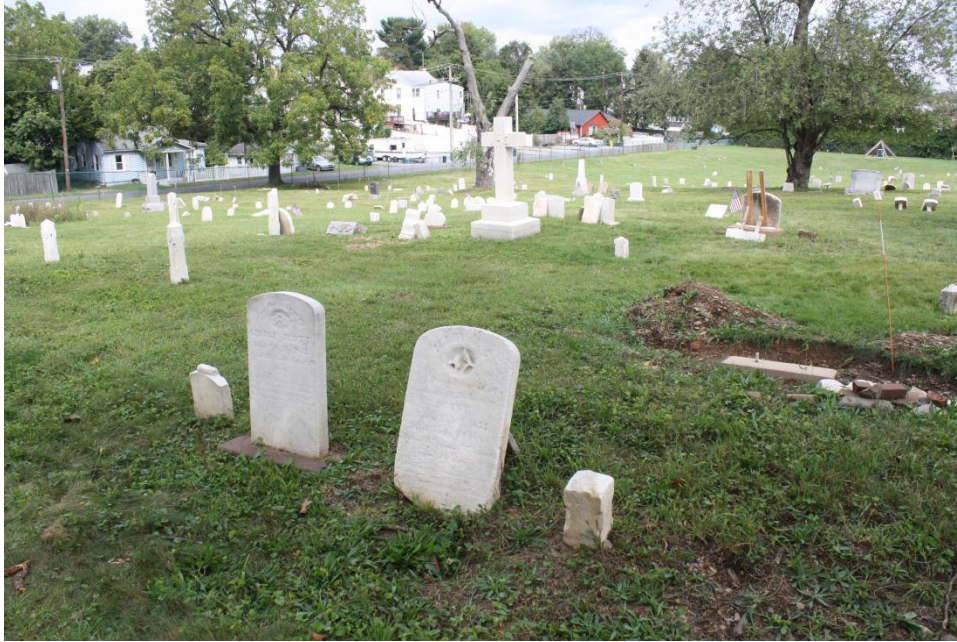
Figure 29: Primarily marble gravemarker and marble corner posts for plot enclosures near Lincoln Cemetery's northwest corner. Visible in the photograph are gravemarkers partially repaired by SOAL's volunteers; Photo view: Northeast; Photographer: Jason Harpe; Date: September 18, 2023.

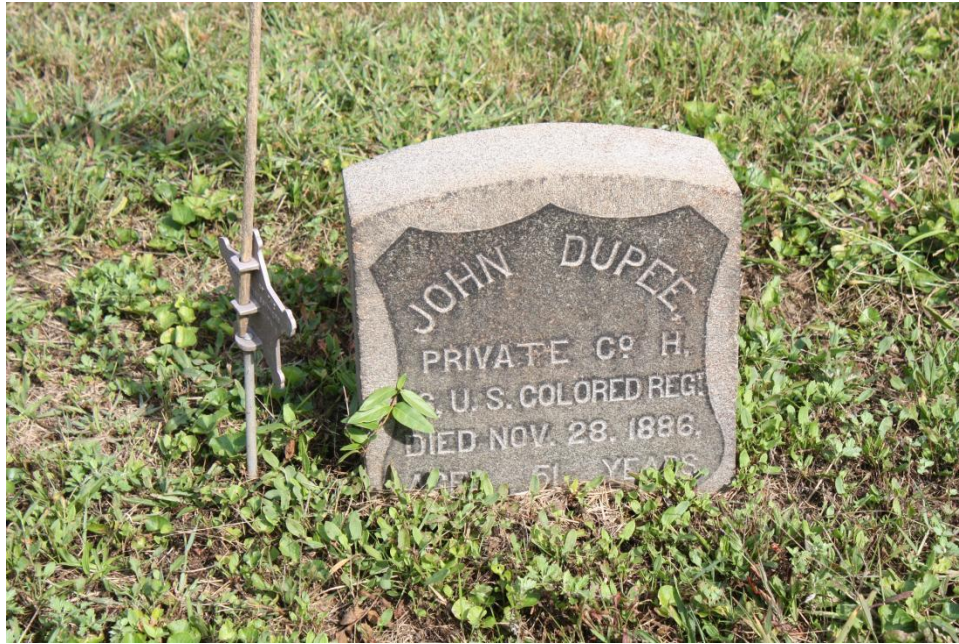
Figure 33: Granite gravemarker for John Dupee (d. 1886); Photo view: West; Photographer: Jason Harpe; Date: September 18, 2023.

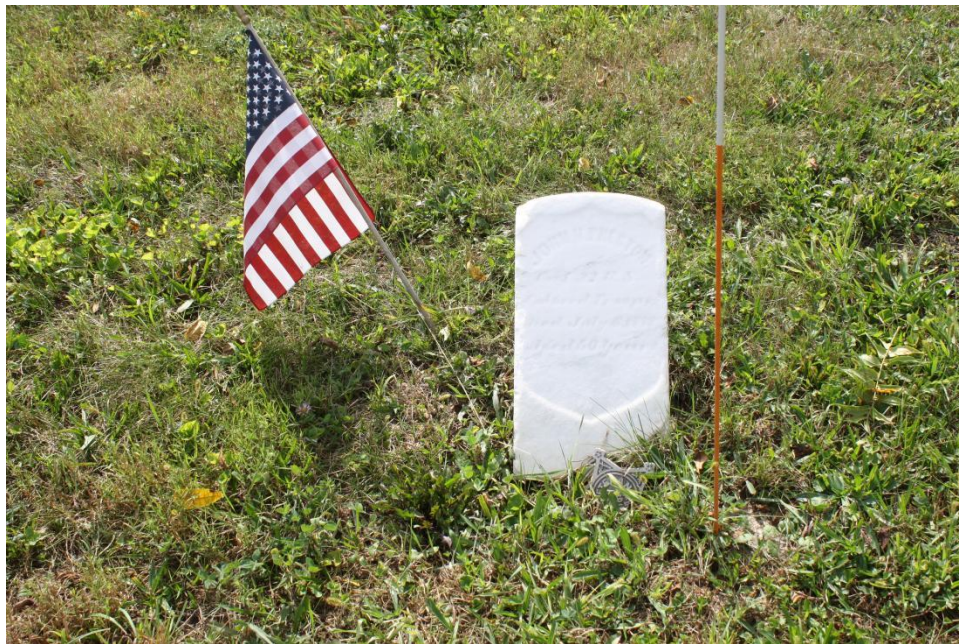
Figure 34: Marble military marker for John H. Preston (d. 1888); Photo view: West; Photographer: Jason Harpe; Date: September 18, 2023.

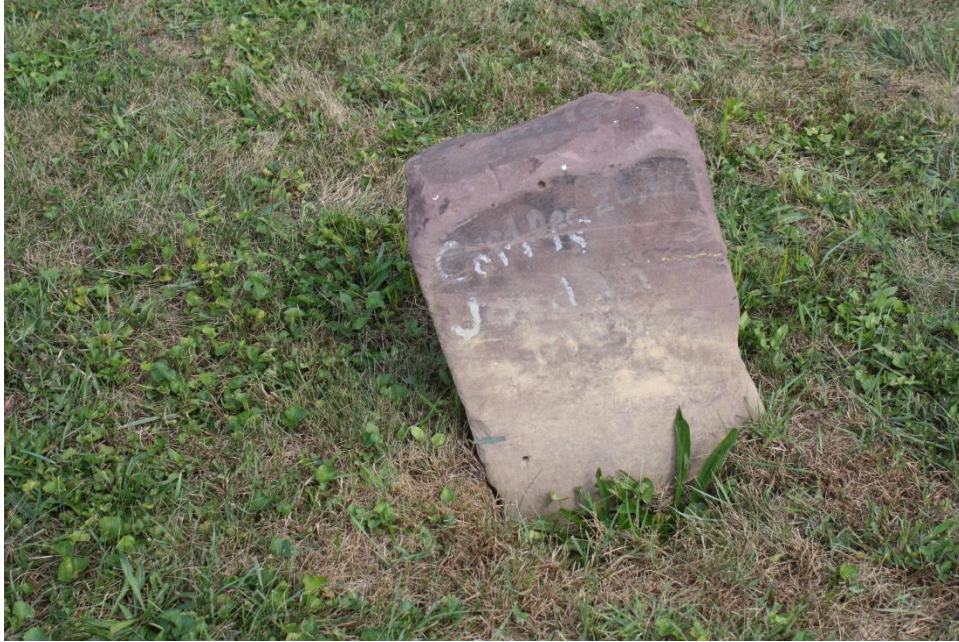
Figure 35: Brownstone tablet for Carrie Jordan (d. 1924); Photo view: East; Photographer: Jason Harpe; Date: September 18, 2023.

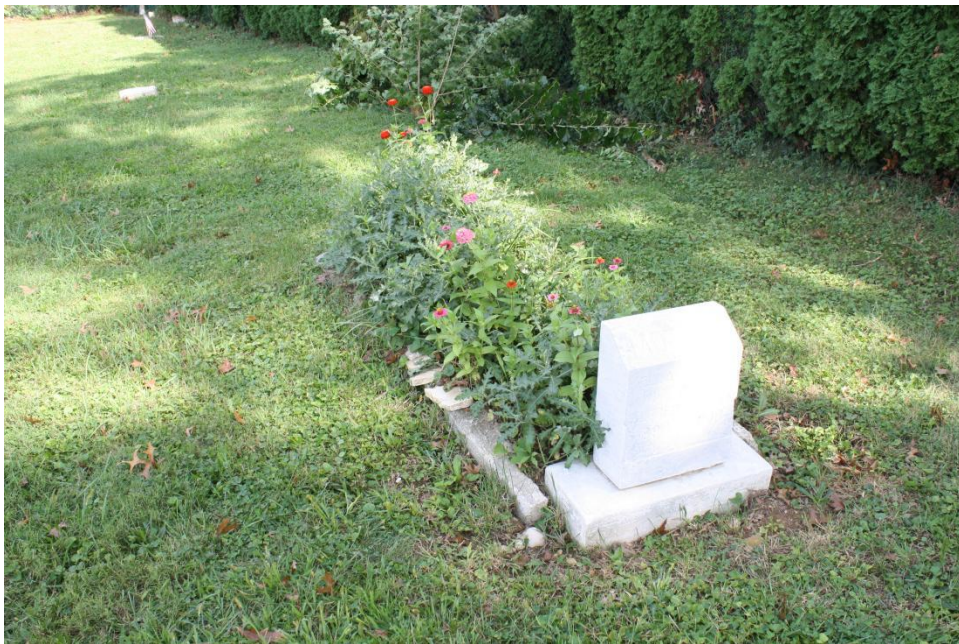
Figure 36: Marble and concrete bedstead grave marker for Ella Banks (d. 1940); Photo view: East; Photographer: Jason Harpe; Date: September 18, 2023.

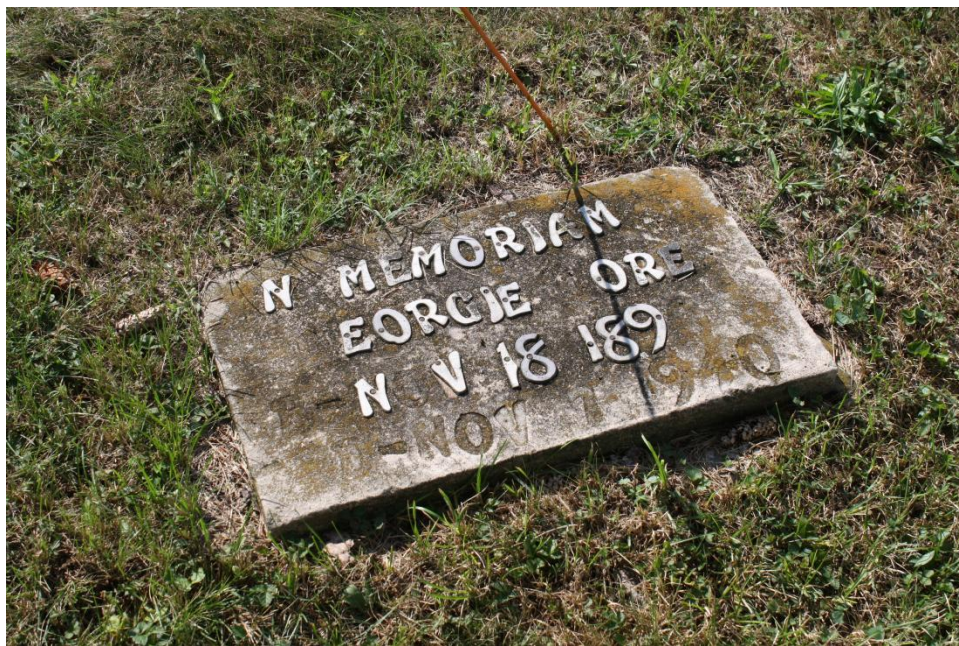
Figure 40: Cast concrete gravemarker with metal letters and house numbers for George Gore (d. 1940); Photo view: West; Photographer: Jason Harpe; Date: September 18, 2023.

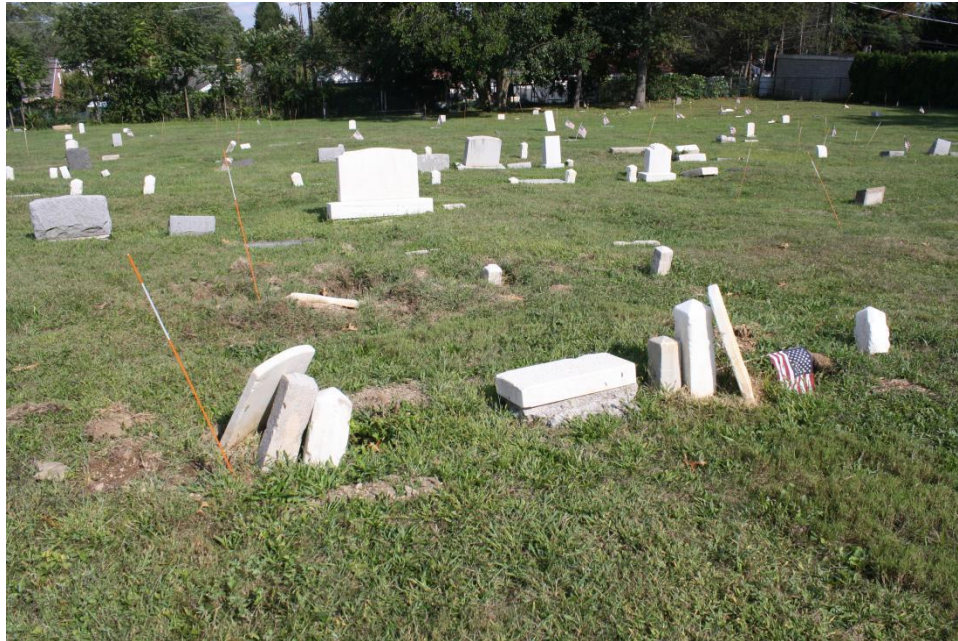
Figure 41: Marble and granite die-on-base and slant-front markers and marble corner post for plot enclosures. Visible in the photograph are gravemarkers displaced by SOAL’s volunteers during excavation; Photo view: East; Photographer: Jason Harpe; Date: September 18, 2023.

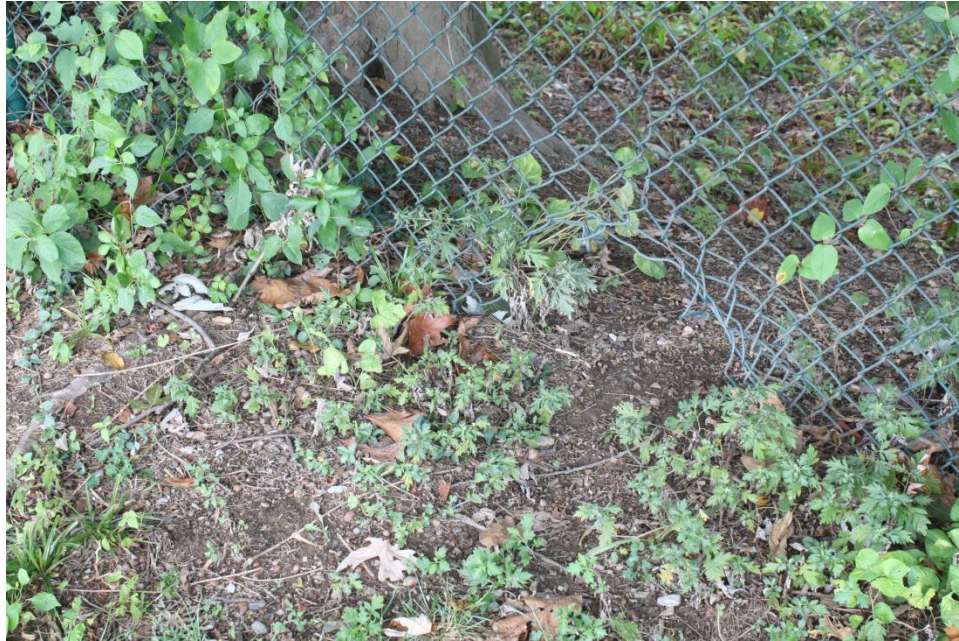
Figure 42: Damage to the chain link fence at Lincoln Cemetery's east elevation; Photo view: East; Photographer: Jason Harpe; Date: September 18, 2023.

guidance in eradicating burrowing animals in Lincoln Cemetery. RGA recommends that Wesley Union A.M.E. Zion Church and SOAL's volunteers work collaboratively to repair damage to fencing at each of the cemetery's elevations. These repairs will help limit access to animals who will create maintenance issues and damage gravemarkers and monuments (Figure 42).

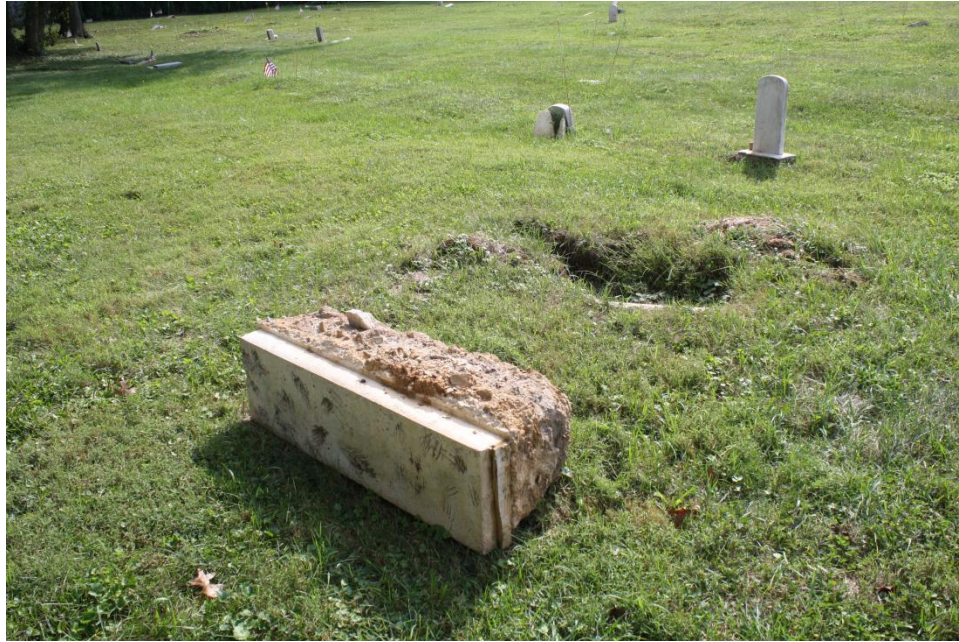
Figure 43: Base with poured concrete support excavated by SOAL's volunteers after learning that a monument company had placed it in a seemingly random location; Photo view: South; Photographer: Jason Harpe; Date: September 18, 2023.

RGA recommends that Wesley Union A.M.E. Zion Church and SOAL volunteers maintain open lines of communication to coordinate future interments and the potential placement of commemorative markers at Lincoln Cemetery. In 2022, Wesley Union A.M.E. Zion Church permitted the erection of a commemorative marker honoring Hattie M. Grant, the First Worthy Grand Matron of the Deborah Grand Chapter of the Order of the Eastern Star from 1909–1915, before determining whether a burial or burials were in the area where the marker was planned to be set. The monument company employed to set the commemorative marker dug a deep hole in a seemingly random location and poured an excessive amount of concrete on which the marker's base would rest near Lincoln Cemetery's east boundary. SOAL's volunteers learned about the monument company's actions and SOAL's volunteers excavated the base and attached concrete form (Figure 43).

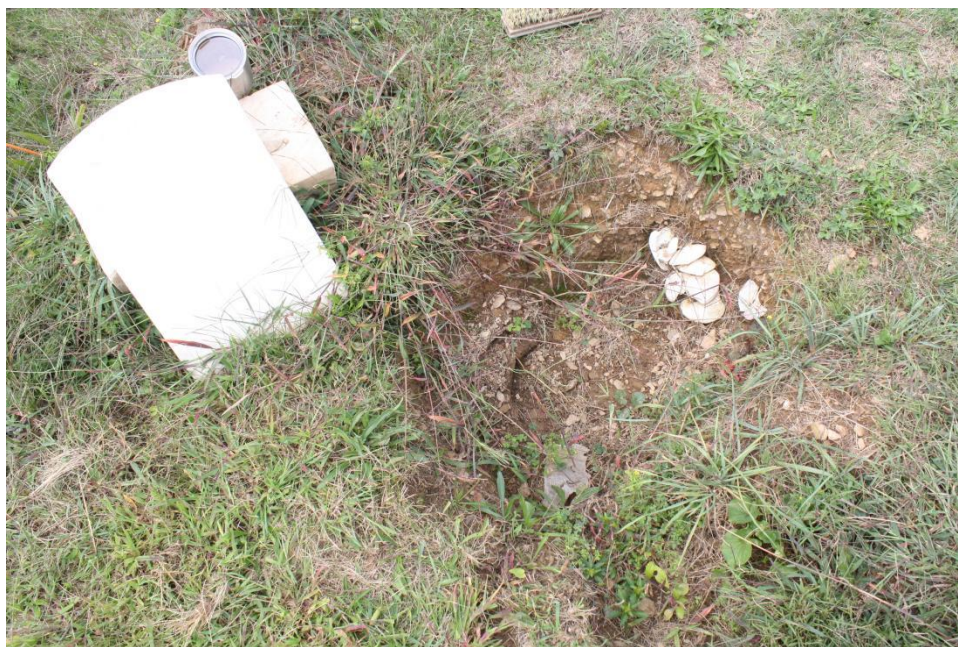
Figure 44: Displaced marble die-on-base gravemarker and excavated grave goods (shells); Photo view: West; Photographer: Jason Harpe; Date: September 18, 2023.

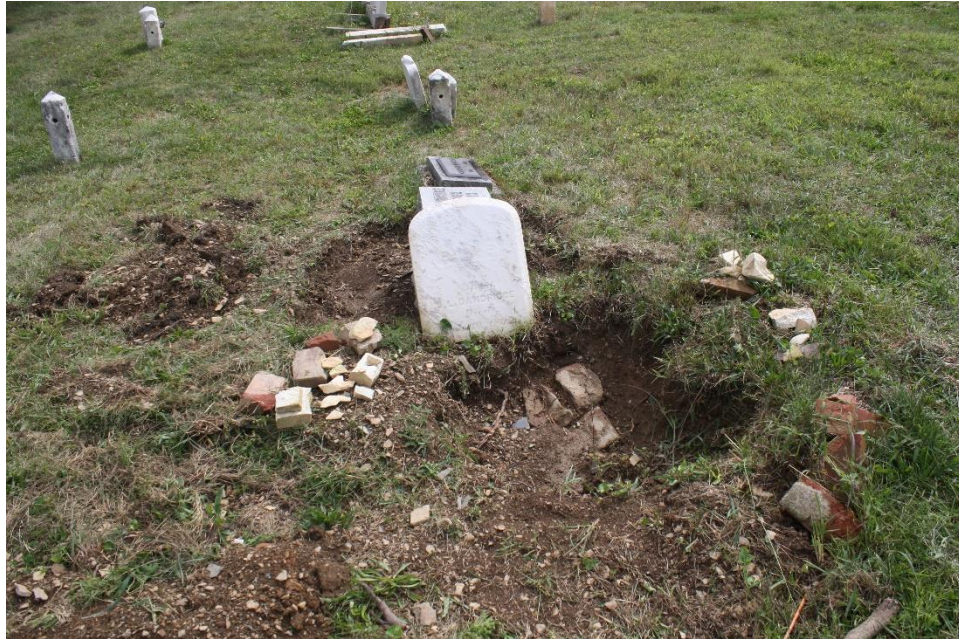
Figure 45: Displaced marble die of Ella Dandridge (d. 1892) and piles of brick and stone; Photo view: North; Photographer: Jason Harpe; Date: September 18, 2023.

As part of a cyclic conservation maintenance plan, Wesley Union A.M.E. Zion Church and/or SOAL volunteers should document the removal of lichens and biofilms from stone monuments and markers so that they can track the amount of time between the removal and lichen recolonization. Removing lichens with water and/or biocides such as D/2 Biological Solution is only a temporary remedy. Lichen recolonization has been documented to take as long as 10 years in certain cases, and as few as 3 years in other cases. The rate of recolonization is affected by environmental factors, as well as the type of stone host (Nascimbene, Salvadori, and Nimis 2009:2420–2; Figures 44–56).

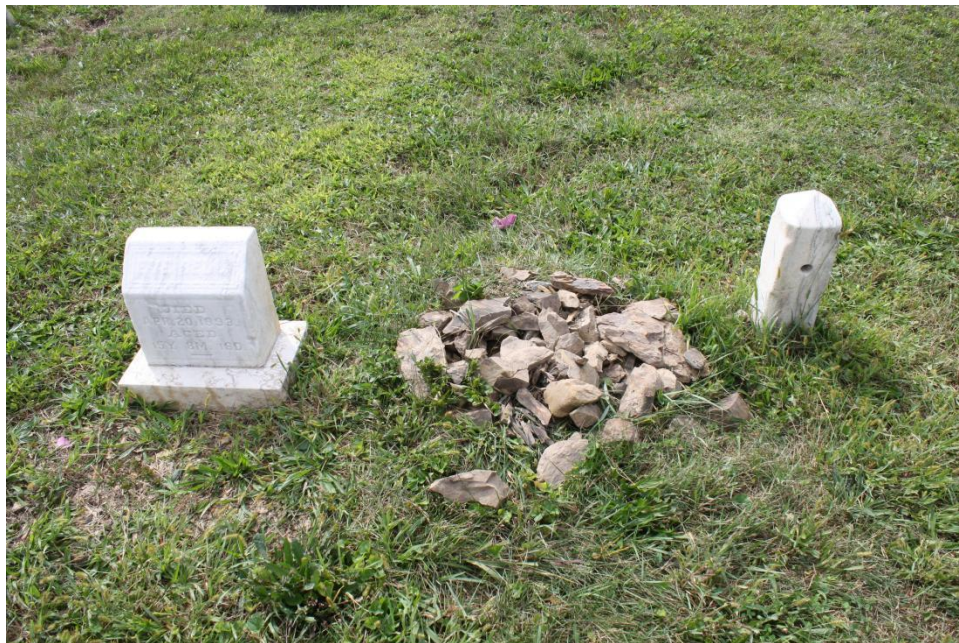
Figure 46: A pile of excavated stone among gravemarkers; Photo view: West; Photographer: Jason Harpe; Date: September 18, 2023.

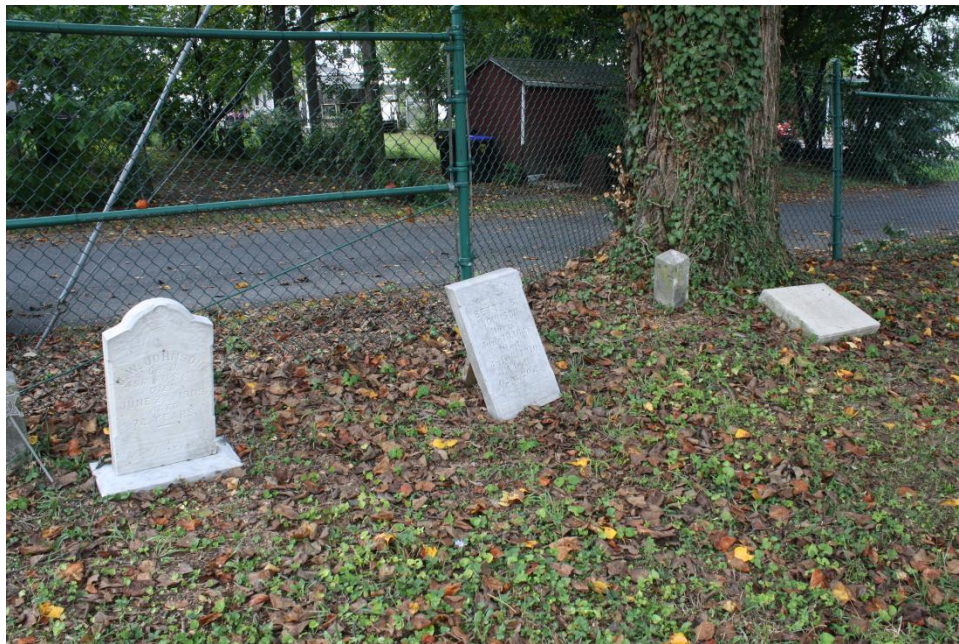
Figure 48: Displaced marble gravemarkers along Lincoln Cemetery's west elevation near its northwest corner; Photo view: West; Photographer: Jason Harpe; Date: September 18, 2023.

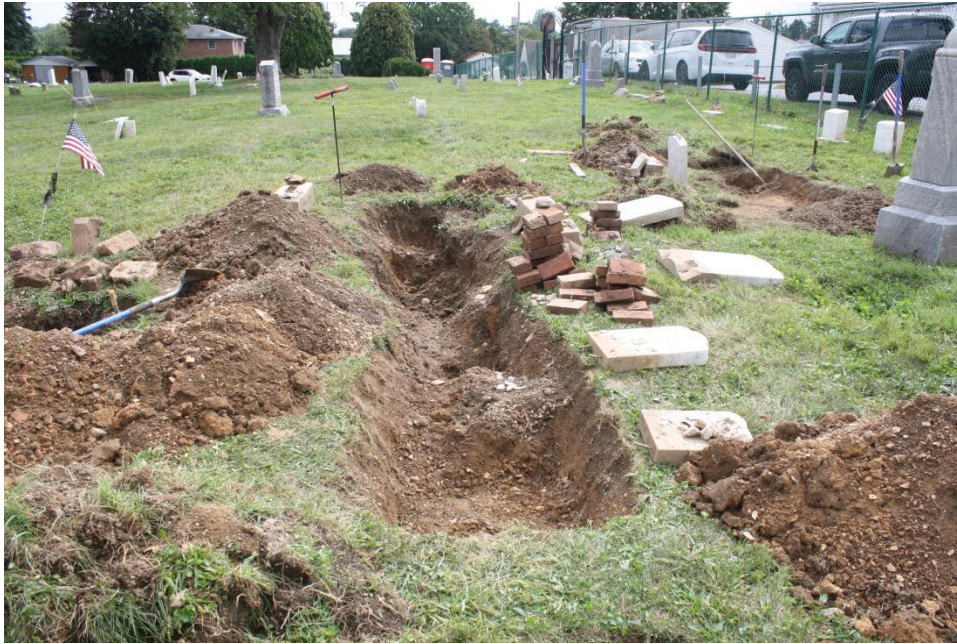
Figure 49: Excavation units and displaced gravemarkers, bricks, and grave goods; Photo view: South;
Photographer: Jason Harpe; Date: September 18, 2023.

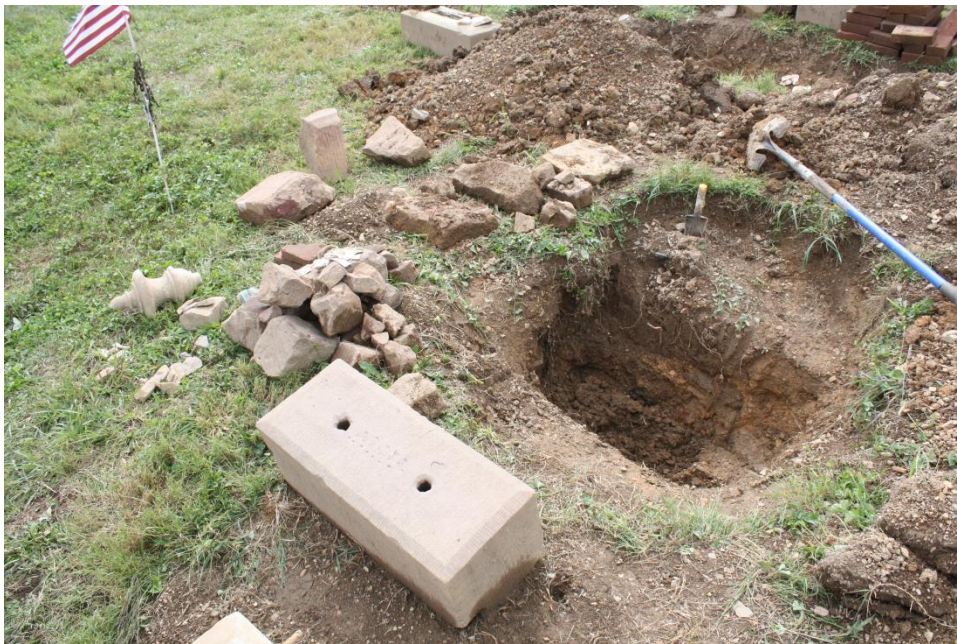
Figure 50: Displaced gravemarker base and piles of stone and brick; Photo view: West;
Photographer: Jason Harpe; Date: September 18, 2023.

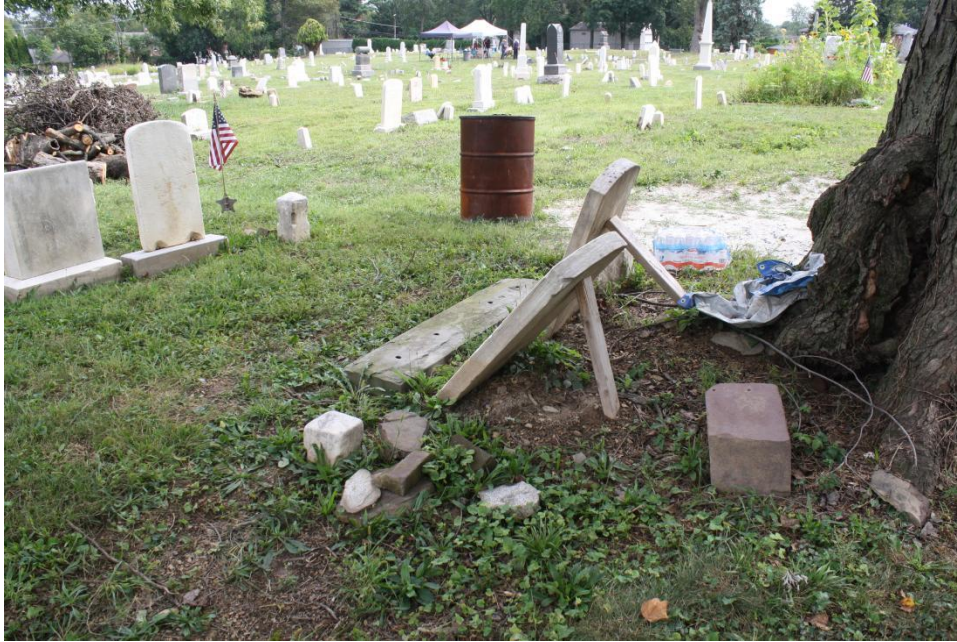
Figure 51: Displaced marble tablets; Photo view: South; Photographer: Jason Harpe; Date: September 18, 2023.

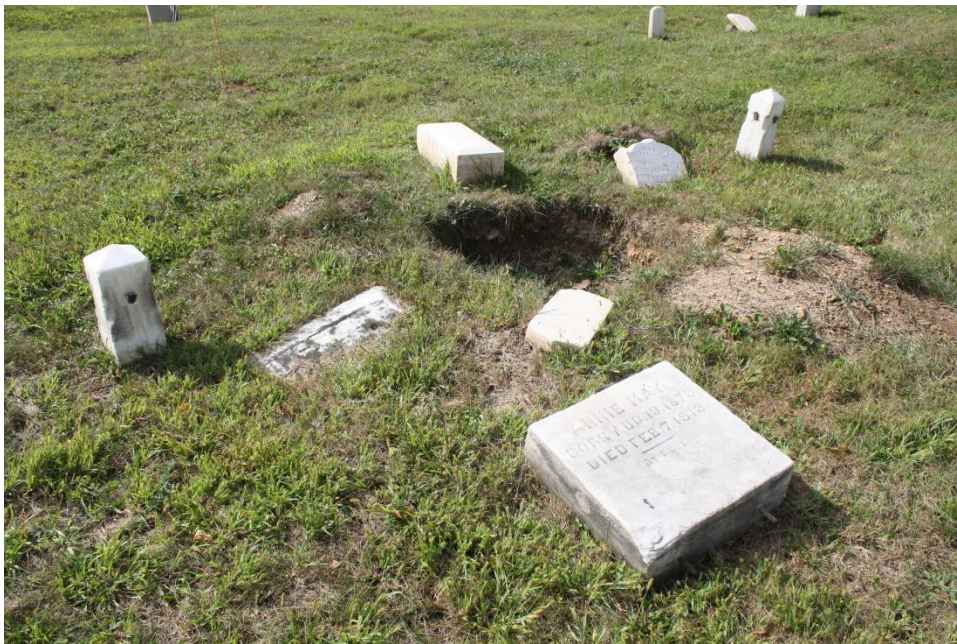
Figure 52: Displaced marble gravemarkers for Annie May (d. 1913) and Luvina May (d. 1912), and marble corner posts; Photo view: North; Photographer: Jason Harpe; Date: September 18, 2023.

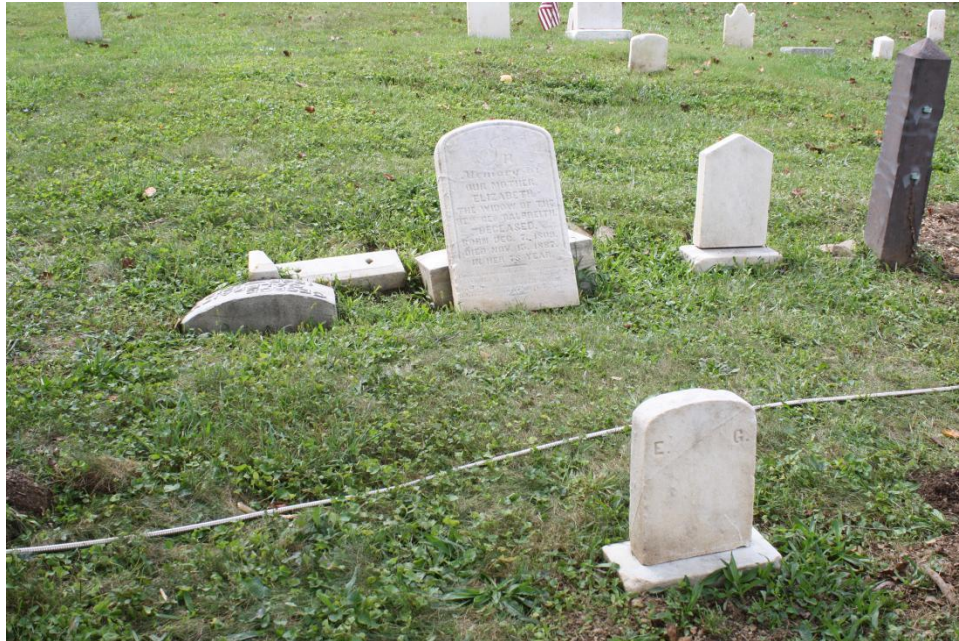
Figure 53: Recently cleaned and displaced gravemarkers near Lincoln Cemetery west elevation; Photo view: East; Photographer: Jason Harpe; Date: September 18, 2023.

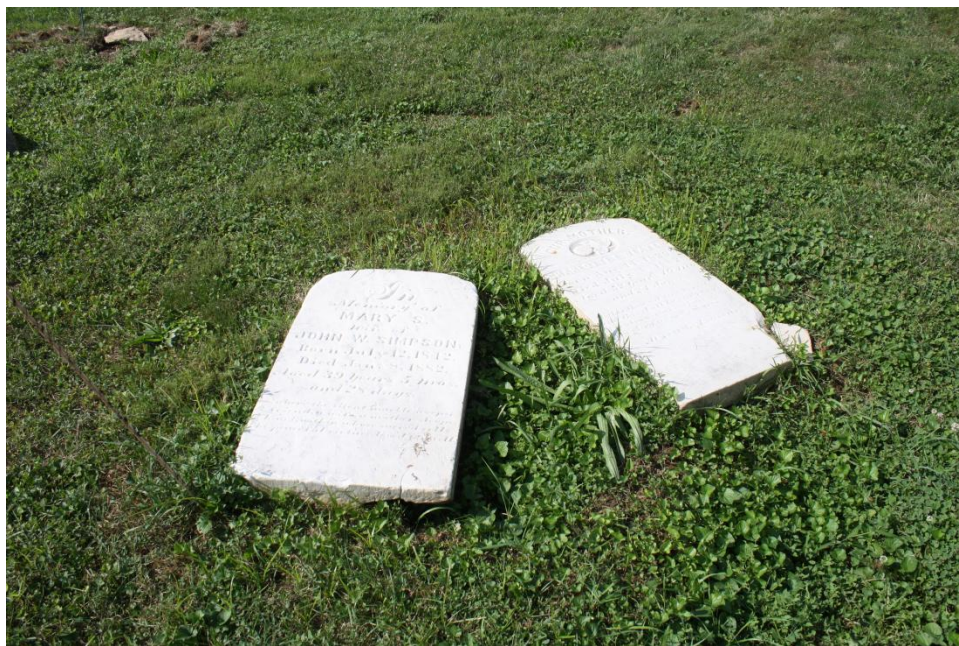
Figure 54: Displaced, ground-supported marble tablets for Mary Simpson (d. 1882) and Charlotte Weaver (d. 1882); Photo view: West; Photographer: Jason Harpe; Date: September 18, 2023.

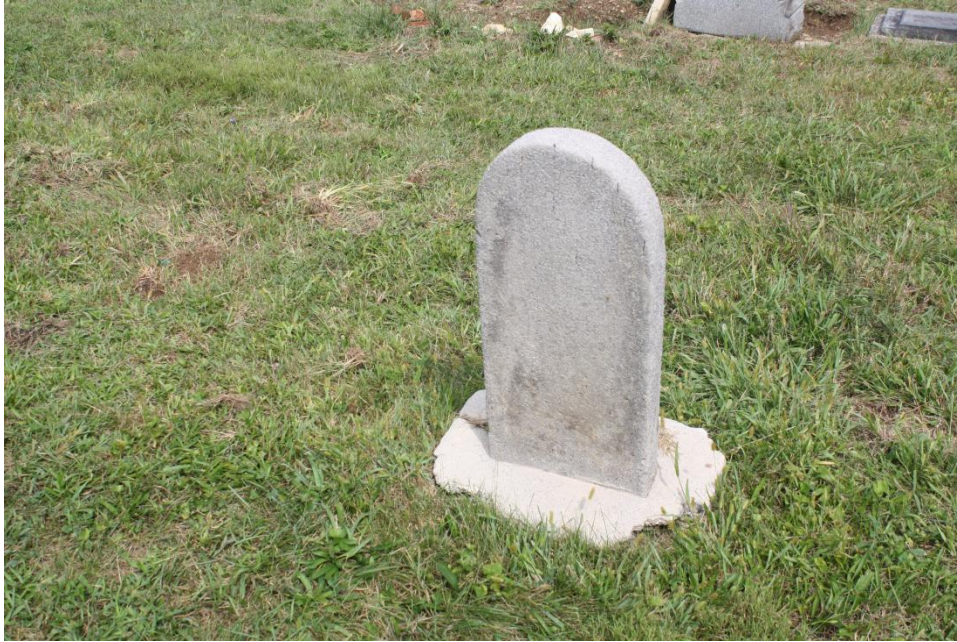
Figure 55: Marble tablet with poured concrete apron; Photo view: East; Photographer: Jason Harpe; Date: September 18, 2023.

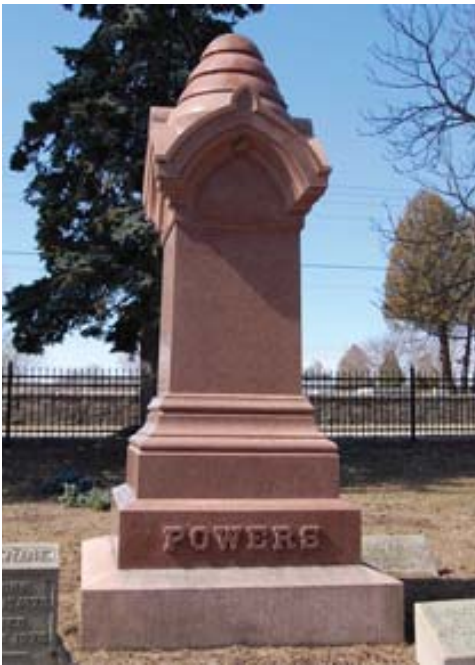
Figure 5. A variety of colors of natural stone are found in historic cemeteries, such as this pink granite marker in the Cedar Grove Cemetery, New London, CT. Photo: Jason Church.

Stone is a naturally occurring material with a wide range of properties and is available in a variety of colors (Fig. 5). Geologists classify stone according to the way in which it was formed with the three categories being igneous, sedimentary and metamorphic rock. Stone found in cemeteries is predominantly quarried, though the use of field stones is not uncommon. The mineralogy and chemical composition of stones vary. Some are composed primarily of silicate minerals; granites, sandstones, slate, and schist are examples. Other stones contain calcium carbonate with marble and limestone in this group. Mineralogy, chemical composition, and physical structure of the stone influence weathering and

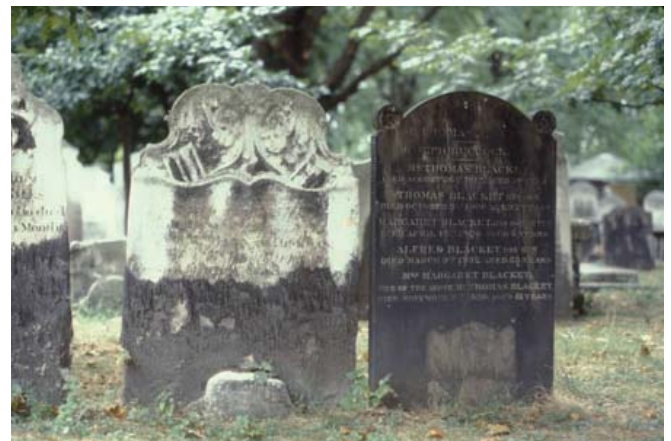
Figure 9. The limestone and sandstone grave markers in this historic cemetery have different weathering processes. On the left, the limestone shows surface loss in areas exposed to rainwater and gypsum crust formation below. The sandstone marker on the right displays uniform soiling, but surface hardening may be occurring. Photo: Fran Gale.

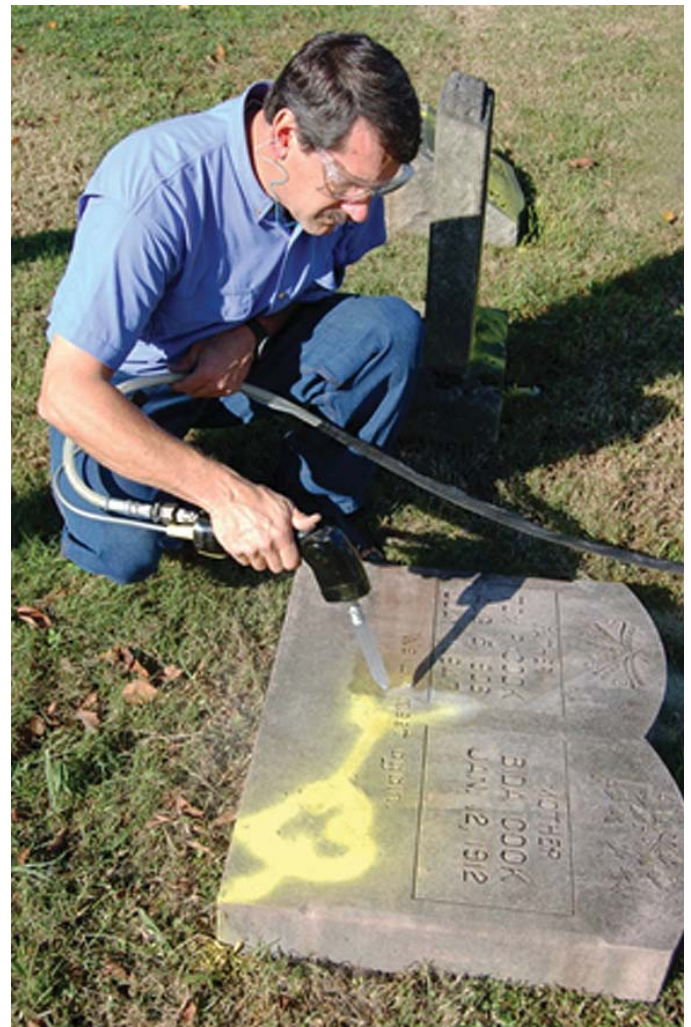
Figure 18. Graffiti is carefully removed using a low-pressure dry-ice misting instrument. Photo: Jason Church.

Markers with graffiti tend to be targets for further vandalism (Fig. 18). Timely removal helps deter future vandalism and improves the marker’s appearance.

If the graffiti is water soluble, it can be removed using water and a soft cloth or towel. Rinsing the cloth frequently helps to avoid smearing graffiti on unaffected areas. If the graffiti is not water soluble, organic solvents or commercial graffiti removal products suitable for the grave marker material are recommended. Products should be tested prior to use. General cleaning of the entire marker is a good follow-up for a more even appearance. For deep-seated graffiti, poultice cleaning (previously described) may be required to extract staining materials.

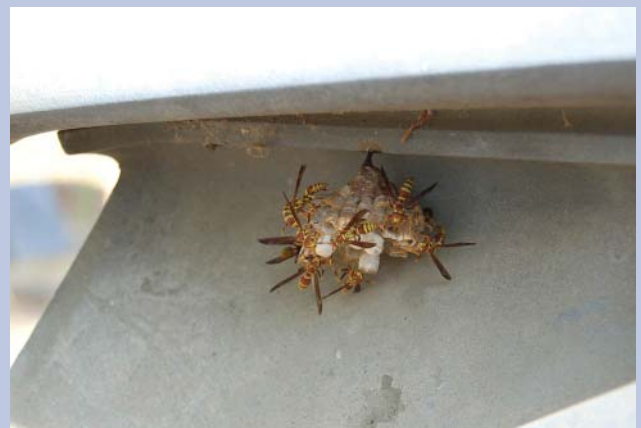
Figure D. Yellow jackets that are nesting below the projecting molding of this grave marker pose a hazard to visitors and staff because, if disturbed, they will vigorously defend their nest. Yellow jacket, paper wasp and hornet nests should be removed from grave markers by trained staff or specialists. Photo: Jason Church.

Snakes, wasps, and burrowing animals inhabit historic cemeteries (Fig. D). Snakes sun on warm stones and hide in holes and ledges, so it is important to be able to identify local venomous snakes. An appropriate venomous snake management plan should be in place, and
