PRESERVATION PLAN

PENNSYLVANIA AFRICAN AMERICAN CEMETERY STEWARDSHIP PROGRAM

Union Cemetery
416 E. Howard Street
Bellefonte, Centre County, Pennsylvania

February 2024

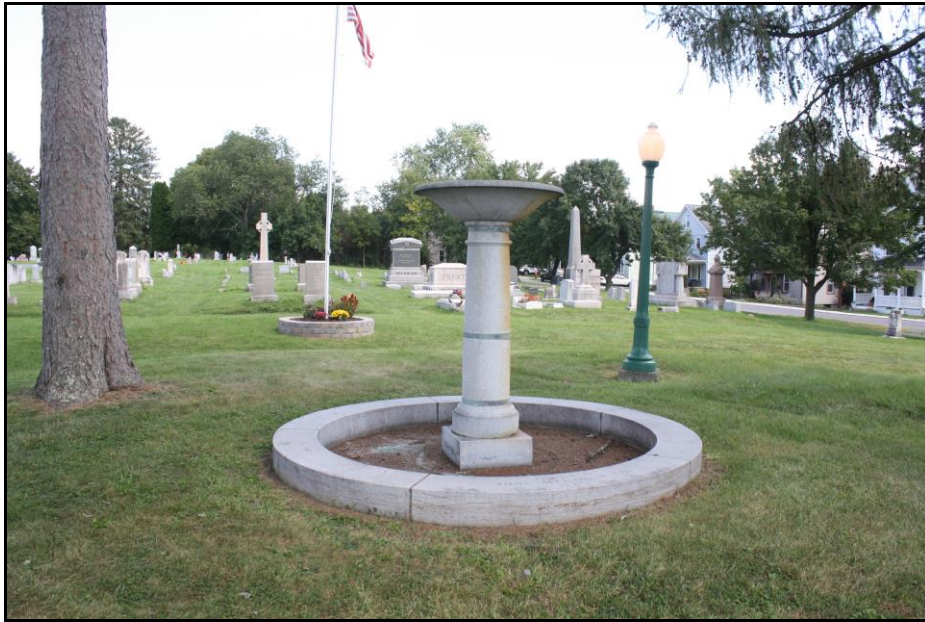
Figure 16: Granite water fountain funded by Anna Allison McCoy in 1954 that stands in Section 5 of Union Cemetery; Photo view: East; Photographer: Jason Harpe; Date: September 20, 2023.

The water feature is not currently functional, but Association members explained to Mr. Harpe during his site visit to the cemetery that they hope to raise funds in the future to fix the water feature (Figures 35–52).

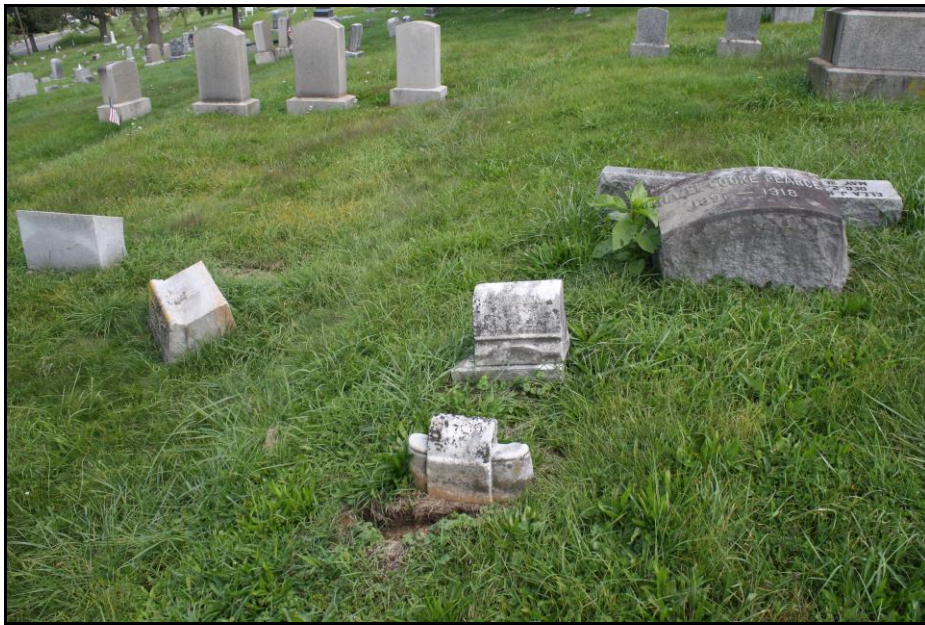
Figure 53: Displaced and partially sunken gravemarkers; Photo view: East; Photographer: Jason Harpe; Date: September 20, 2023.

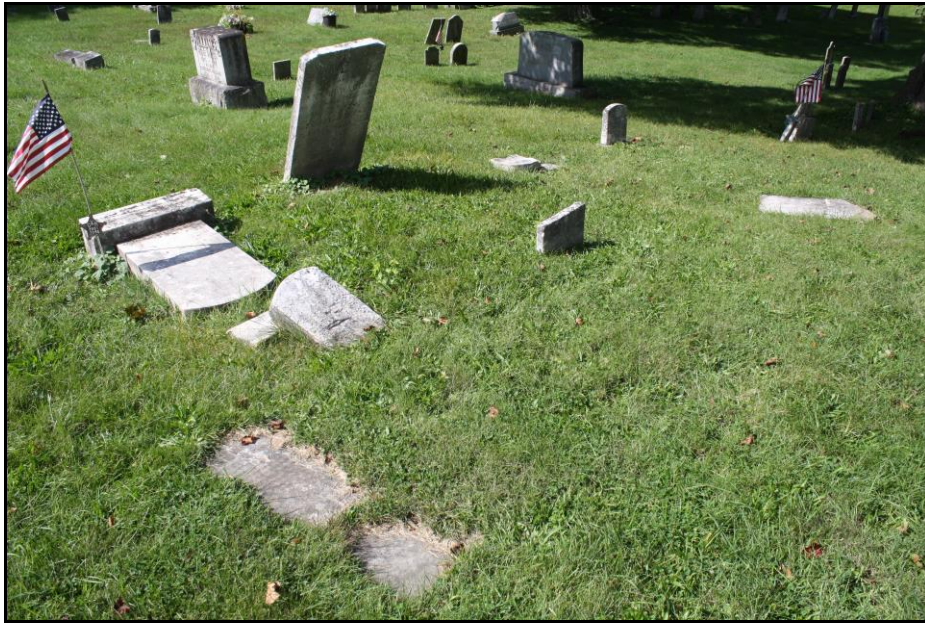
Figure 55: Leaning, displaced, broken, and partially sunken gravemarkers; Photo view: West; Photographer: Jason Harpe; Date: September 20, 2023.

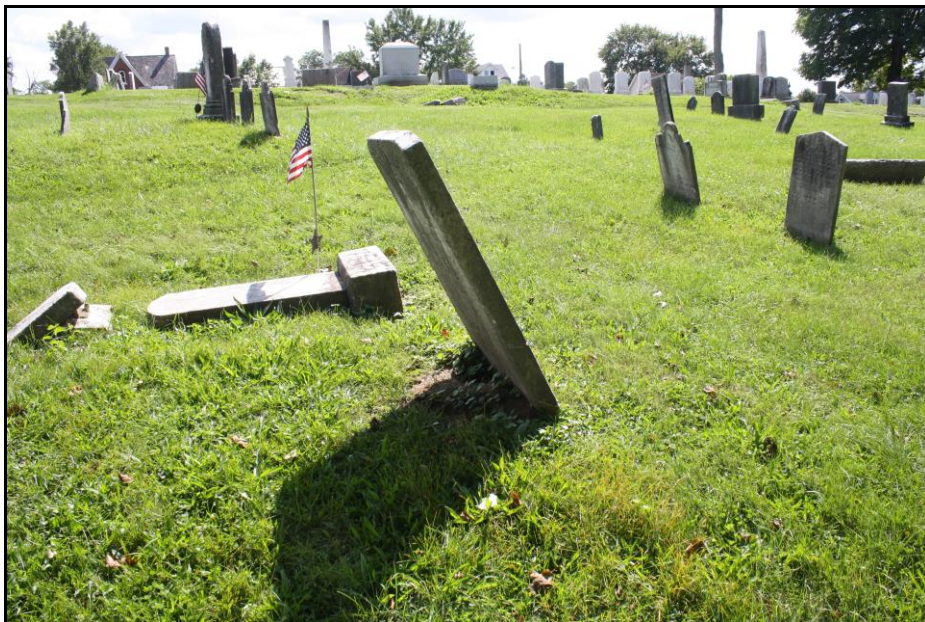
Figure 56: Leaning and displaced gravemarkers; Photo view: South; Photographer: Jason Harpe; Date: September 20, 2023.

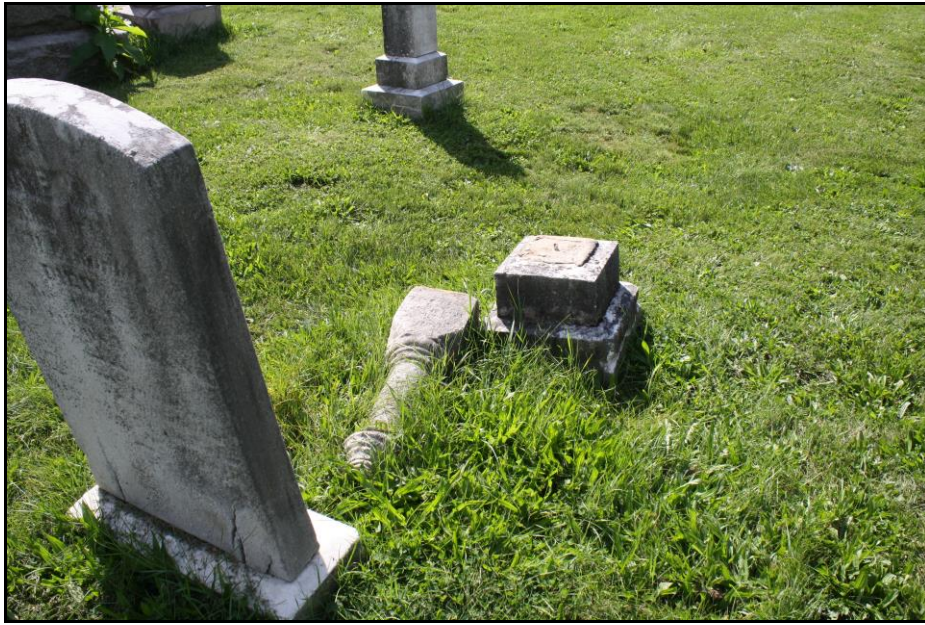
Figure 57: Displaced upper section of a pedestal tomb; Photo view: West; Photographer: Jason Harpe; Date: September 20, 2023.

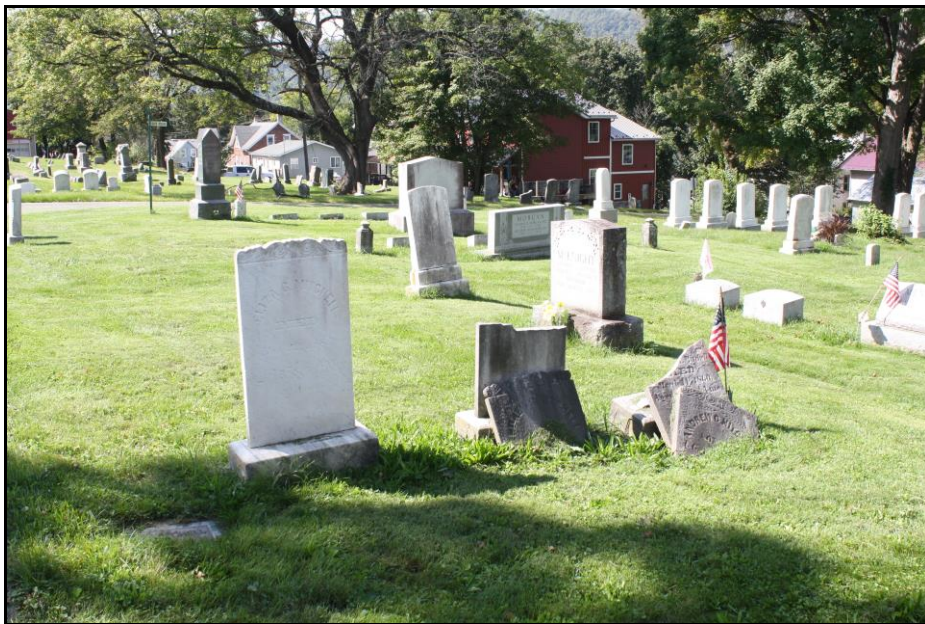
Figure 58: Mitchell family broken tablets; Photo view: West; Photographer: Jason Harpe; Date: September 20, 2023.

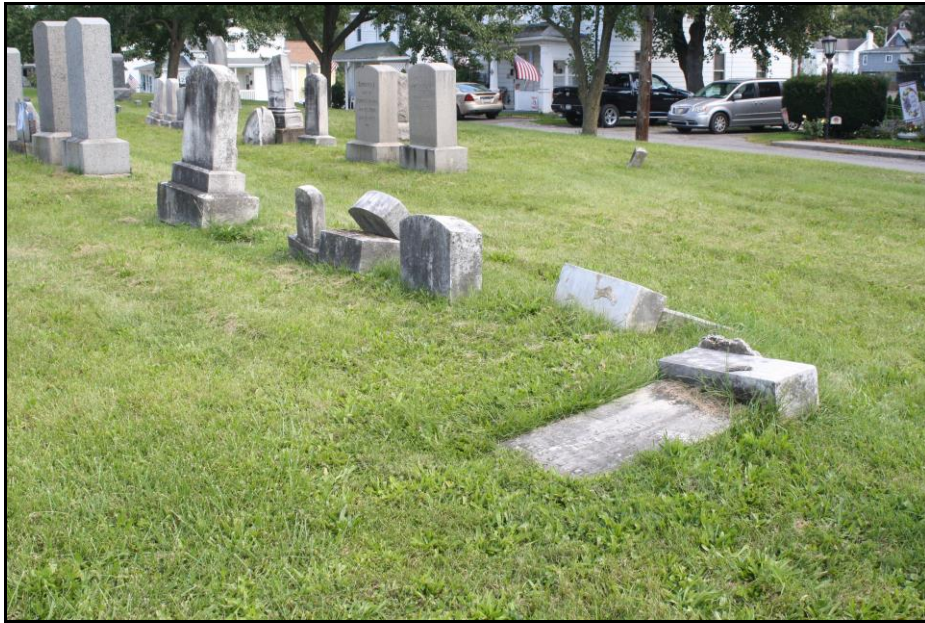
Figure 59: Damaged and toppled gravemarkers near East High Street at the cemetery's southern edge; Photo view: East; Photographer: Jason Harpe; Date: September 20, 2023.

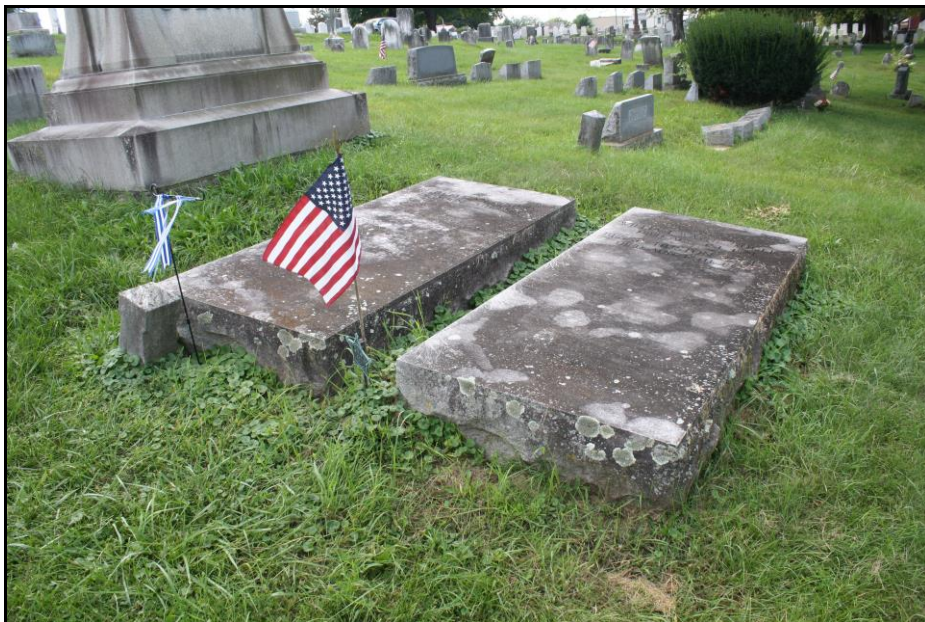
Figure 60: Biofilm and lichens on Rogers family ledger stones; Photo view: West; Photographer: Jason Harpe; Date: September 20, 2023.

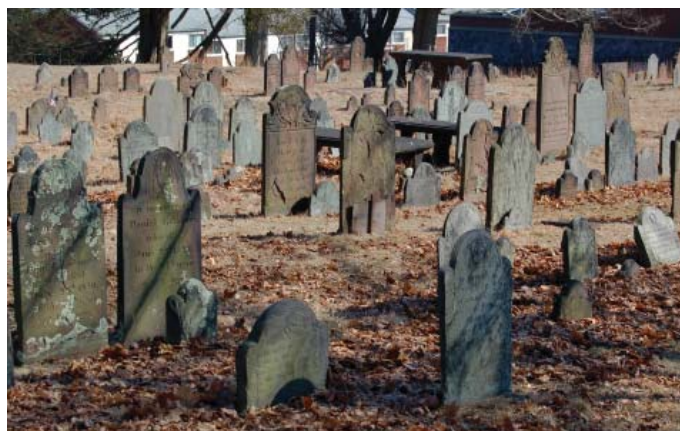
Figure 1. Sandstone and slate grave markers in the Ancient Burying Ground in New London, CT, display a variety of weathering conditions. Markers in the cemetery date from the mid-17th to the early 19th centuries. Photo: Jason Church.

While cemeteries are often considered to be perpetual, their most prominent feature—the grave markers—are not. They weather, naturally decay, often are poorly maintained and repaired and, on occasion, are vandalized (Fig. 1). Grave markers are usually noteworthy not only for their inscriptions but also for their craftsmanship. Exceptional markers are considered works of art.

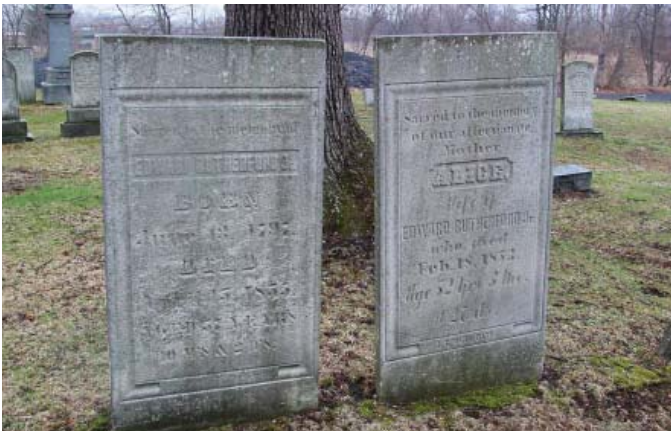
Figure 2. These mid-19th century, single-element stone grave markers in the Grove Cemetery in Bath, NY, are set in a vertical position. Photo: Jason Church.

The great variety in the types of grave markers is a fascinating aspect of the study and appreciation of historic cemeteries. Three broad categories can be used to describe grave markers—(1) single-element, (2) multiple-element, and (3) structures. Single-element grave markers are stone, cast iron, or wood elements that are set in a vertical position or placed as a horizontal slab on the ground (Fig. 2). Early examples of this simplest type of grave markers are field stone and basic wooden or wrought iron crosses, with the name of the deceased person scratched into or engraved on the marker. Often, these rudimentary grave markers are overlooked, significantly deteriorated, or lost. Vertical stone slabs and large stone ledgers laid horizontally over the gravesite are more sophisticated examples of this type.

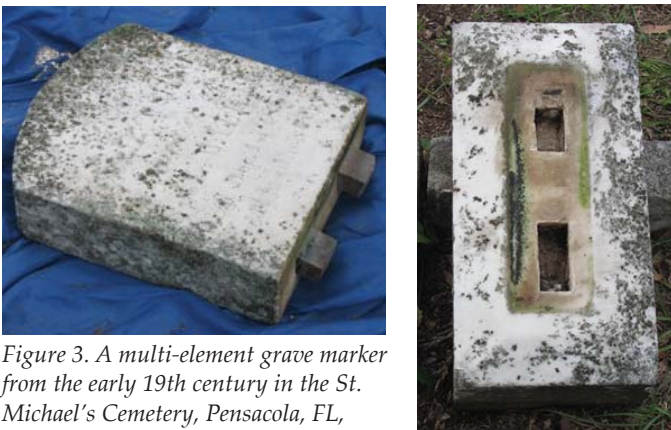
Figure 3. A multi-element grave marker from the early 19th century in the St. Michael's Cemetery, Pensacola, FL, consists of a vertical element with tabs (left image) into a slotted base (right image). Photo: Fran Gale.

Multiple-element grave markers are found in a number of different forms (Fig. 3). In the most typical form, a grave marker would consist of two stones—an upper headstone placed on top of a base stone. The upper headstone may be secured in a number of different ways to the base. In the simplest of forms, the upper stone was placed on the base, set in a bed of mortar on top of the base, or joined with pins and mortar. With a “tab-and-

slot" grave marker, the tabbed upper stone was set in a slotted base. More common today, the upper headstone is secured with a technique that uses small spacers set on the base and a setting compound. This technique or one that uses an epoxy adhesive may be found on older markers where the stones have been reset.

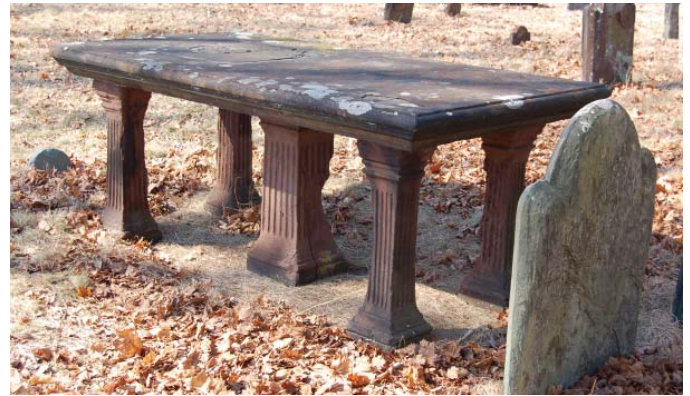
Figure 4. This sandstone table tomb, located in Cedar Grove Cemetery, New London, CT, is an engineered grave marker structure consisting of a horizontal stone tablet supported by four vertical table "legs" with and a central column,. Photo: Jason Church.

Grave markers can also be engineered structures. Examples of grave marker structures include masonry arches, box tombs, table tombs, grave shelters, and mausoleums (Fig. 4). The box tomb is a rectangular structure built over the gravesite. The human remains are not located in the box itself as some believe, but rather in the ground beneath the box structure. The table tomb is constructed of a horizontal stone tablet

supported by small corner supports or columns. Grave shelters, also called grave houses, can be simple or elaborate wooden structures built over the gravesite. Mausoleums are above-ground buildings with compartments for multiple burials. Engineered structures also include hillside and underground tombs.

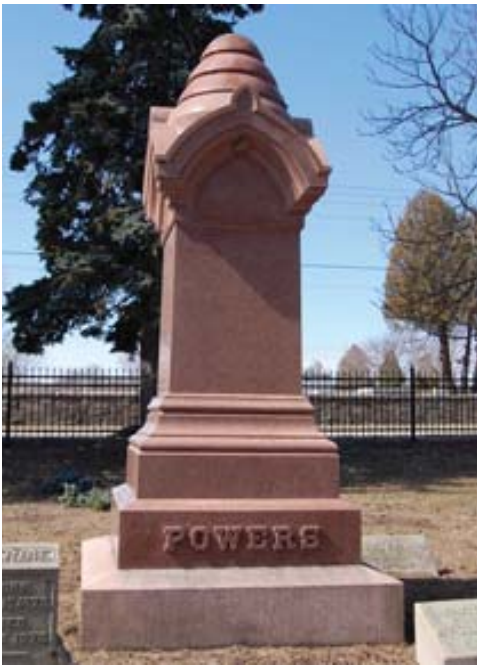
Figure 5. A variety of colors of natural stone are found in historic cemeteries, such as this pink granite marker in the Cedar Grove Cemetery, New London, CT. Photo: Jason Church.

Stone is a naturally occurring material with a wide range of properties and is available in a variety of colors (Fig. 5). Geologists classify stone according to the way in which it was formed with the three categories being igneous, sedimentary and metamorphic rock. Stone found in cemeteries is predominantly quarried, though the use of field stones is not uncommon. The mineralogy and chemical composition of stones vary. Some are composed primarily of silicate minerals; granites, sandstones, slate, and schist are examples. Other stones contain calcium carbonate with marble and limestone in this group. Mineralogy, chemical composition, and physical structure of the stone influence weathering and

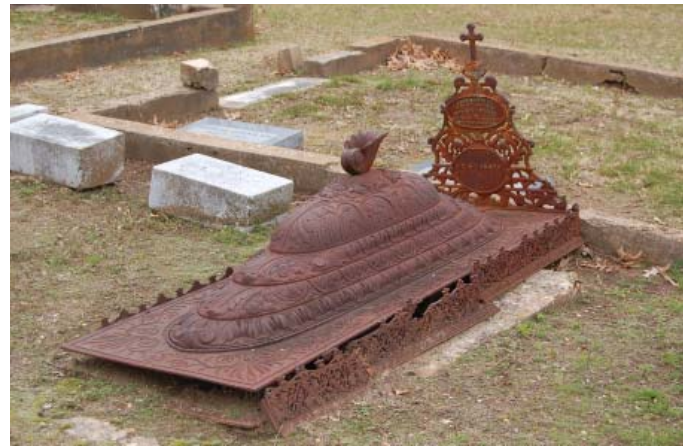
Figure 6. Decorative cast-iron grave markers like this late-19th century one in Oakland Cemetery in Shreveport, LA, are produced by heating the iron alloy and casting the liquid metal into a mold. Photo: Jason Church.

Metals are solid materials that are typically hard, malleable, fusible, ductile, and often shiny when new (Fig. 6). A metal alloy is a mixture or solid solution of two or more metals. Metals are easily worked and can be melted or fused, hammered into thin sheets, or drawn into wires. Different metals have varying physical

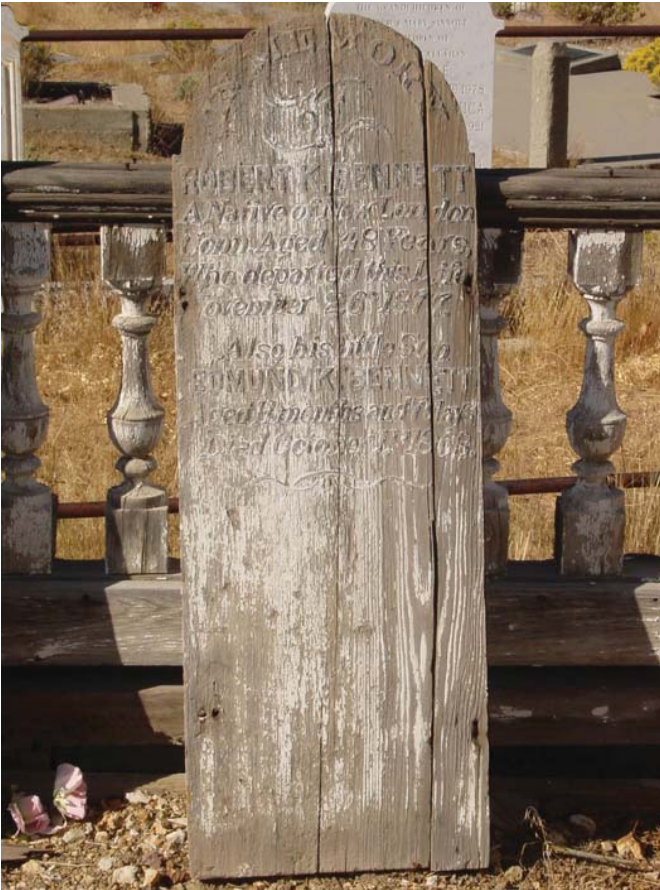
Figure 7. As shown by this 1877 marker in Silver Terrace Cemetery, Virginia City, NV, exposure to sunlight can damage wood grave markers, making the wood more susceptible to water damage and cracking. Photo: Jason Church.

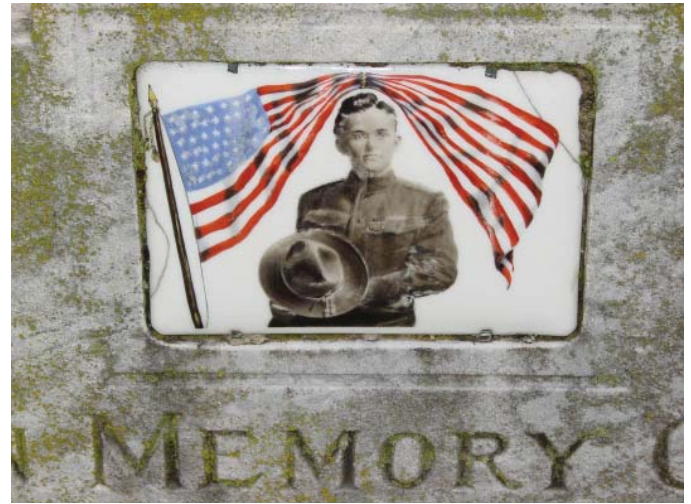
Figure 8. A fired ceramic, this cameo is set in a marble grave marker, located in Elmwood Cemetery, Memphis, TN. Different materials may require different conservation approaches. Photo: Mary Striegel.

Old cemeteries often include a wide variety of other materials not normally associated with contemporary grave markers, such as ceramics, stained glass, shells, and plastics (Fig. 8). As with masonry, metals, and wood, each has its own chemical and physical properties which affect durability and weathering. These materials

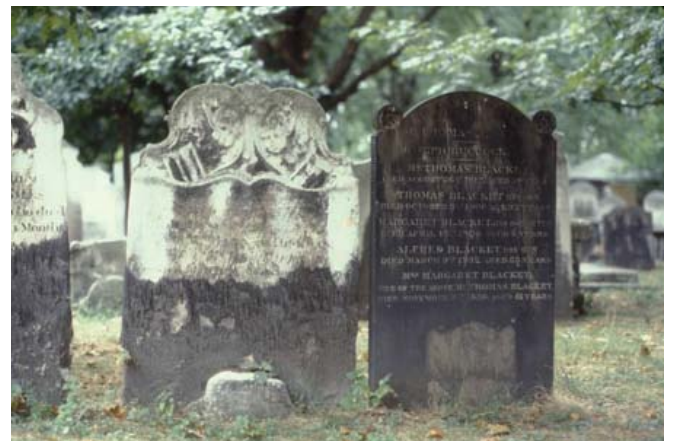
Figure 9. The limestone and sandstone grave markers in this historic cemetery have different weathering processes. On the left, the limestone shows surface loss in areas exposed to rainwater and gypsum crust formation below. The sandstone marker on the right displays uniform soiling, but surface hardening may be occurring. Photo: Fran Gale.

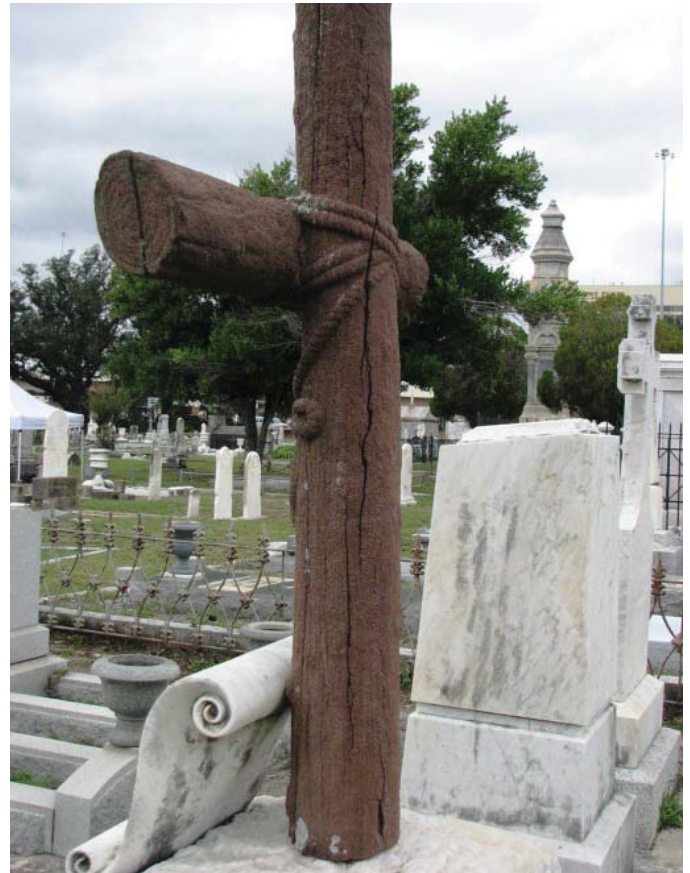
Figure 10. The sandstone cross (carved to look like wood) in this grave marker in St. Michael's Cemetery in Pensacola, FL, provides an example of inherent vice – the severe delamination affecting the sandstone has occurred along its natural bedding planes.

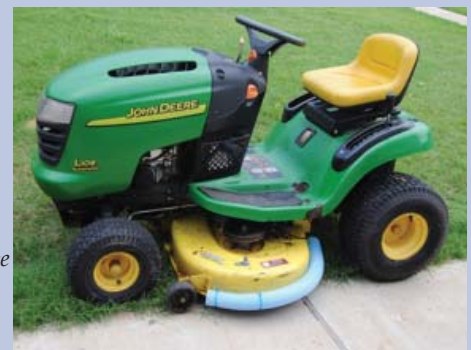
Figure B. A pool ‘noodle’ can be fitted to the deck of a lawnmower to prevent damage to grave markers. Photo: Debbie Dietrich Smith.

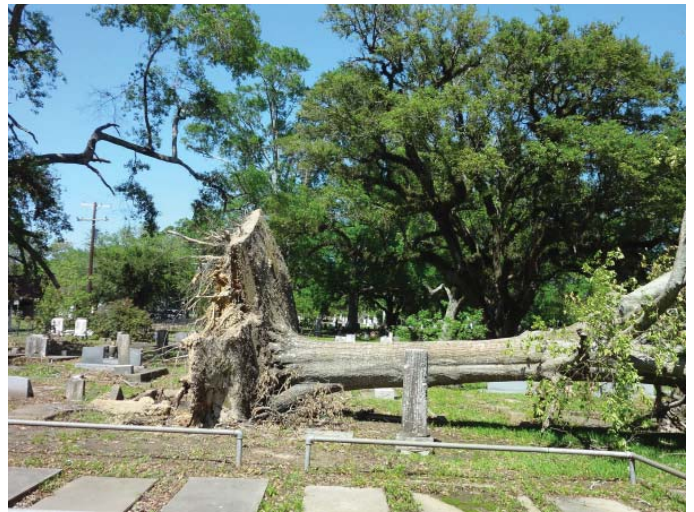
Figure 11. Woody vegetation can damage grave markers and pose a risk to visitors unless well managed and maintained. Photo: Jason Church.

Woody vegetation can damage grave markers in a variety of ways (Fig. 11). Trees, bushes, and vines can shade grave markers, extending the time that the markers are exposed to moisture. Tendrils and roots may burrow into mortar joints and openings, causing mechanical damage and large plants may lift up or shift markers. Even leaves and twigs, when allowed to collect on the ground near grave markers, can affect water drainage and evaporation (Fig. 12).

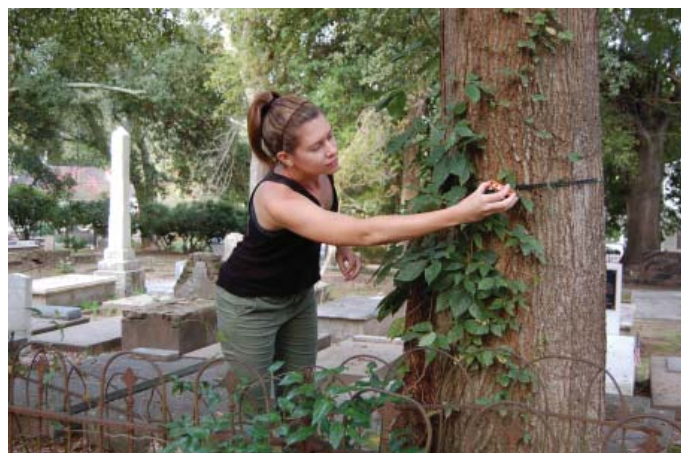
Figure 12. A cemetery professional undertakes a tree inventory in American Cemetery, Natchitoches, LA, to determine the health of trees in the cemetery. Management decisions for trimming or removal are based on the inventory. Photo: Debbie Dietrich Smith.

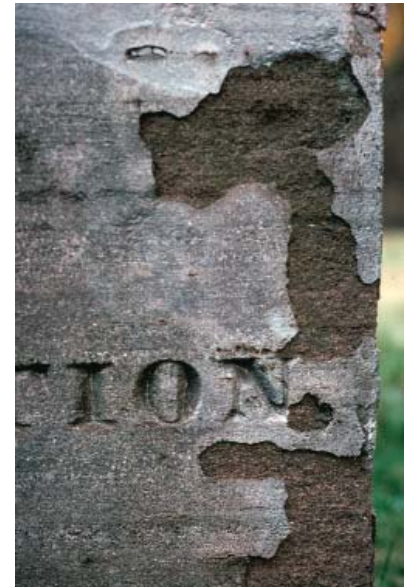
Figure 14. High-pressure water washing can damage grave markers. The photograph shows "wand marks" on the headstones produced by inappropriate pressure washing. Photo: Jason Church.

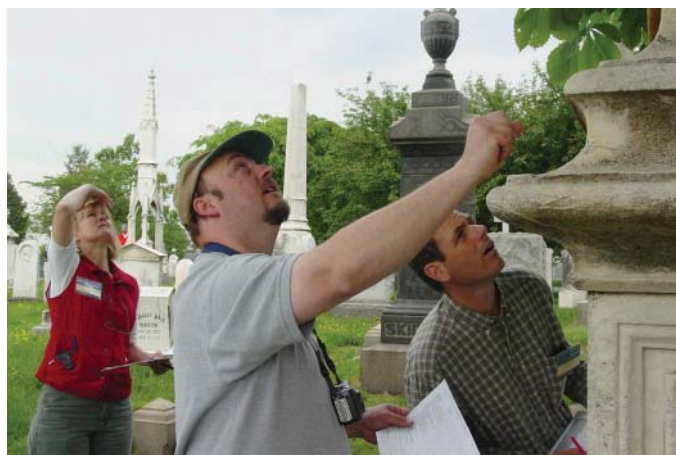
Figure 15a. Condition surveys are undertaken to document current conditions, determine safety issues, and plan both emergency stabilization and future treatment plans. There are a variety of survey forms available that can be tailored to the specific cemetery. Photo: Mary Striegel.

Depending upon the size of the cemetery and funding available, the initial assessment may be carried out by a team consisting of cemetery staff, a materials conservator, and, where necessary, an architect or structural engineer for cases involving large monuments and mausoleums (Figs. 15a and 15b). For smaller cemeteries without large monuments and mausoleums, and where funding is problematic, volunteers can be trained to prepare a condition assessment under the guidance of an experienced individual.

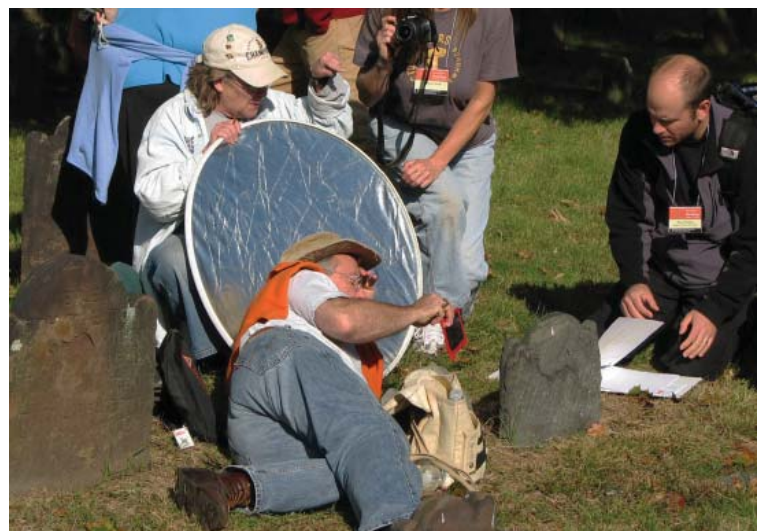
Figure 15b. Photographs are used to document the condition of the grave marker as part of a condition assessment. Photo: Fran Gale.

A tool kit for the condition assessment may include binoculars, digital camera, magnifying glass, measuring tape, clipboard, carpenter's rule, level, magnet, and flashlight. For large monuments, a ladder or aerial lift may be required. Photographs of each marker, including overall shots and close-up details, are an essential part of the documentation process. Photo logs are helpful for

recording the date, direction, and photographer. Digital photographs should be captured in a standardized size and format (.tif, .jpg, .raw).

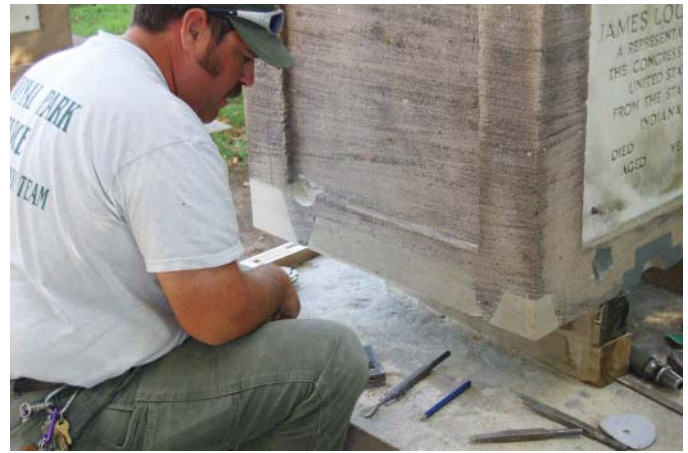
Figure 16. A professional mason works to insert a new piece of stone. Often referred to as a “dutchman”, this repair technique requires replacing the deteriorated stone section with a new finished piece of the same size and material. Photo: Jason Church.

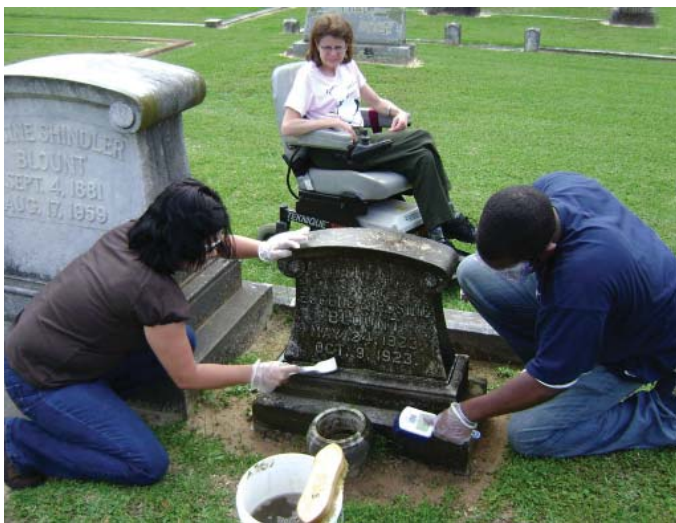
Figure 17. Volunteers can undertake cleaning of grave markers once they have received initial training. Cleaning methods may include wetting the stone, using a mild chemical cleaner, gently agitating the surface with a soft bristle brush, and thoroughly rinsing the marker with clean water. Photo: Jason Church.

Cleaning is carried out to remove soiling, staining, and contamination from grave markers (Fig. 17). Cleaning improves the visual appearance of the marker and sometimes reveals existing problems such as erosion and cracks. For various protective treatments, cleaning may be a necessary step in surface preparation. Although cleaning often is desirable and beneficial, the use of improper materials and techniques can cause great damage; when cleaning historic grave markers is undertaken, one should keep in mind the principle, “first do no harm.”

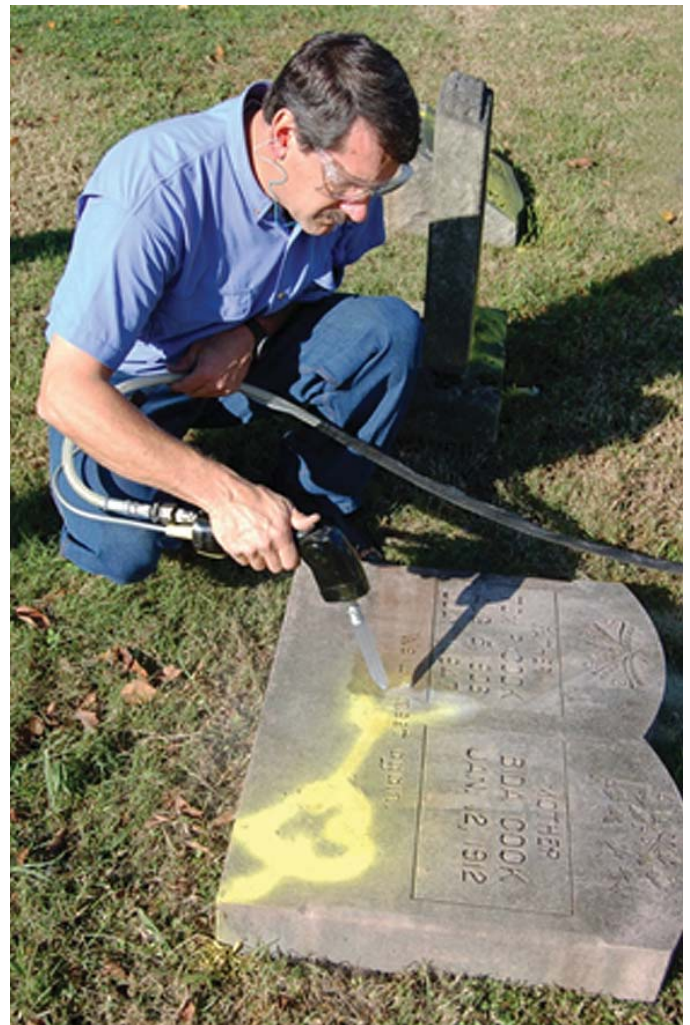
Figure 18. Graffiti is carefully removed using a low-pressure dry-ice misting instrument. Photo: Jason Church.

Markers with graffiti tend to be targets for further vandalism (Fig. 18). Timely removal helps deter future vandalism and improves the marker’s appearance.

If the graffiti is water soluble, it can be removed using water and a soft cloth or towel. Rinsing the cloth frequently helps to avoid smearing graffiti on unaffected areas. If the graffiti is not water soluble, organic solvents or commercial graffiti removal products suitable for the grave marker material are recommended. Products should be tested prior to use. General cleaning of the entire marker is a good follow-up for a more even appearance. For deep-seated graffiti, poultice cleaning (previously described) may be required to extract staining materials.

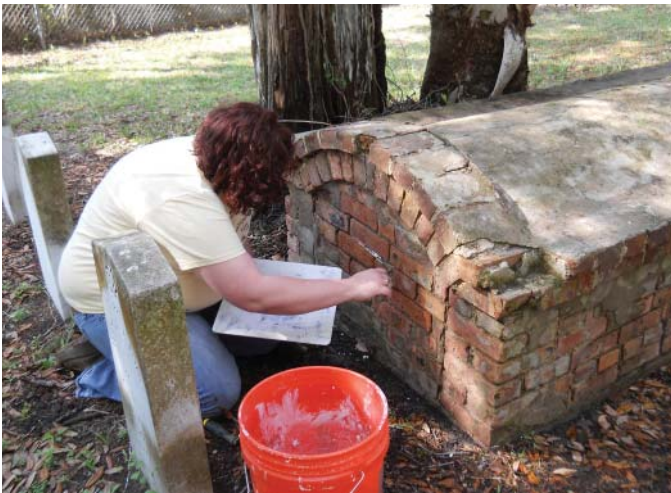
Figure 19. Masonry markers like this box tomb may require the repointing of mortar joints. It is important to use a mortar that is softer than the historic brick. In this case a conservator uses a lime putty-based mortar to repoint. Photo: Jason Church.

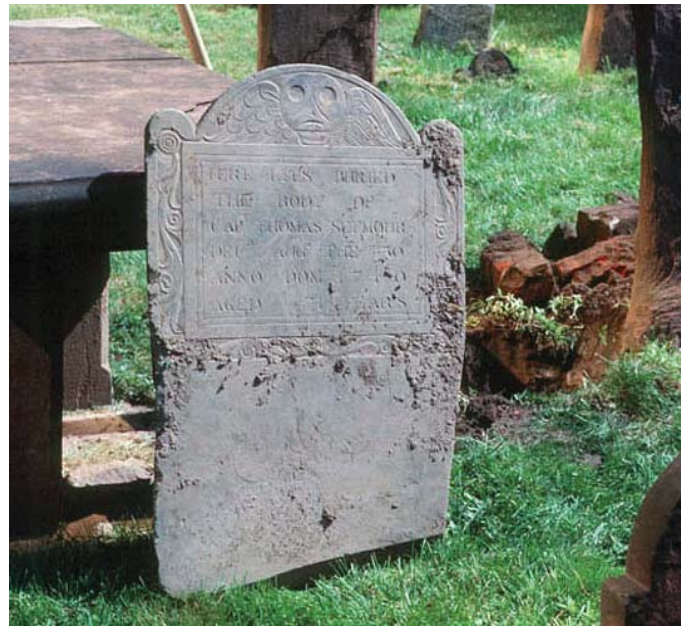
Figure 20a. This slate grave marker in the Ancient Burying Ground in Hartford, CT, is a ground-support stone. Resetting requires digging a hole that will hold the base of the stone and then compacting the soil at the bottom of the hole by hand. Photo: Fran Gale.

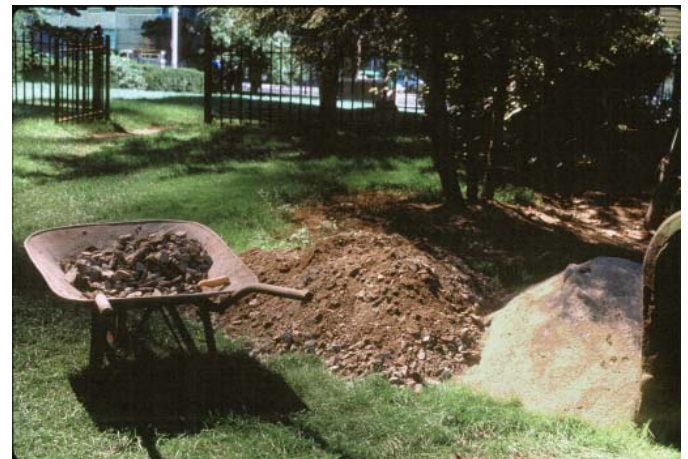
Figure 20b. To facilitate drainage, crushed stone, gravel, and sharp sand line the hole and are hand-tamped around the stone after placement. Photo: Fran Gale.

Resetting is recommended for grave markers when their foundations are unstable or out of plumb (Figs. 20a through 20c). This often complex activity involves lifting the grave marker, leveling its foundation, and returning the marker to its original upright position. Workers can be injured and the grave marker damaged if resetting is not carried out properly and safely.

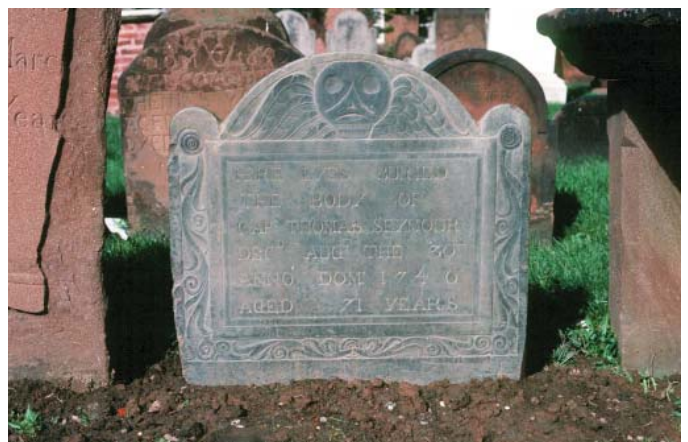
Figure 20c. The reset ground-supported grave marker should be level and plumb. Photo: Fran Gale.

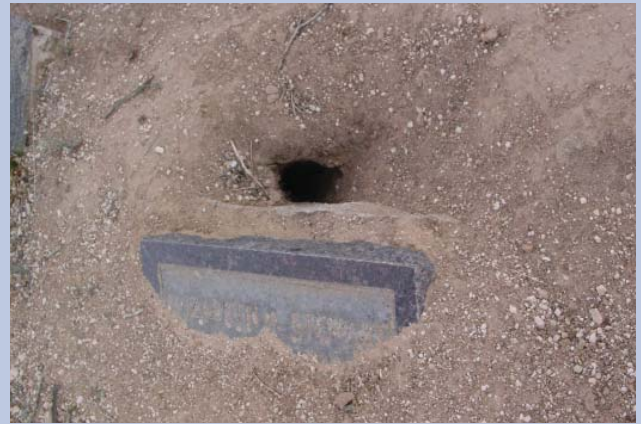
Figure C. Gophers and other burrowing animals produce uneven ground and holes that are trip and falling hazards to visitors and staff of historic cemeteries. Photo: Jason Church.

Trip and falling hazards include uneven ground, holes, open graves, toppled grave markers, fallen tree limbs, and other debris (Fig. C). Sitting, climbing, or standing on a grave marker should be avoided since the additional weight may cause

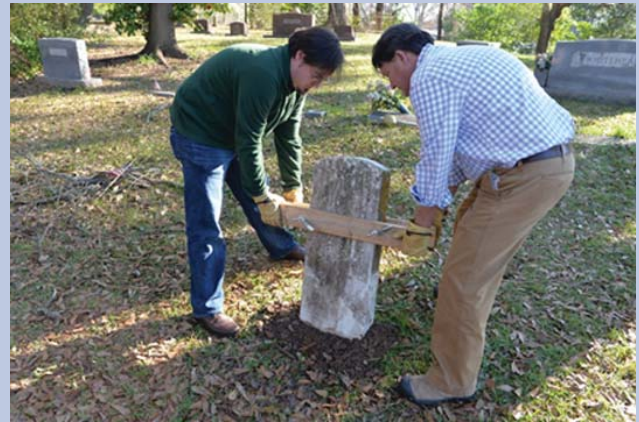
Figure E1. The simple wooden clamp system allows two people to safely lift a marble grave marker. Photo: Sarah Jackson.

lifting techniques. Lift equipment and ergonomically correct tools should be routinely used to lift heavy markers (for most people this includes markers that weight more than 50 pounds). For smaller grave markers, a simple wooden clamp system can be constructed for a two-person lift (Figs. E1 and E2).

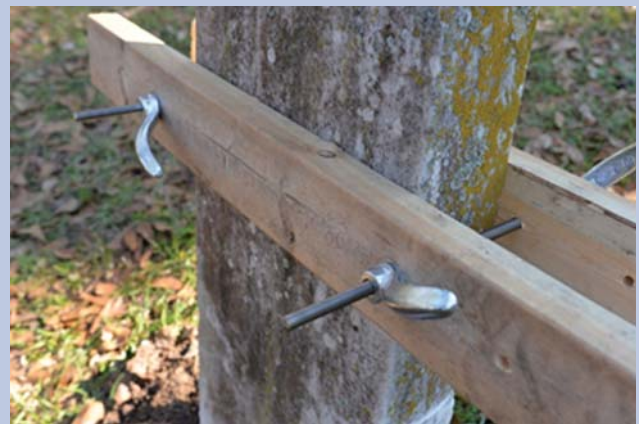
Figure E2. The clamp system is constructed from off-the-shelf wooden boards. Photo: Sarah Jackson.

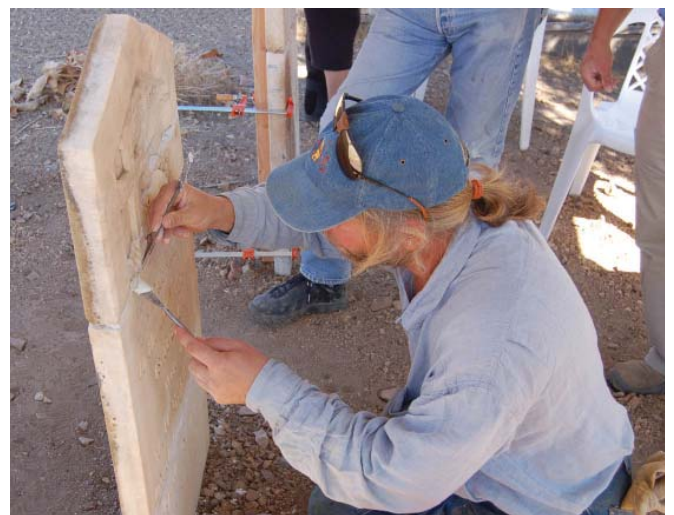
Figure 21. Cracks in a stone marker should be filled to keep water and debris out and prevent the crack from becoming larger. A patching mortar is designed to be used, in this case, with historic marble. Photo: Mary Striegel.

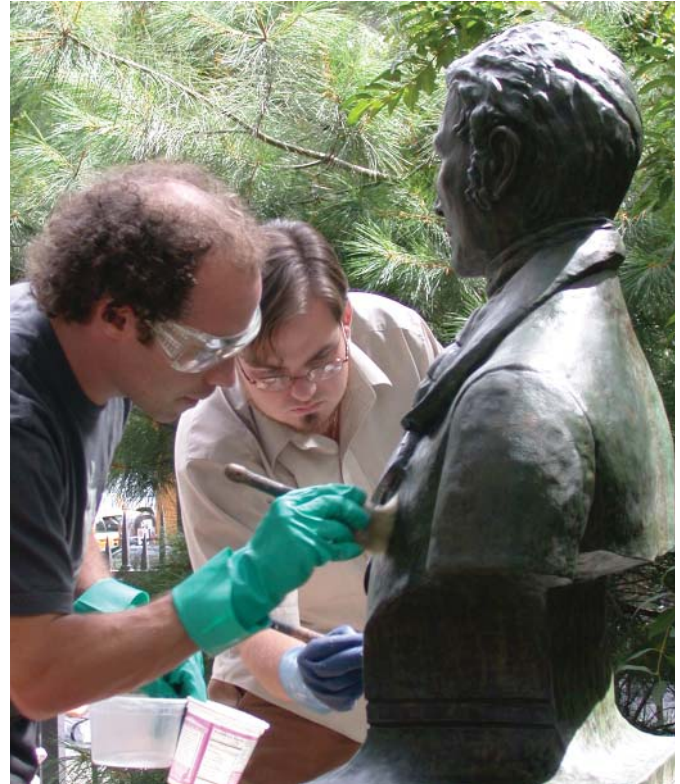
Figure 22. A protective coating must be maintained on metal elements. Wax or lacquer coatings help preserve the bronze patina and slow corrosion. Conservators apply a microcrystalline wax to this bust at St. Mark's Church in-the-Bowery, New York, NY. Photo: John Scott.

Wax coatings are often used for bronze markers (Fig. 22). Wax provides a protective barrier against moisture, soiling, and graffiti. There are several steps in the wax application process. Where there is little corrosion, gentle cleaning of the marker is undertaken prior to applying the wax coating. Apply a thin layer of wax to the marker using a stencil brush or chip brush. Mineral spirits can be added to the wax to facilitate

brush application. A soft, clean cloth is used to remove excess wax and buff the surface. A second coat of wax is sometimes needed.

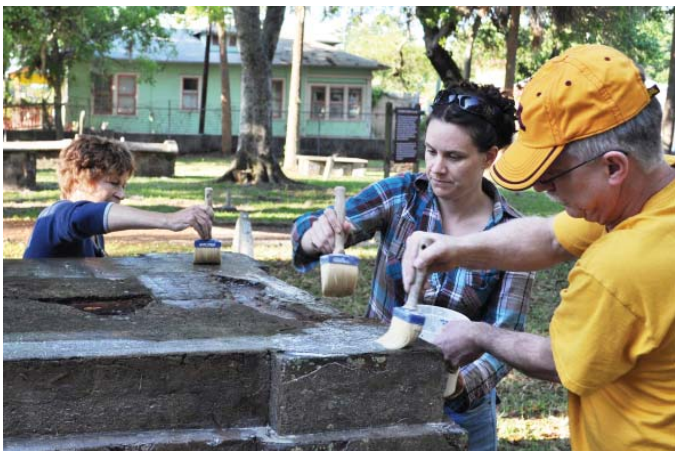
Figure 23. Limewash is a breathable coating sometimes used to protect the surface of the grave marker and provide a decorative finish. Limewash is applied by brush in five to eight thin coats (with each coat about the consistency of skim milk). The surface is allowed to slowly dry between coats. Sometimes the surface is covered by damp burlap to slow the drying process. Photo: Sarah Jackson.

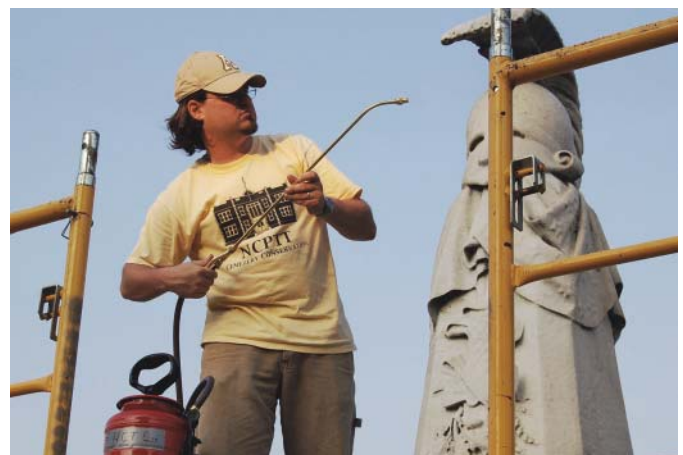
Figure 24. A severely deteriorating monument or grave marker can be treated with a stone consolidant. The treatment is usually applied using a spray system. The consolidant soaks into the stone and replaces mineral binders that hold the stone together. On-site and laboratory testing and evaluation are performed prior to using this non-reversible type of treatment. Photo: Lucas Flickinger.
