PRESERVATION PLAN

PENNSYLVANIA AFRICAN AMERICAN CEMETERY STEWARDSHIP PROGRAM

Zion Union Cemetery
Bennett Avenue/Zion Lane
Mercersburg, Franklin County, Pennsylvania

February 2024

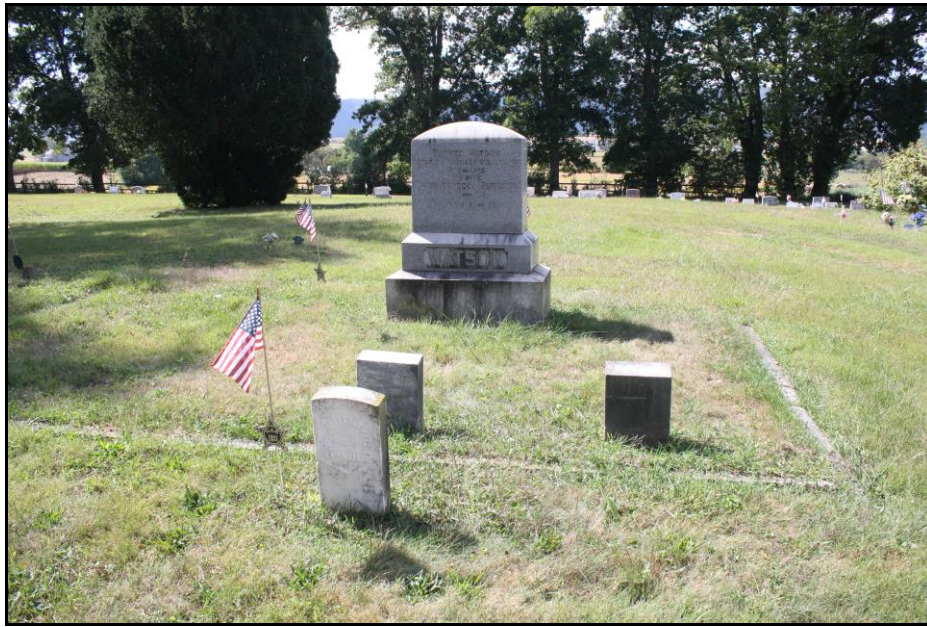
Figure 21: Granite sarcophagus on stacked bases for Parker Watson who was a sergeant with 127th Colored Volunteer Infantry (d. 1885), his wife Mary Rebecca Burgess (d. 1912), and their daughter Nancy (d. 1880); Photo view: West; Photographer: Jason Harpe; Date: September 19, 2023.

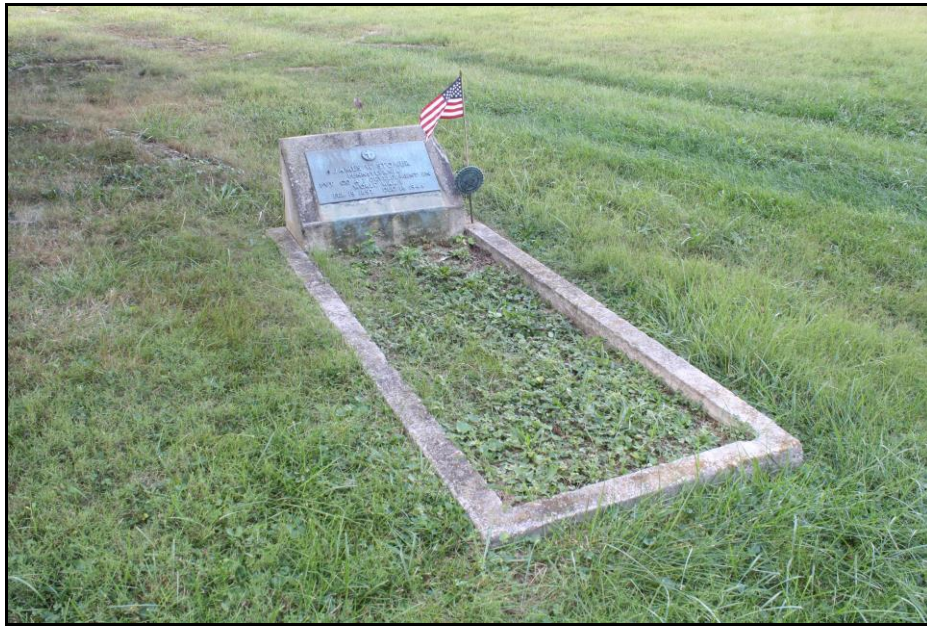
Figure 27: Cast concrete slant-front marker with bronze plaque and cast concrete plot enclosure for James Stoner (d. 1944) who served in World War I; Photo view: South; Photographer: Jason Harpe; Date: September 19, 2023.

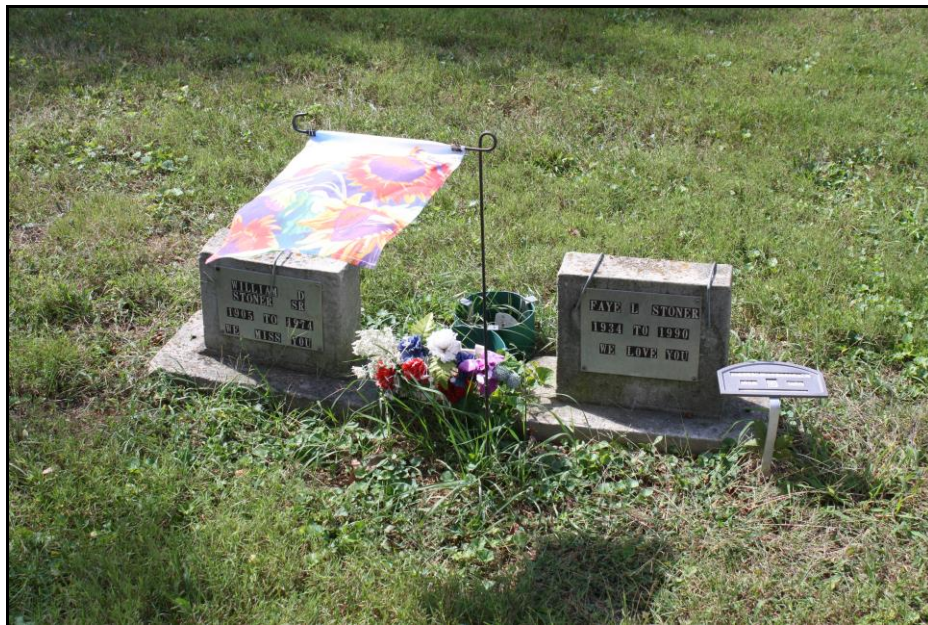
Figure 30: Cast concrete die-on-base gravemarkers with metal plaques and mailbox letters and numbers at Zion Union Cemetery's west elevation; Photo view: West; Photographer: Jason Harpe; Date: September 19, 2023.

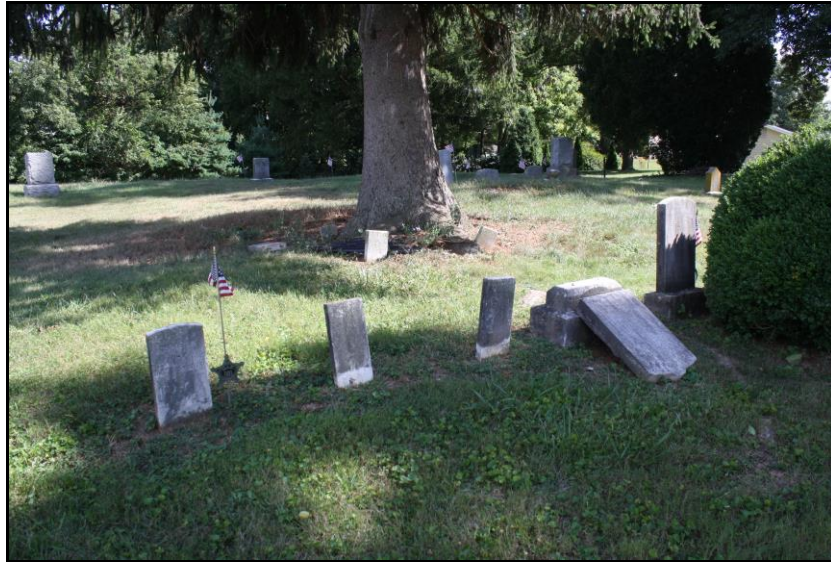
Zion Union Cemetery's gravemarkers and monuments are currently in good condition. During the site visit to Zion Union Cemetery, RGA staff noticed only one gravemarker near the middle of the cemetery that is displaced from its stacked bases. This gravemarker is in a row of Demas family gravemarkers. RGA was unable to read the decedent's name or attributes because the tablet is leaning against its stacked bases and the top of the tablet is partially underground. Except for the cemetery's newest gravemarkers from the 1990s to the present, all marble, granite, and concrete gravemarkers display atmospheric staining, soiling, and some biological growth.

Figure 33: Gravemarkers with atmospheric staining, biological growth, and displacement near Zion Union Cemetery south elevation; Photo view: Southwest; Photographer: Jason Harpe; Date: September 19, 2023.

Gravemarkers made of marble and concrete in Zion Union Cemetery that have become displaced and are on the ground should be leveled and reattached as soon as possible. Deterioration of these displaced and broken pieces is accelerated by constant exposure to moisture in the soil, lawn mowers and weed eaters, and herbicides. Marble is very porous and susceptible to "sugar decay," a phenomenon "in which acid precipitation attacks along the joints or boundaries between the calcite crystals that comprise marble" and "the grains or crystals are ultimately loosened and can be brushed off like granulated sugar" (Anson-Cartwright 1997:8).

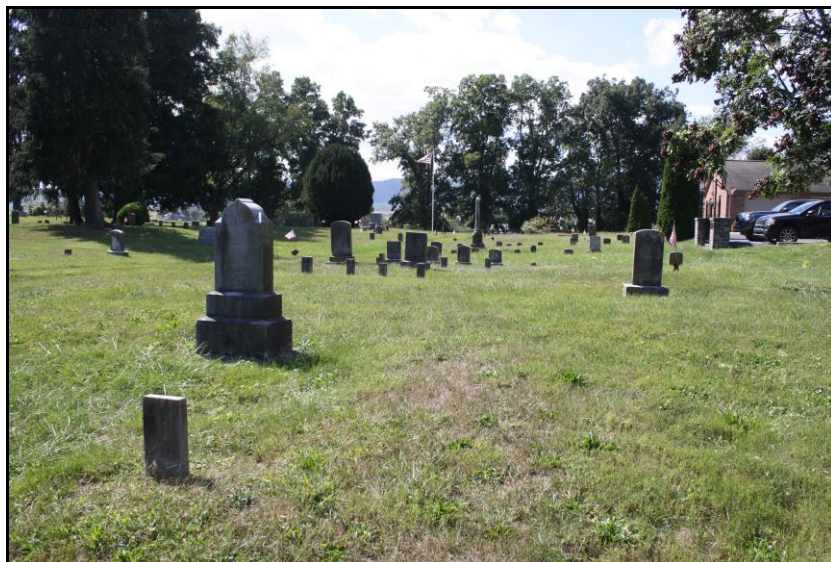
Figure 34: Gravemarkers throughout Zion Union Cemetery have atmospheric staining and biological growth; Photo view: West; Photographer: Jason Harpe; Date: September 19, 2023.

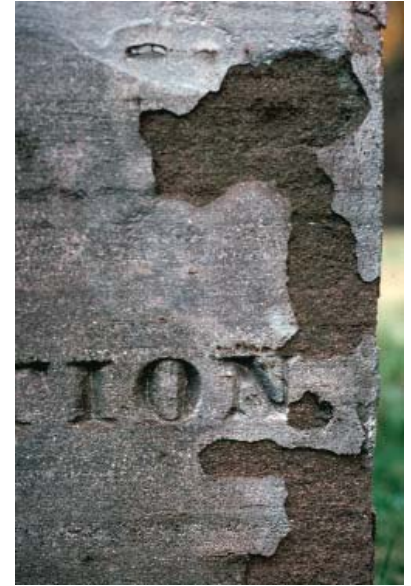
Figure 14. High-pressure water washing can damage grave markers. The photograph shows "wand marks" on the headstones produced by inappropriate pressure washing. Photo: Jason Church.

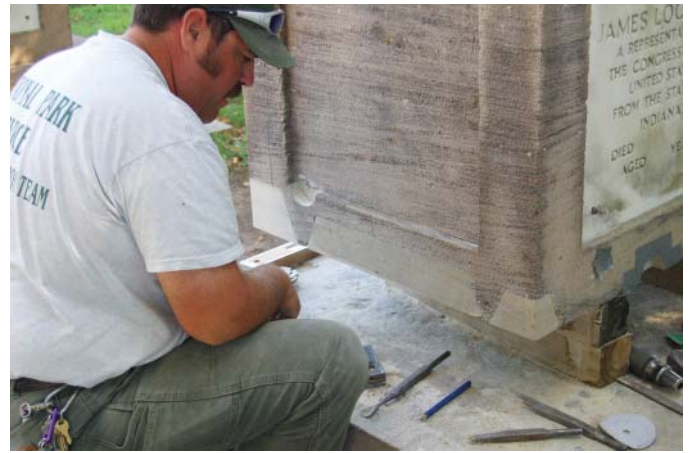
Figure 16. A professional mason works to insert a new piece of stone. Often referred to as a “dutchman”, this repair technique requires replacing the deteriorated stone section with a new finished piece of the same size and material. Photo: Jason Church.

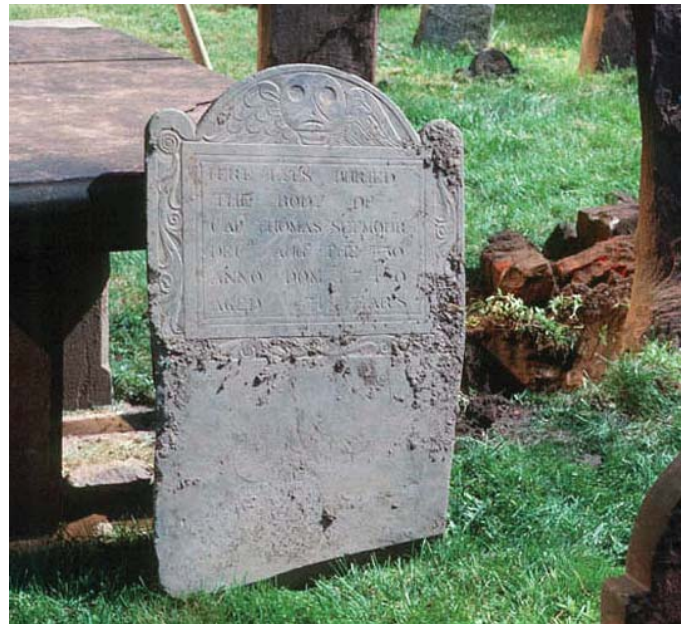
Figure 20a. This slate grave marker in the Ancient Burying Ground in Hartford, CT, is a ground-support stone. Resetting requires digging a hole that will hold the base of the stone and then compacting the soil at the bottom of the hole by hand. Photo: Fran Gale.
