GREEN LAWN CEMETERY PRESERVATION PLAN

Aston, Delaware County, Pennsylvania

RGA Technical Report 2022-341PA

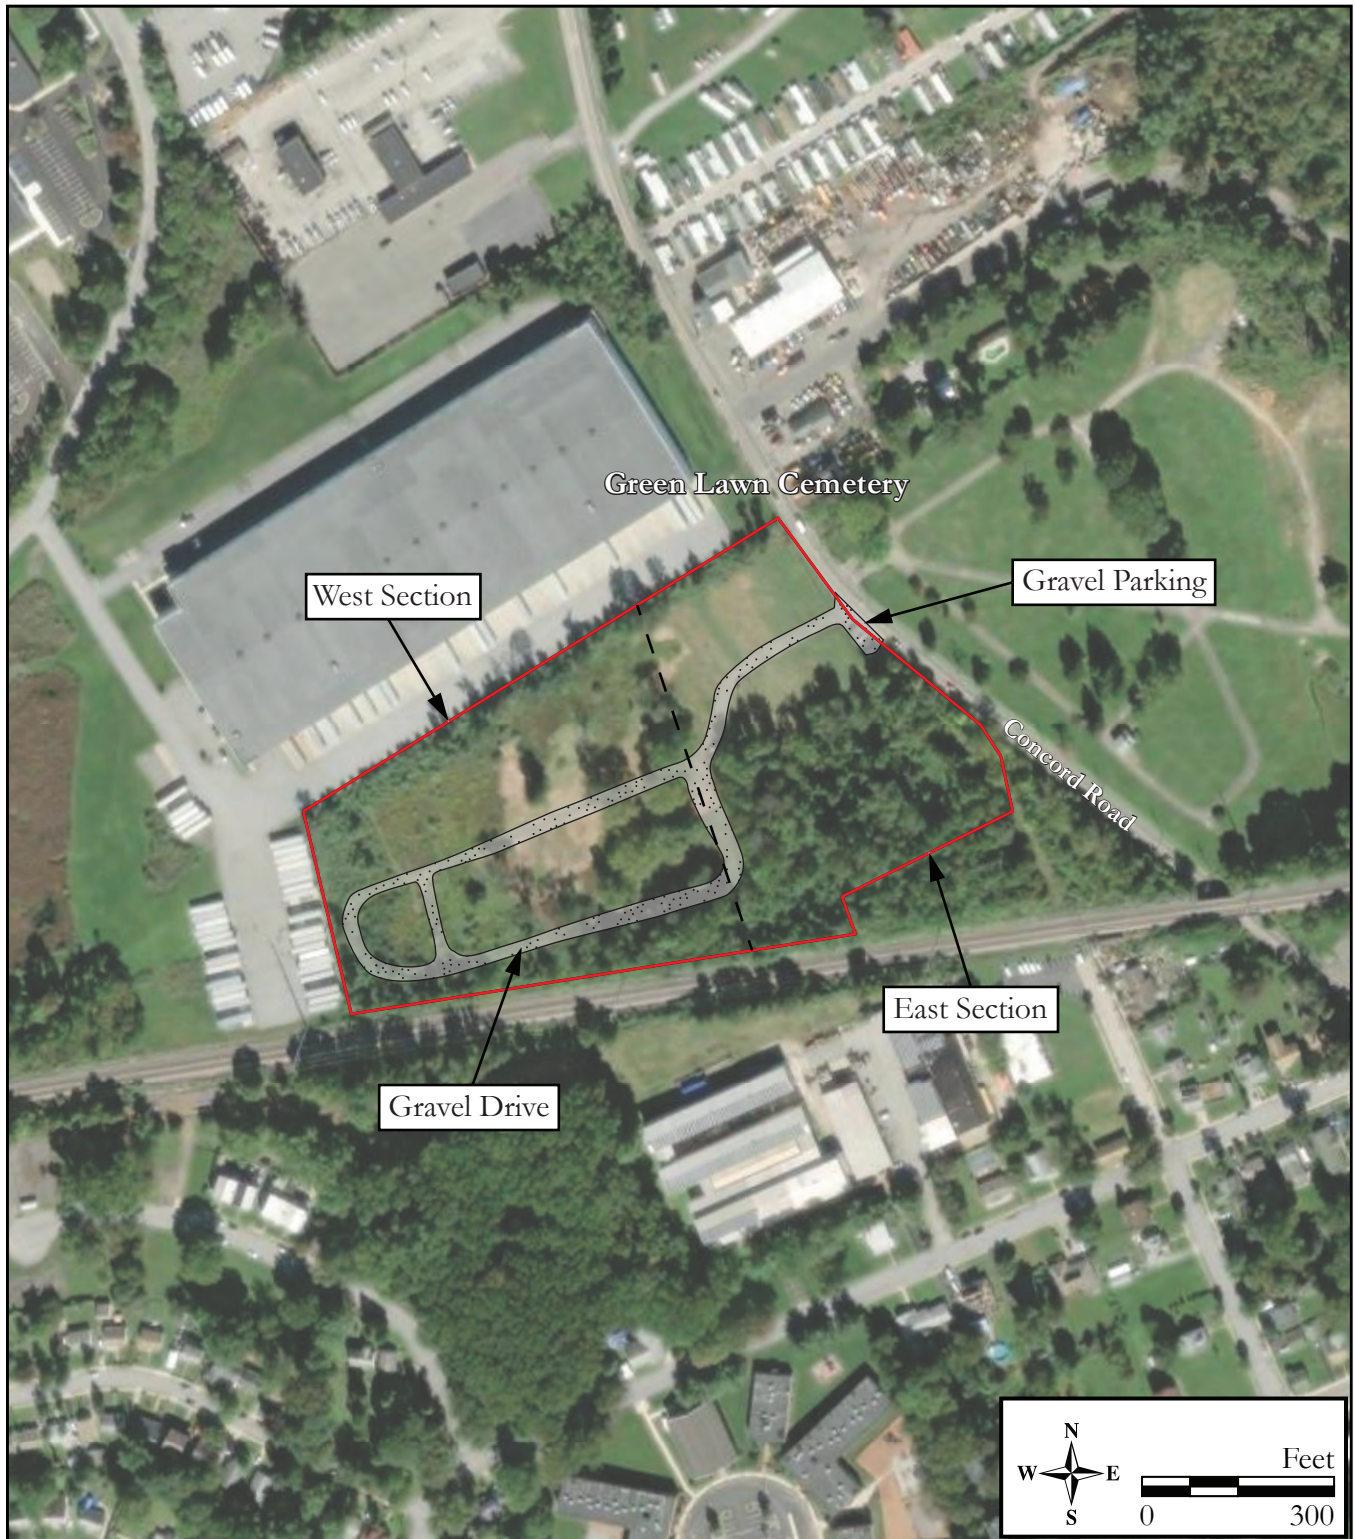
Figure 1.5: Aerial map of Green Lawn Cemetery showing sections, the gravel drive and parking. A dashed line divides the two sections, which are visually distinguished by how they are maintained (World Imagery, ESRI 2002).

Green Lawn Cemetery is accessed by a single lane drive off Concord Road that extends east to west through the middle of the cemetery. The drive loops south at the property's western edge and runs parallel to the active CSX Transportation railroad to the eastern front section of the cemetery. The cemetery is bounded on the north by Refresco Beverage's 240,000 square foot warehouse and parking lot; on the east by Concord Road; on the south by the CSX Transportation railroad; and on the west by a large parking lot where Refresco Beverage parks their tractor trailer shipping containers. A gravel driveway along the cemetery property's eastern edge extends from the small parking area between Concord Road and the cemetery entrance into the Gravel Hill Cemetery property (see Figure 1.5).

The cemetery's landscape is level but slopes east towards Concord Road at the property's eastern edge. A narrow, graveled strip along Concord Road at the property's east elevation allows for parking outside the cemetery. One-quarter of the cemetery grounds (at the eastern end of the property) are grassed and well-maintained by cemetery stewards. Large trees on the property are widely spaced across the western part of the property and along the property's northern, southern, and western edges (see Figure 1.5).

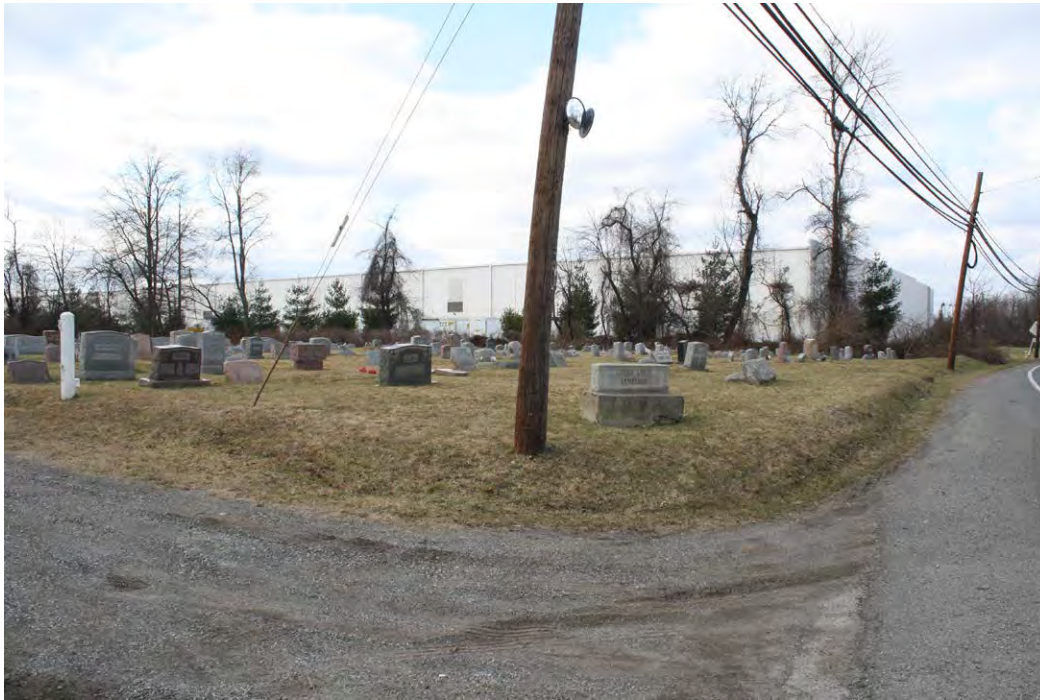
Figure 2.1: Gravel driveway off Concord Road at Green Lawn Cemetery's eastern edge
Photo view: North; Photographer: Jason Harpe; Date: January 18, 2023.

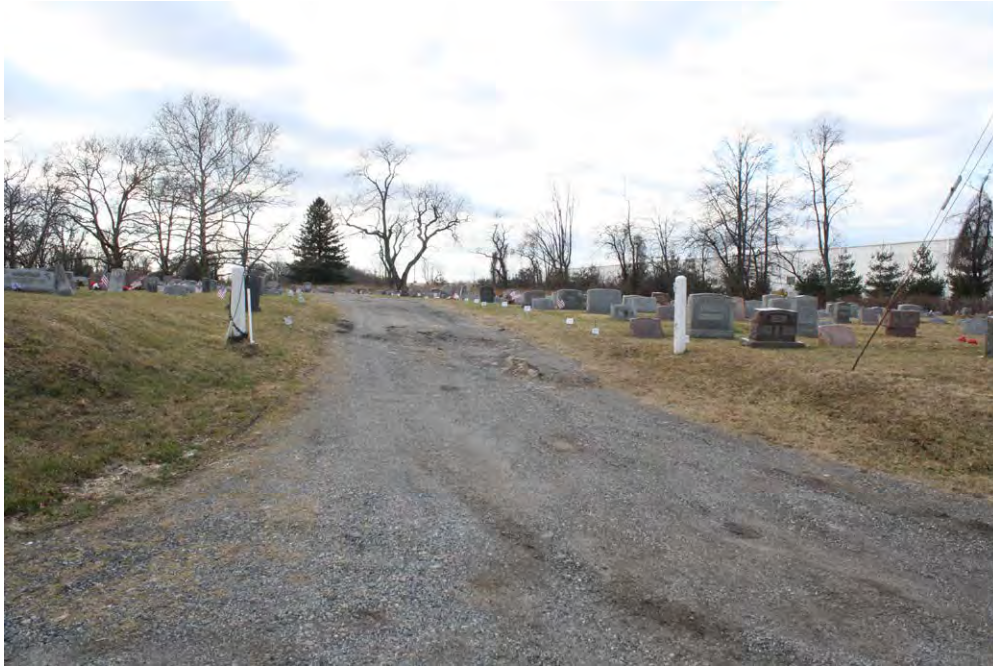
Figure 2.3: Gravel driveway off Concord Road at Green Lawn Cemetery's eastern edge
Photo view: West; Photographer: Jason Harpe; Date: January 18, 2023.

Access to the cemetery by the heavy equipment required to excavate graves is possible only through the unsecured gravel drive at the cemetery's entrance. Although two iron posts flank the driveway at this location, no barrier across the entrance is present (see Figure 2.3). The cemetery stewards should replace the two iron posts with more stable and aesthetically pleasing posts between which they can hang metal gates or stretch a cable. The chain or cable, which they can install quickly and at a relatively low cost, should be marked with reflectors and mounted high enough that it is clearly visible to vehicles and pedestrians as a barrier. Other barriers are also possible, including hedge plantings or large boulders. If the hedges or boulders are successful in eliminating vehicular access from those areas, the installation of a fence may not be necessary. The cost and time required for the installation of fencing or plantings will depend on the final selection of style and extent (Figure 4.1).

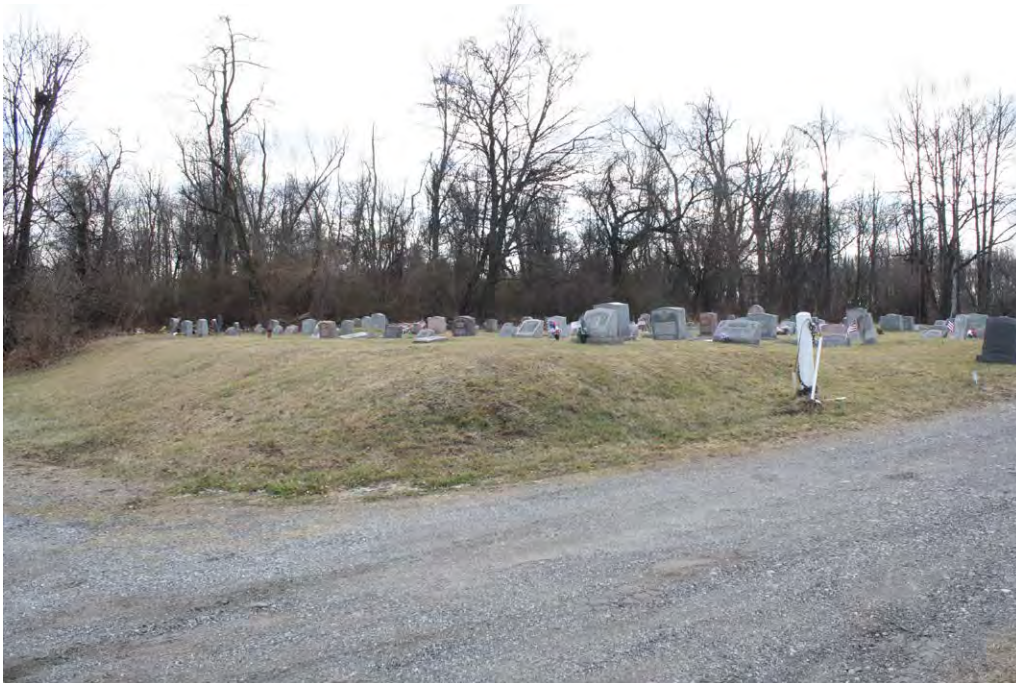
Figure 2.4: Gravemarkers near the cemetery's southeast corner
Photo view: South; Photographer: Jason Harpe; Date: January 18, 2023.

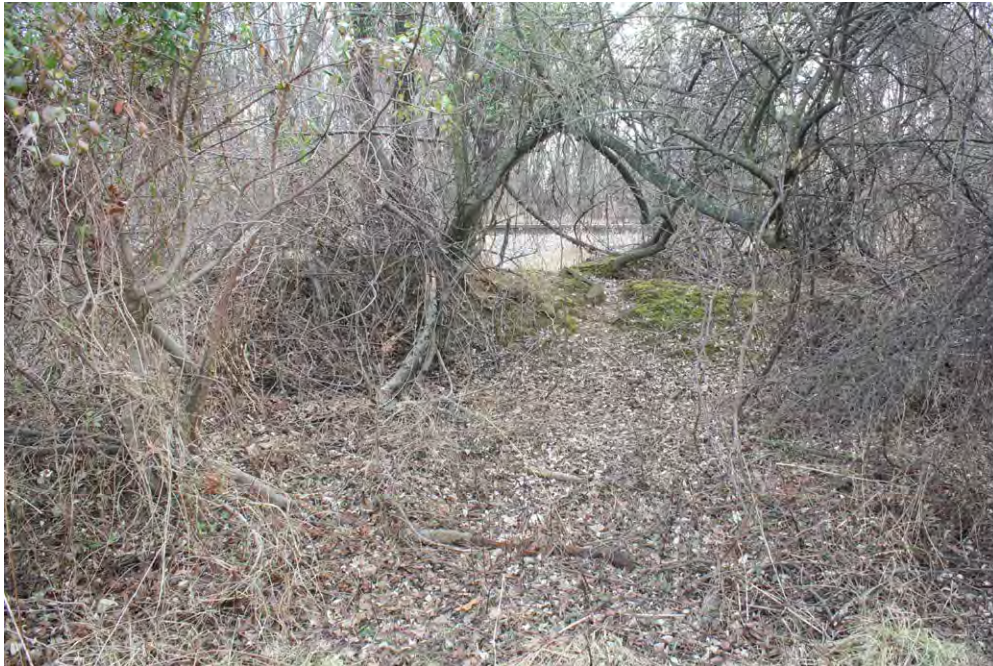
Figure 2.7: Underbrush between the cemetery and the CSX Transportation railroad at the property's southern edge
Photo view: South; Photographer: Jason Harpe; Date: January 18, 2023.

Access to Green Lawn Cemetery’s grounds is a concern because of issues such as unauthorized burials, vandalism, and littering. Cemetery stewards are aware that large trucks access the cemetery grounds to dump loads of dirt near the southern and western edges of the property and use the gravel drive between the cemetery property and Concord Road to dump trash on the Gravel Cemetery property (Grasty 2023). The cemetery is accessible along its southern edge, close to the CSX Transportation railroad, and people have dumped clothes, funerary urns, household items, beer bottles, and even mattresses on burial plots and around gravemarkers (see Figures 2.7 and 2.9). Fencing the southern edge of the property may be cost prohibitive

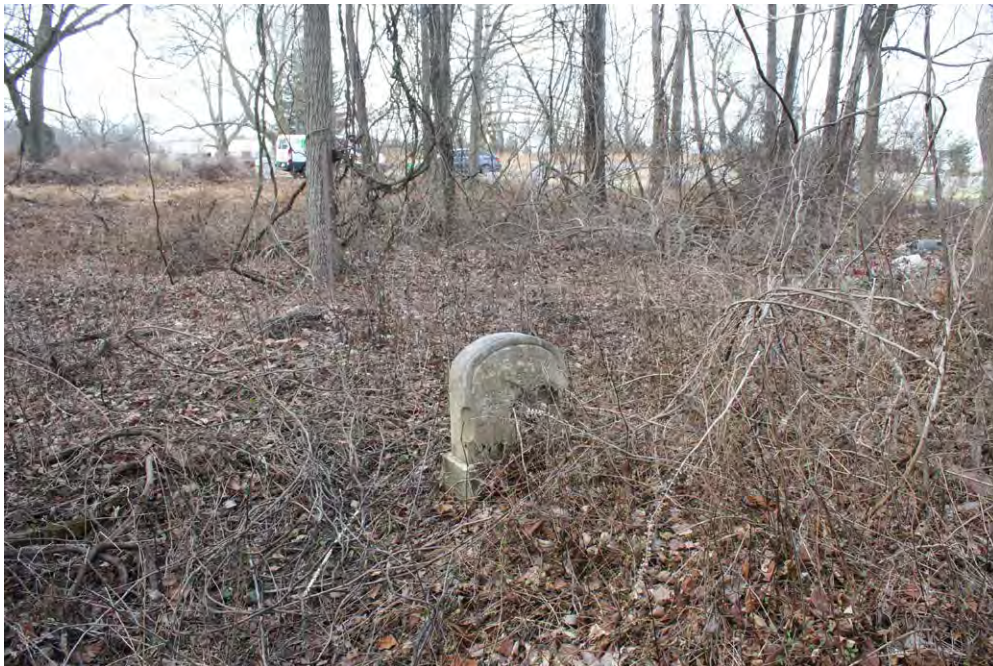
Figure 2.8: Vines and underbrush in the Gravel Hill Cemetery, southeast of Green Lawn Cemetery
Photo view: Northwest; Photographer: Jason Harpe; Date: January 18, 2023.

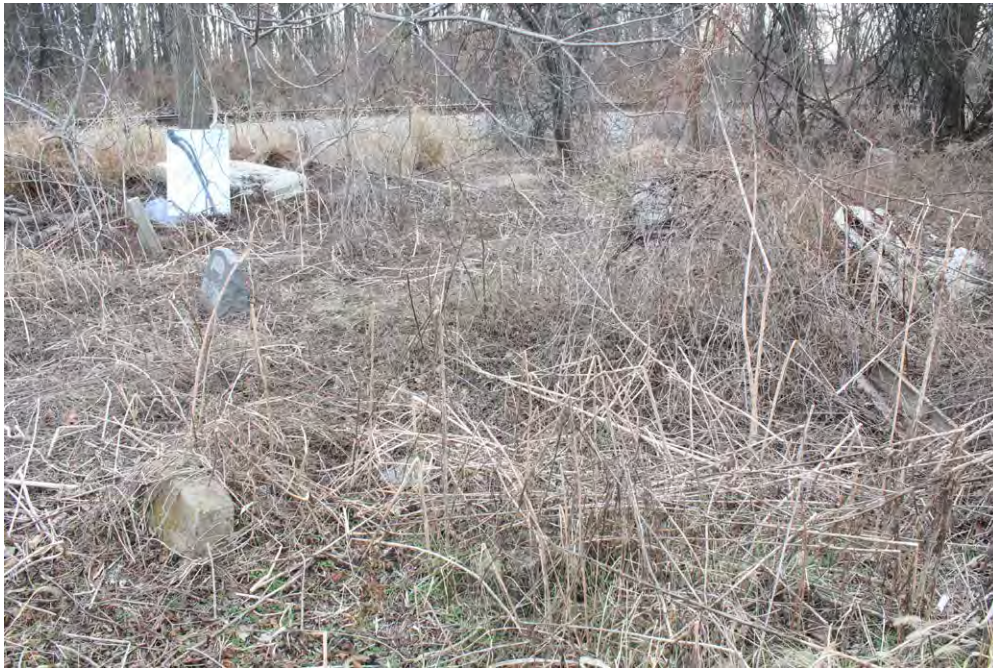
Figure 2.9: Vines, underbrush, gravemarkers, and trash between the cemetery and the CSX Transportation railroad at the property's southern edge
Photo view: South; Photographer: Jason Harpe; Date: January 18, 2023.

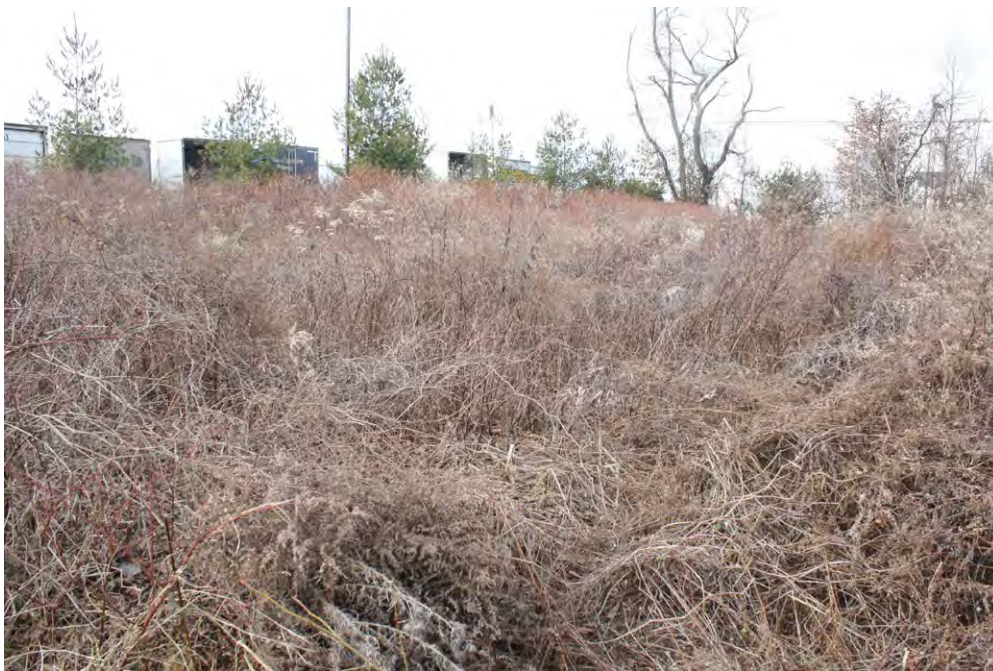
Figure 2.10: Thick underbrush near the cemetery's western edge
Photo view: Northwest; Photographer: Jason Harpe; Date: January 18, 2023.

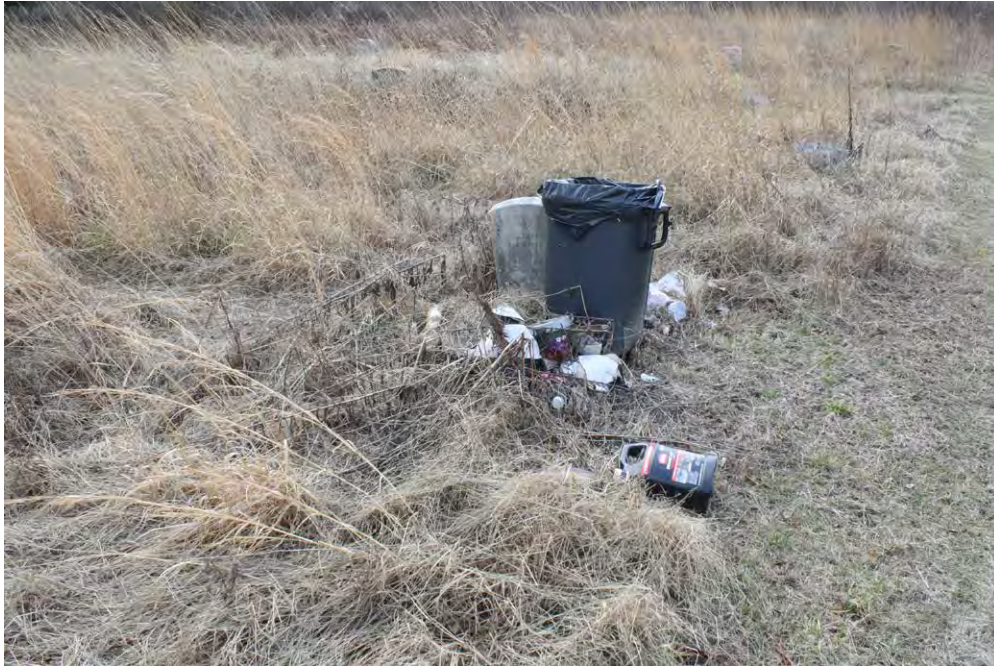
Figure 2.11: Trash receptable near the middle of the cemetery
Photo view: West; Photographer: Jason Harpe; Date: January 18, 2023.

During fieldwork, RGA staff noted a few trash cans in the cemetery, one of which was full, and trash was lying on the ground around it (see Figure 2.11). If the cemetery stewards plan to keep these trashcans on the property, they should empty them once each week or at least check them once each week to make sure that they have not reached their storage capacity. Trash placed indiscriminately across the property makes the site look unkempt and gives people the impression that the cemetery stewards care very little for the property.

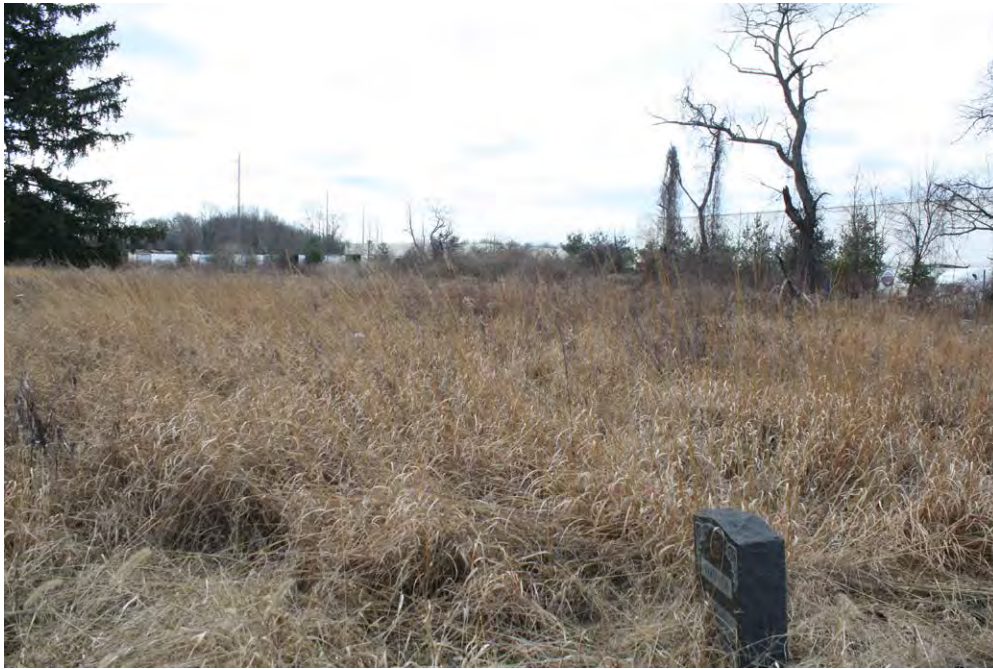
Figure 2.15: Thick underbrush and gravemarkers near the cemetery's northern edge
Photo view: West; Photographer: Jason Harpe; Date: January 18, 2023.

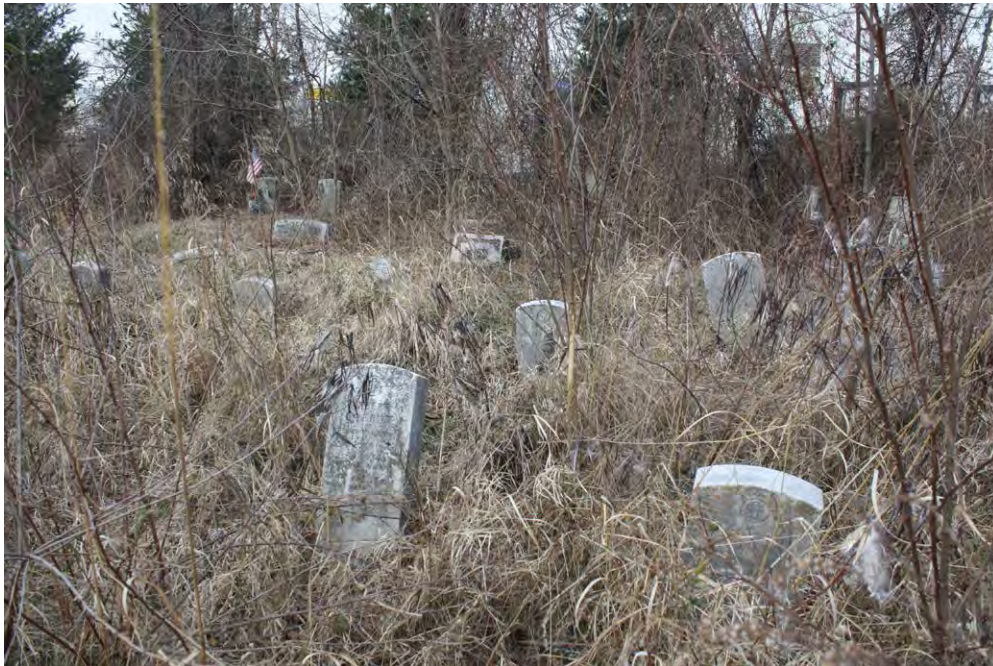
Figure 2.16: Thick underbrush and gravemarkers near the cemetery's northern edge
Photo view: North; Photographer: Jason Harpe; Date: January 18, 2023.

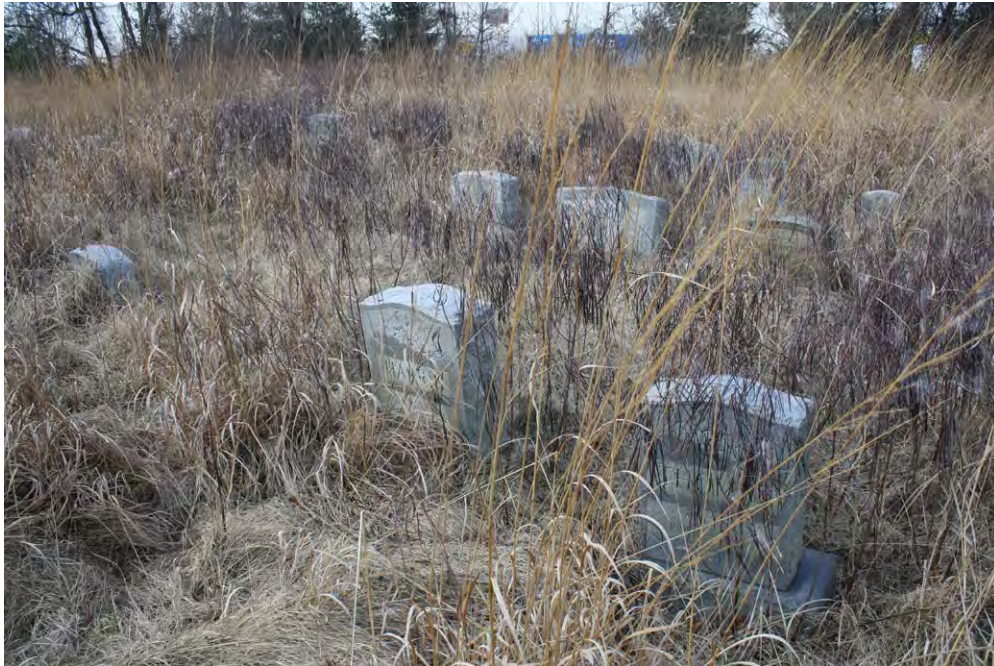
Figure 2.17: Thick underbrush and gravemarkers near the cemetery's northern edge
Photo view: North; Photographer: Jason Harpe; Date: January 18, 2023.

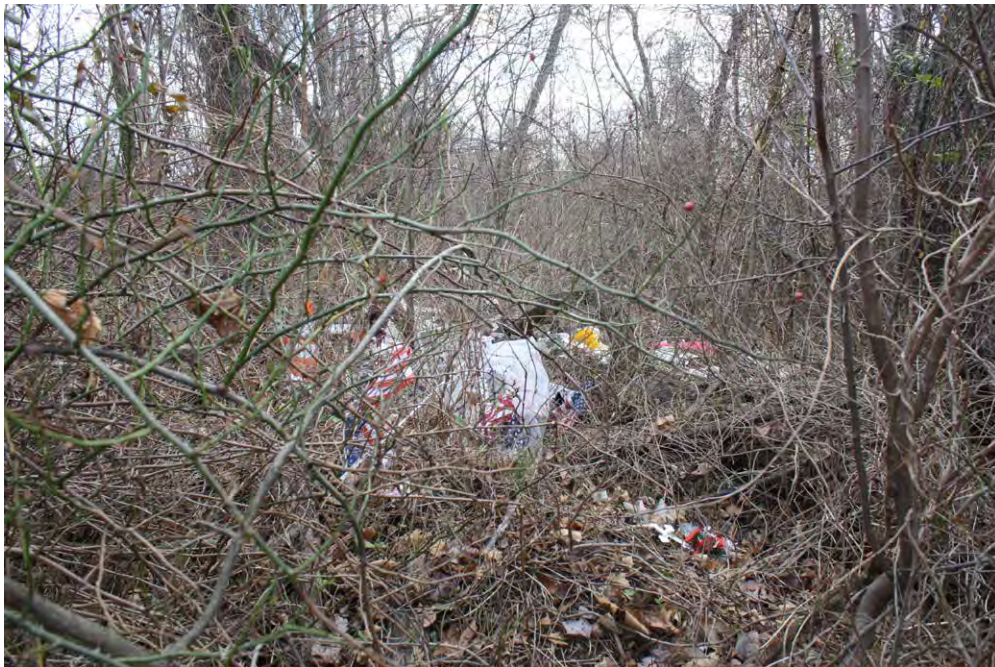
Figure 2.22: Trash in the Gravel Hill Cemetery, in an overgrowth area south of the Green
Lawn Cemetery
Photo view: South; Photographer: Jason Harpe; Date: January 18, 2023.

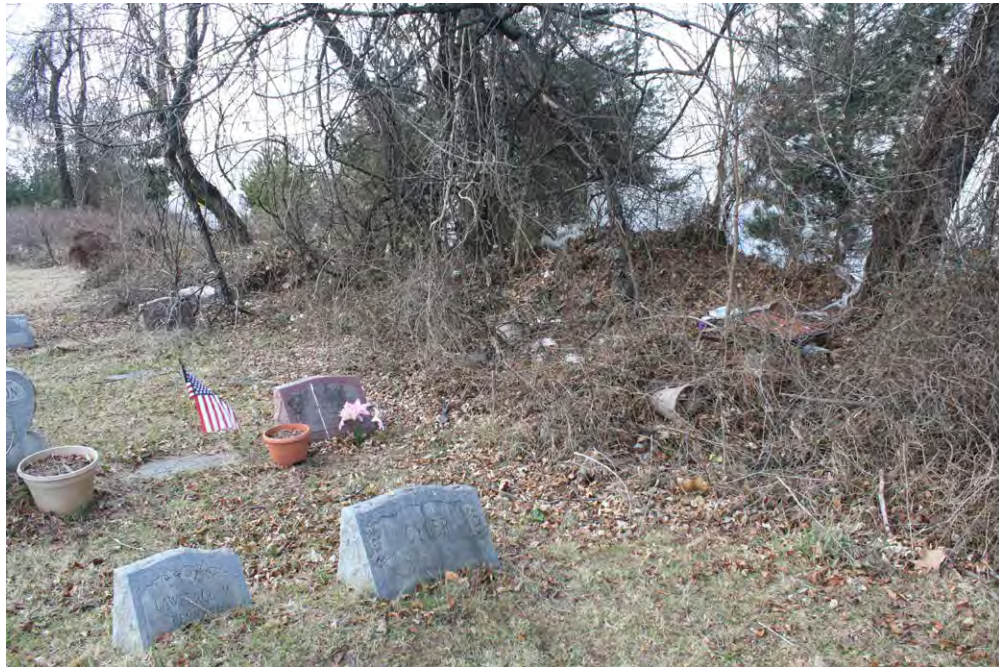
Figure 2.23: Trash along the cemetery's wooded northern edge
 Photo view: West; Photographer: Jason Harpe; Date: January 18, 2023.

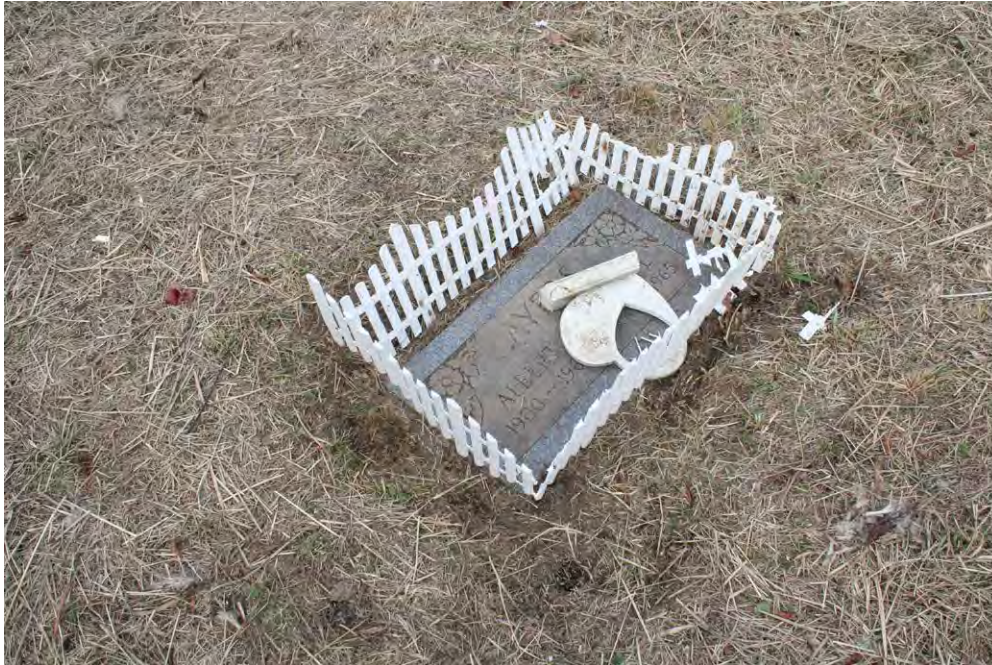
Figure 2.27: A granite lawn-style gravemarker enclosed by plastic fencing
Photo view: North; Photographer: Jason Harpe; Date: January 18, 2023.

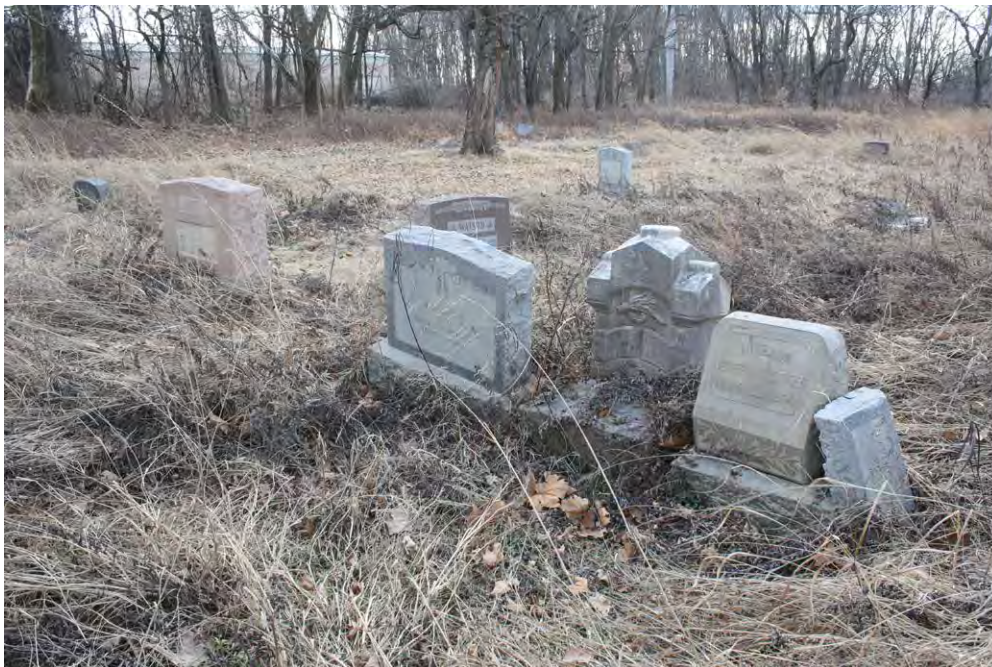
Figure 2.28: Underbrush around marble and granite die-on-base gravemarkers
Photo view: Southwest; Photographer: Jason Harpe; Date: January 18, 2023.

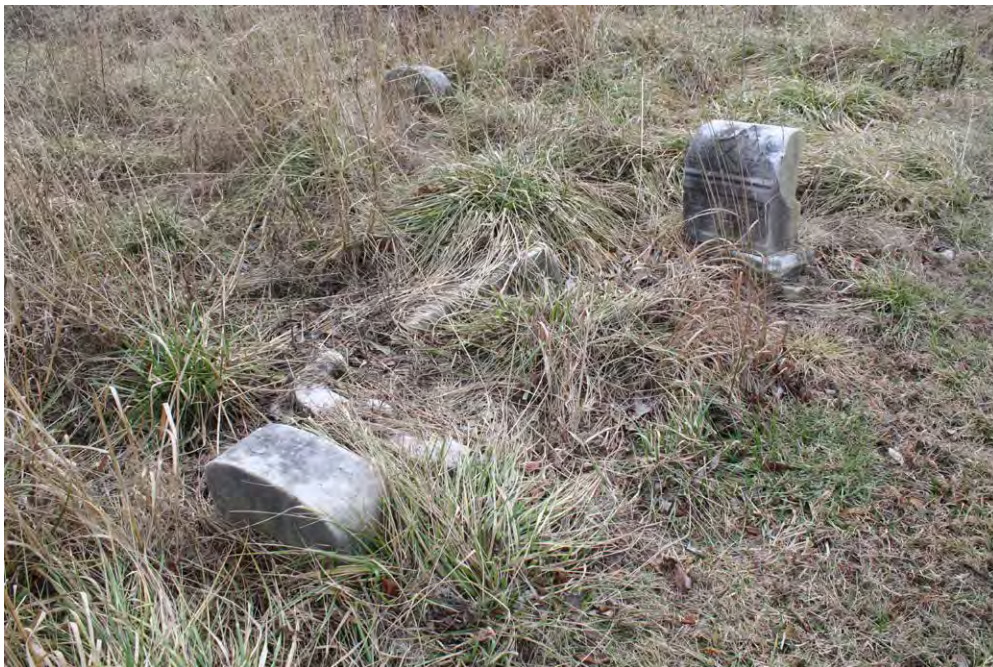
Figure 2.30: Marble cradle grave that is partially underground
Photo view: South; Photographer: Jason Harpe; Date: January 18, 2023.

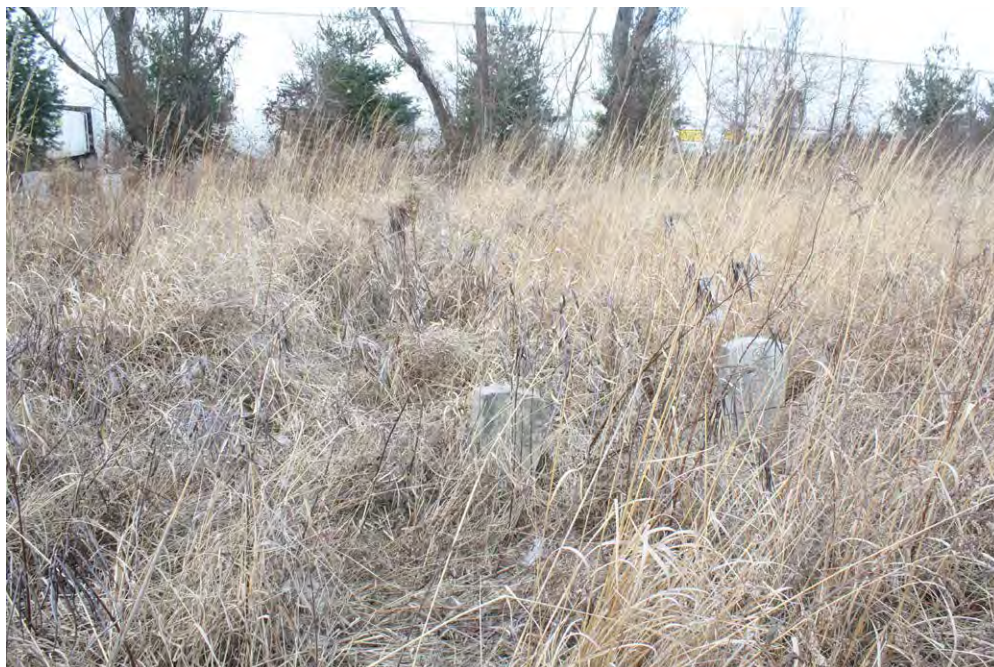
Overall, Green Lawn Cemetery is in fair condition. Years of neglect, vandalism, and infrequent and improper lawn care practices have resulted in damaged, displaced, and sunken gravemarkers; overgrown grass and weeds; and trash being dumped on the property. Grass has grown over what could be interpreted as either gravemarkers or small broken sections of concrete curbing. Gravemarkers with multiple components are damaged and displaced in family burial plots. Flush lawn-style markers in the cemetery's western section are barely visible because grass and weeds cover them (Figures 3.1–3.3).

Figure 3.1: Heavy underbrush covering gravemarkers near Green Lawn Cemetery's northern edge

Over half of Green Lawn Cemetery is overgrown, particularly on its west side. This growth, which includes grasses, shrubs, weeds, and an assortment of other woody plants makes it almost impossible to access portions of the cemetery, in addition to obscuring gravemarkers and other cemetery features. This growth can be a safety concern for visitors searching for burials in these areas, creating tripping hazards and the possibility of allergic reactions to some of the weeds and grasses. While conducting fieldwork, RGA staff were not able to walk through some sections without stepping on small, granite lawn-style gravemarkers that are almost completely engulfed by tall grass and weeds.

Although the preparation of a site map and documentation are generally recommended prior to a clearing project (Strangstad 1988:42), the thickness and extent of the overgrowth in the western section of Green Lawn Cemetery makes documenting the site significantly more difficult and less accurate, even if the mapping is done in the winter when much of the plant material has died off or is dormant. The cemetery stewards have established a cyclic maintenance schedule for the eastern front section of the cemetery and have taken steps to properly map and document the gravemarkers in this section. They have printed and laminated cards that have the section and row numbers on them and have mounted the cards to small stakes at the south end of each row. It is recommended that the stewards remain steadfast on their regular maintenance schedule for the east section while choosing small areas of the overgrown west section to clear so that it too can be mapped and documented.

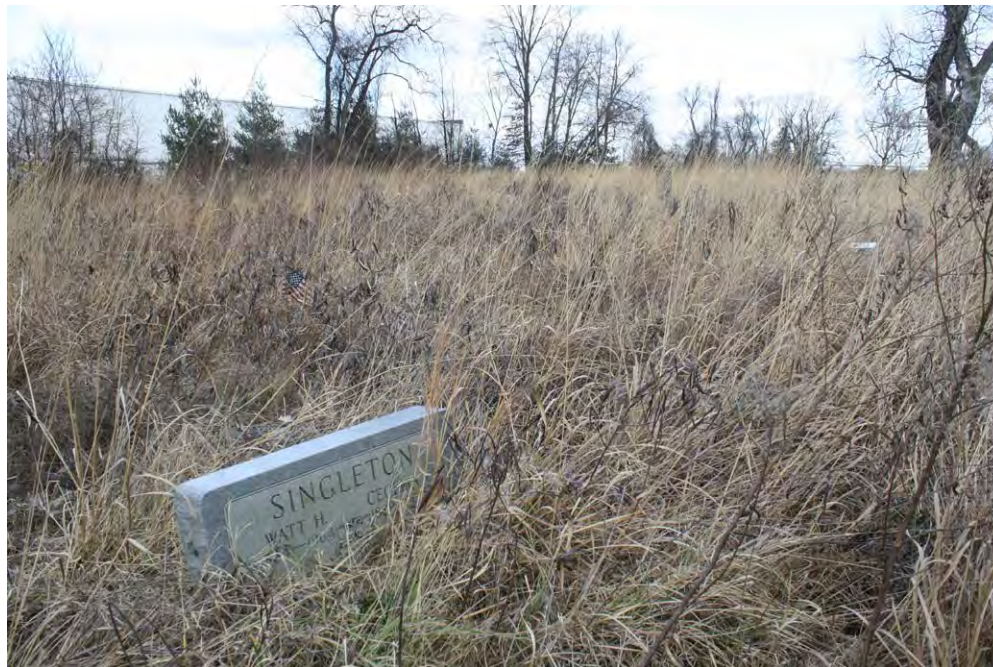
Figure 3.2: Heavy underbrush covering gravemarkers near Green Lawn Cemetery's northern edge
Photo view: West; Photographer: Jason Harpe; Date: January 18, 2023.

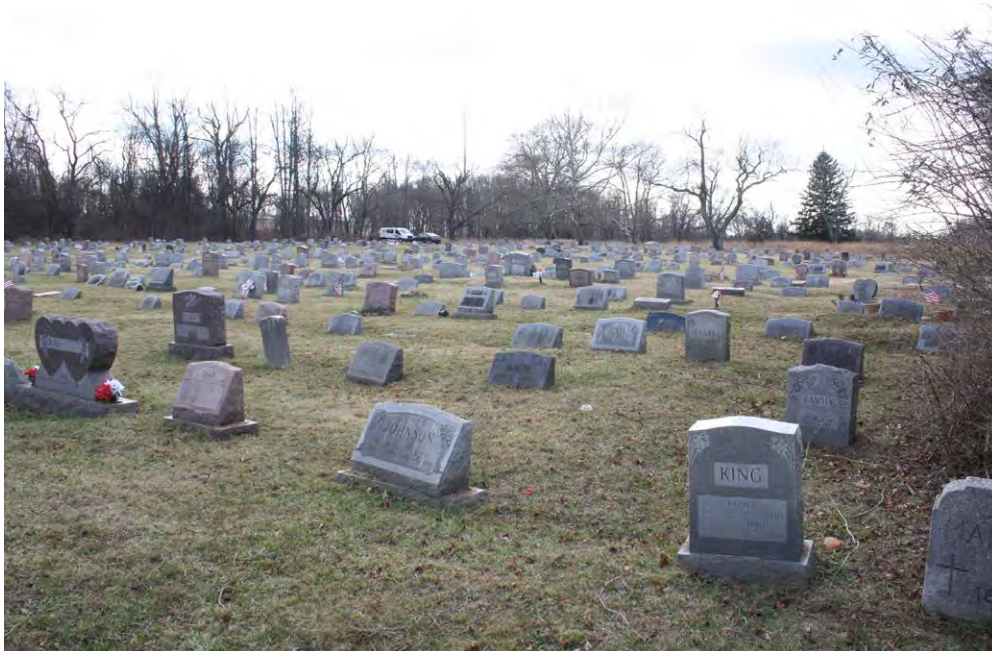
Figure 3.4: The well-maintained section of burials near Green Lawn Cemetery's southeast corner
Photo view: Northwest; Photographer: Jason Harpe; Date: January 18, 2023.

Fortunately, Clarence Grasty now maintains the grass in the eastern section of Green Lawn Cemetery. Over the past five years, Mr. Grasty has been assisted by various individuals in the community who have an interest in clearing the overgrowth from the cemetery's western section. Family, Incorporated of Brookhaven, Pennsylvania, and Greg Humphries have assisted Mr. Grasty on numerous occasions, but their assistance has been much less frequent lately because of other commitments. Descendants of some individuals buried in the cemetery clear paths from the road leading through the cemetery to individual gravemarkers and family plots in the cemetery's western section, but it does not appear that they intend to widen these paths and contribute to the larger effort to clear this section for overgrown grass and weeds (Figures 3.4–3.5).

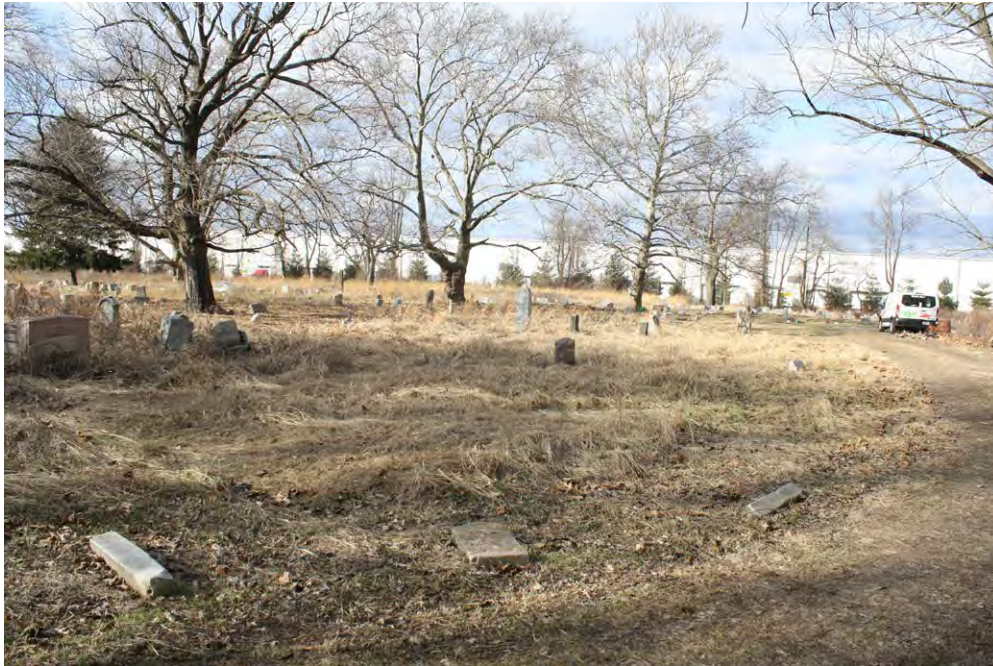
Gravemarkers are leaning, displaced, broken, sunken, covered by grass, missing components, and are deteriorating. The marble and concrete gravemarkers are in the most immediate need of leveling, conservation, and restoration. Granite die-on-base gravemarkers are the cemetery’s predominant type and are to a certain degree, when compared to the marble and concrete gravemarkers, sound and stable. Granite became one of the most popular stones during the 1880s and remains the preferred stone material for gravemarkers and monuments because it is hard, heavy, and durable (Anson-Cartwright 1998:12). The granite die-on-base gravemarkers at Green Lawn do not display an accelerated level of

Figure 3.6: Parts of gravemarkers along the road running through Green Lawn Cemetery.
Photo view: North; Photographer: Jason Harpe; Date: January 18, 2023.

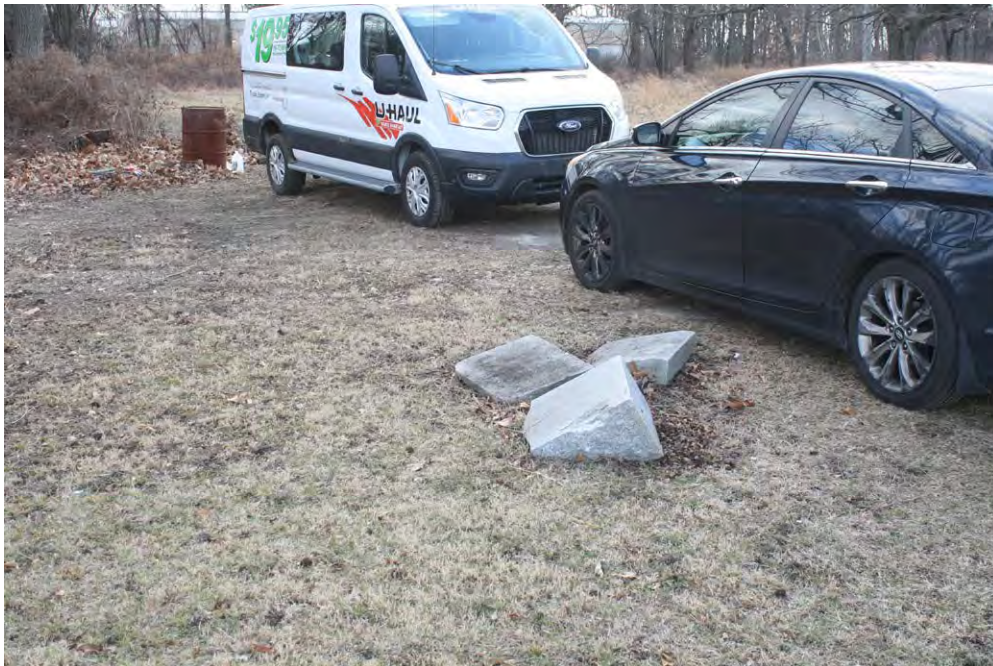
Figure 3.7: Displaced gravemarkers along the road running through Green Lawn Cemetery.
Photo view: South; Photographer: Jason Harpe; Date: January 18, 2023.

Broken gravemarkers, particularly those made of marble and concrete, that are displaced and laying on the ground for extended periods of time have sunk and been overtaken by grass. Deterioration of these displaced and broken pieces is accelerated by constant exposure to moisture in the soil, lawn mowers and weed eaters, and herbicides. Marble is very porous and susceptible to “sugar decay,” a phenomenon “in which acid precipitation attacks along the joints or boundaries between the calcite crystals that comprise marble” and “the grains or crystals are ultimately loosened and can be brushed off like granulated sugar” (Anson-Cartwright 1997:8).

If it is necessary to move stones or stone fragments (i.e., to prevent theft or further damage), their location and orientation should first be fully documented on paper, in photographs, and ideally with scaled maps with GPS coordinates. Ideally, these fragments should be documented, clearly identified, and stored in a safe, dry place; however, this is often impractical due to the lack of appropriate storage facilities and/or the large number or size of pieces requiring curation. In these cases, the burial of stone fragments behind their associated standing "parent stone" is acceptable; these should still be fully documented prior to burial. For both on-site burial and off-site curation, documentation should include the location at which the fragment was found, the gravemarker or other landscape feature to which it belongs, orientation, a sketch, and a photograph. No fragments or bricks should be discarded because they will be important for any future stone conservation. If the pieces are to be buried, a sketch map and notes describing the placement of the fragments in relationship to the parent stone must also be included. Unidentifiable fragments, where the parent stone cannot be determined, should be buried at the nearest of a few carefully documented locations.

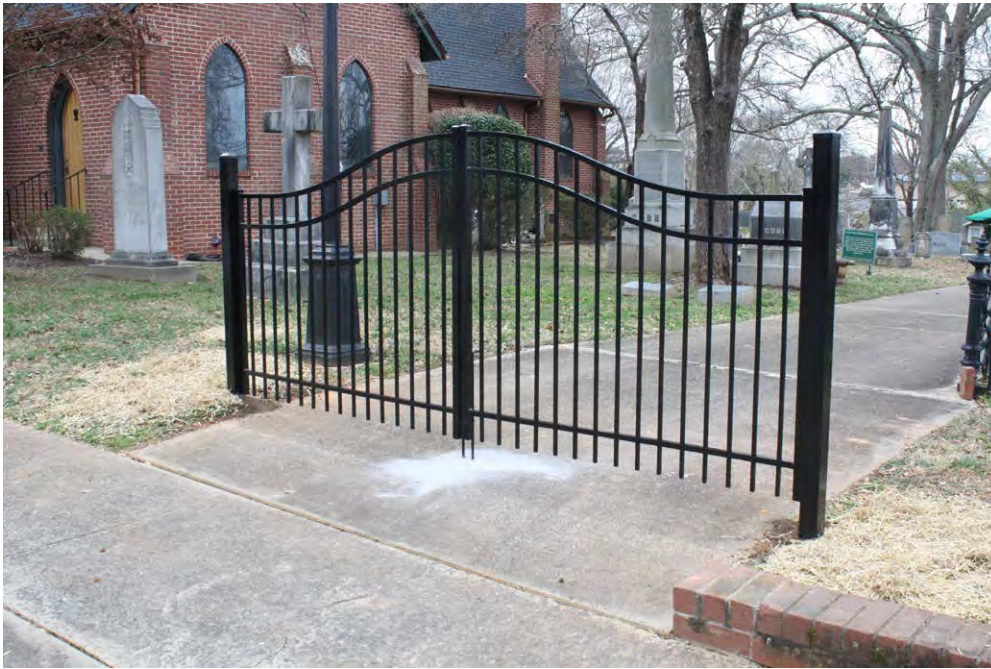
Figure 4.1: Aluminum gates at the entrance to St. Luke Episcopal Church's Cemetery in Lincolnton, North Carolina.
Photographer: Jason Harpe.

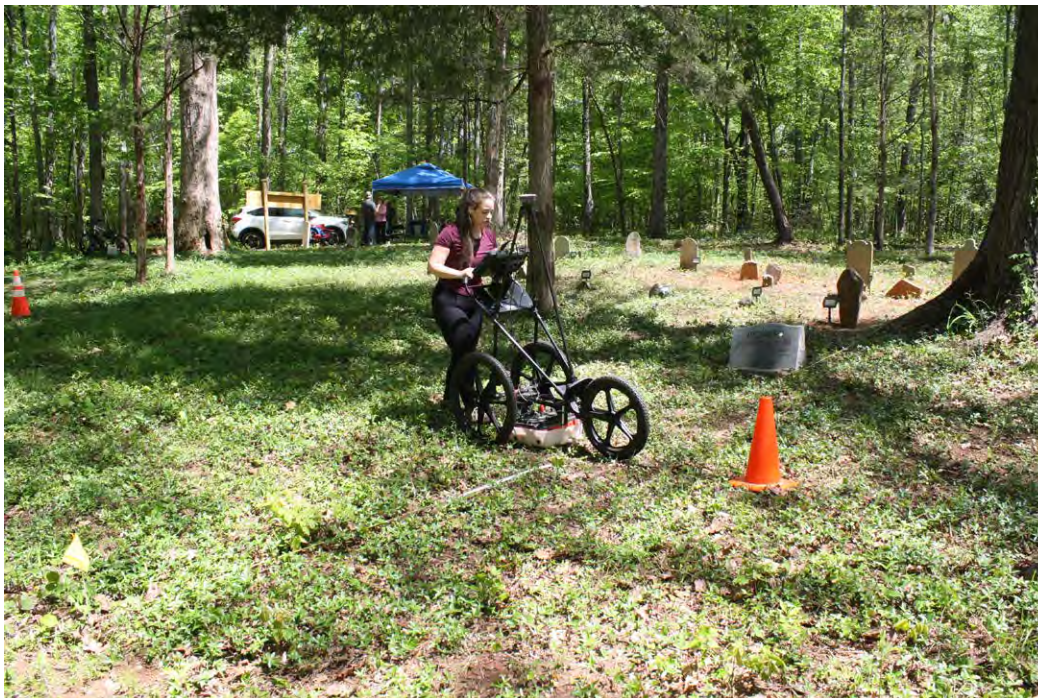
Figure 4.5: Cayla Cannon, RGA's Geophysical Specialist, conducting a ground-penetrating radar (GPR) survey at the Kiser-Huffstetler Cemetery in Lincolnton, North Carolina.

The objective of the GPR survey is to identify the location of marked graves and potential unmarked burials within the limits of the survey area. A GPR survey can identify subsurface features, such as grave shafts or coffins, without disturbing the ground surface, and provide the location of marked graves and potential unmarked burial anomalies. Field conditions, such as tree roots, debris, and rocks could affect the results of the survey. Contrast in soils is important for detecting subsurface anomalies such as burials. Over time, distinctions in the soil may be diminished. Since contrast in soils is reduced over time, older burials may be difficult to identify though survey without post-processing (Figures 4.5–4.6).
