GREEN LAWN CEMETERY PRESERVATION PLAN

Aston, Delaware County, Pennsylvania

RGA Technical Report 2022-341PA

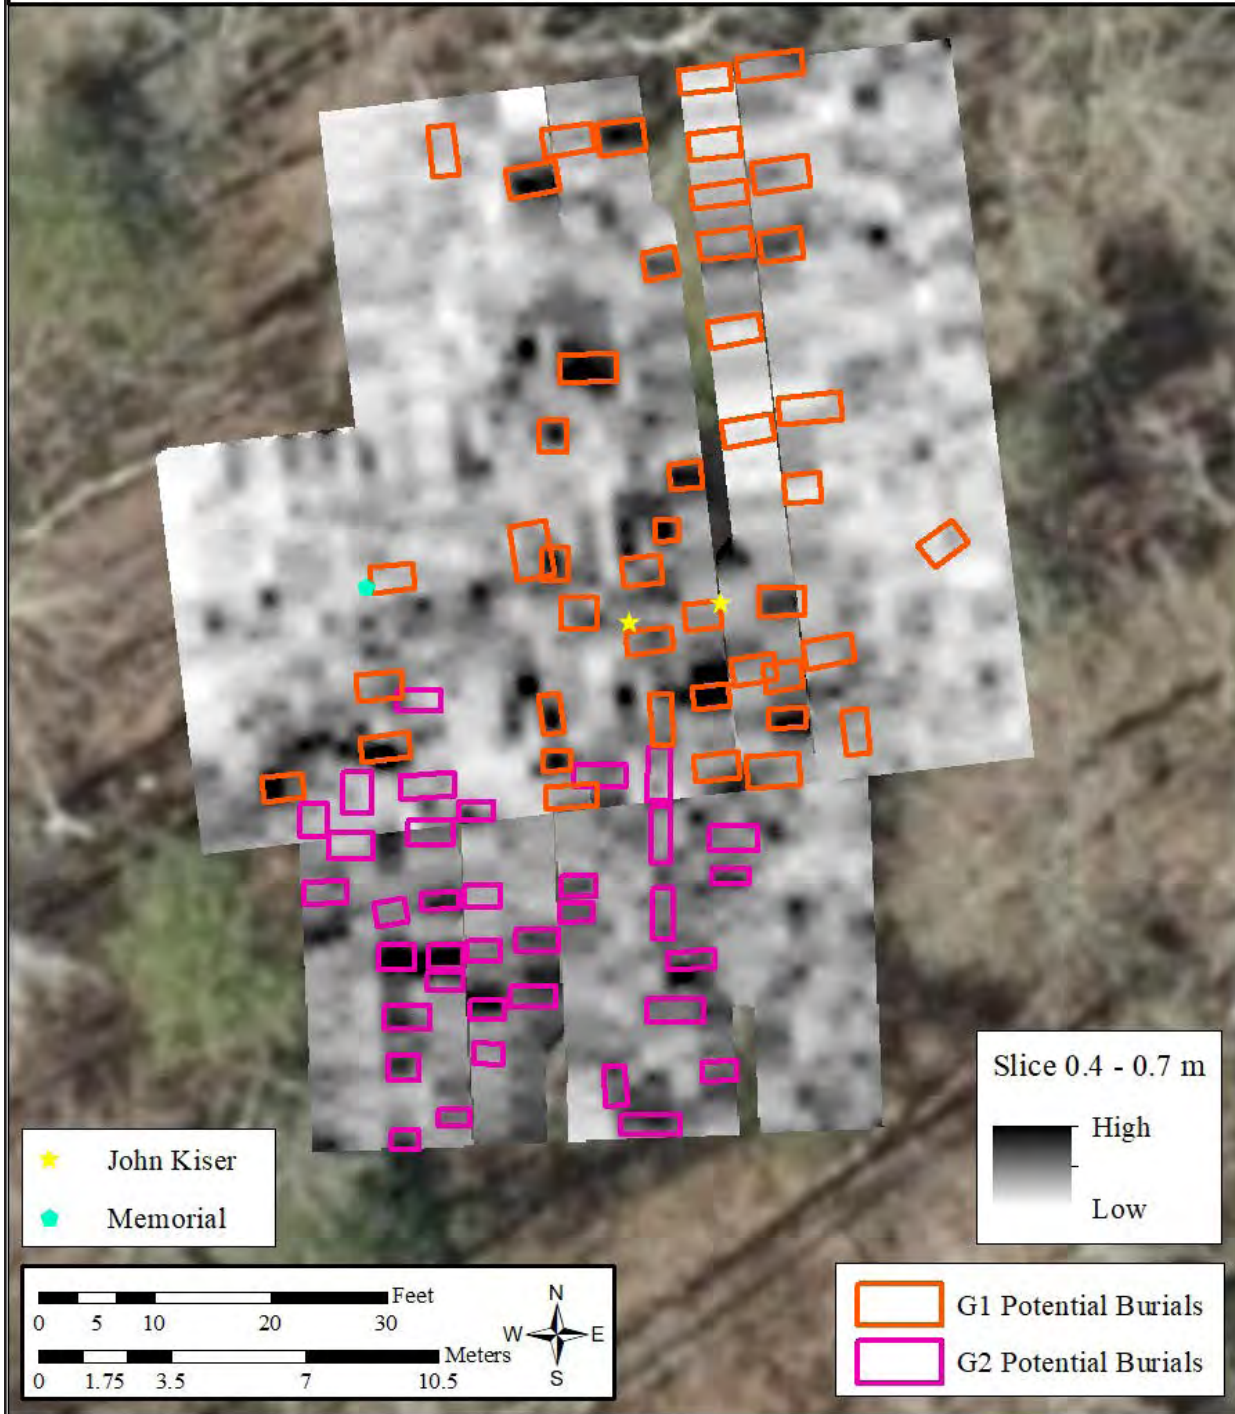
Figure 4.6: A total of 80 potential burials were identified through post processing during the GPR survey of the Kister-Huffstetler Cemetery. This number includes 44 potential marked and 36 potential unmarked burial anomalies. This graphic shows potential burials in Grids 1 and 2 on a time slice map at 0.4 to 0.7 meters below the surface.

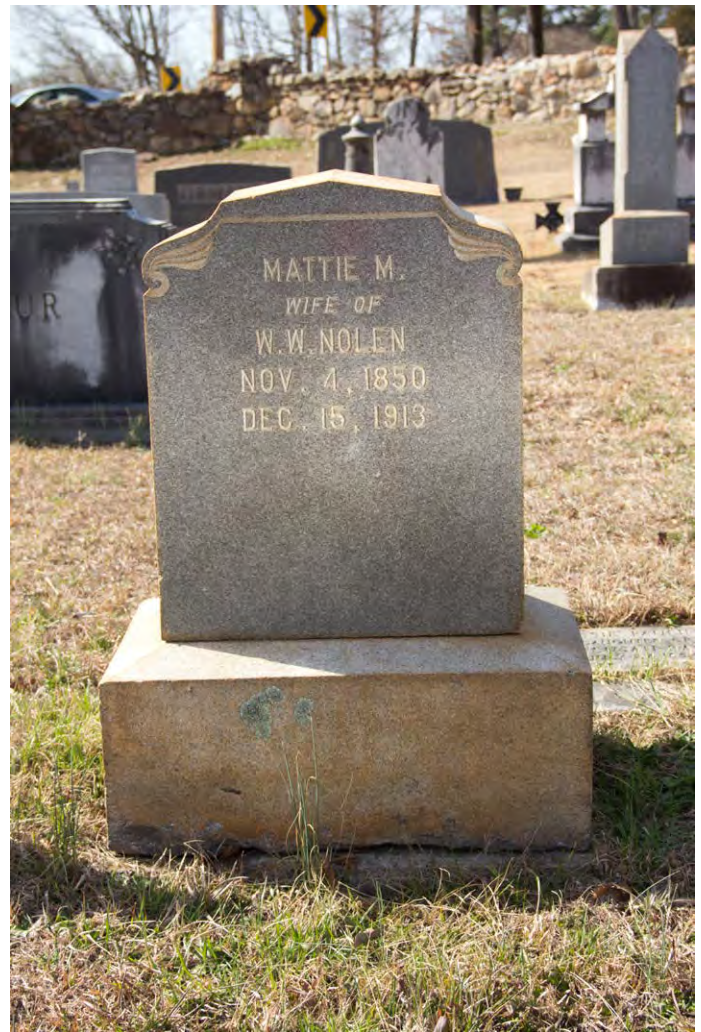
Figure 4.9: A granite die-on-base gravemarker for Mattie M. Nolen (1850–1913), Long Creek Presbyterian Church Cemetery, Bessemer City, Gaston County, North Carolina. The photographer lit the gravemarker with a reflector.

If the cemetery stewards and volunteers become very serious about photographing gravestones and monuments, they should invest in a good, small powerful flashlight with a high lumen value. They should also buy a good tripod and a reflector. Carry a garden sprayer with you when you plan to take photographs of gravestones and monuments. Use a scale bar and if you don't have one just use something like a coffee cup from Starbucks. Do not take photographs of gravemarkers and monument with people in the background (Figure 4.9–4.12).

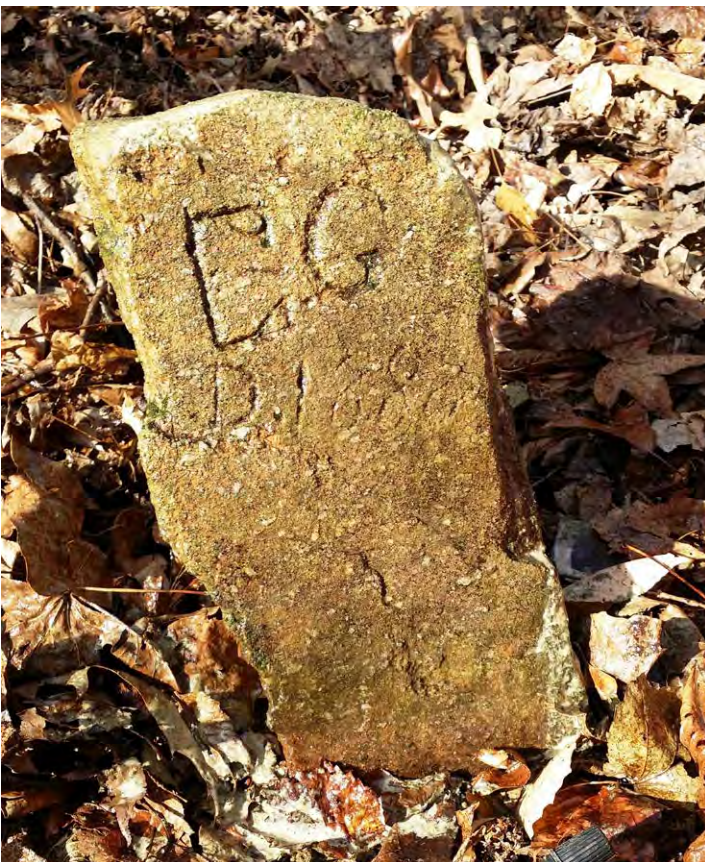
Figure 4.10: The photographer lit a marked fieldstone in a cemetery for enslaved persons with a reflector.

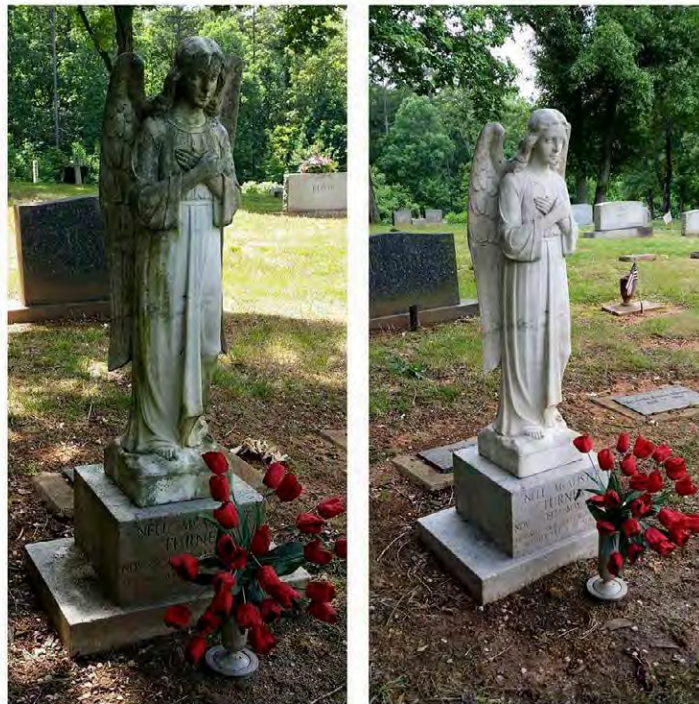
Figure 4.24: Before-and-after photographs of a marble angel in Lincolnton, North Carolina after being cleaned with D/2 Biological Solution.
Photographer: Jason Harpe.

It has been recommended that gravemarkers should not be cleaned with a brush more than once every three years (Illinois Department of Natural Resources [IDNR] and Illinois Historic Preservation Agency [IHPA] n.d.: 10). After the initial cleaning with a biocidal product and brush, D/S Biological Solution or equivalent biocidal product can be applied and allowed to dwell without rinsing as often as once every year (Figures 4.23–4.24).

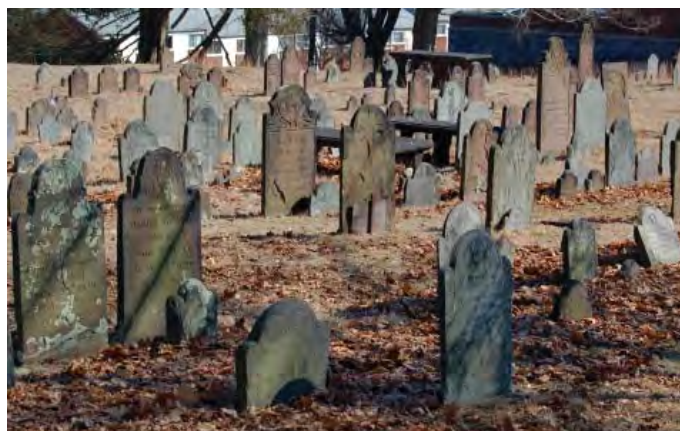
Figure 1. Sandstone and slate grave markers in the Ancient Burying Ground in New London, CT, display a variety of weathering conditions. Markers in the cemetery date from the mid-17th to the early 19th centuries. Photo: Jason Church.

While cemeteries are often considered to be perpetual, their most prominent feature—the grave markers—are not. They weather, naturally decay, often are poorly maintained and repaired and, on occasion, are vandalized (Fig. 1). Grave markers are usually noteworthy not only for their inscriptions but also for their craftsmanship. Exceptional markers are considered works of art.

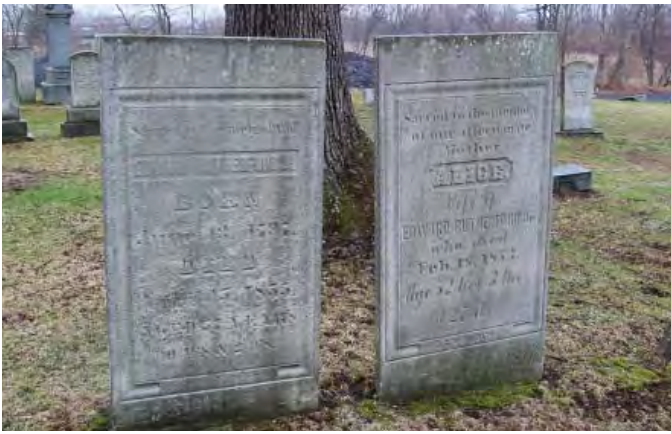
Figure 2. These mid-19th century, single-element stone grave markers in the Grove Cemetery in Bath, NY, are set in a vertical position. Photo: Jason Church.

The great variety in the types of grave markers is a fascinating aspect of the study and appreciation of historic cemeteries. Three broad categories can be used to describe grave markers—(1) single-element, (2) multiple-element, and (3) structures. Single-element grave markers are stone, cast iron, or wood elements that are set in a vertical position or placed as a horizontal slab on the ground (Fig. 2). Early examples of this simplest type of grave markers are field stone and basic wooden or wrought iron crosses, with the name of the deceased person scratched into or engraved on the marker. Often, these rudimentary grave markers are overlooked, significantly deteriorated, or lost. Vertical stone slabs and large stone ledgers laid horizontally over the gravesite are more sophisticated examples of this type.

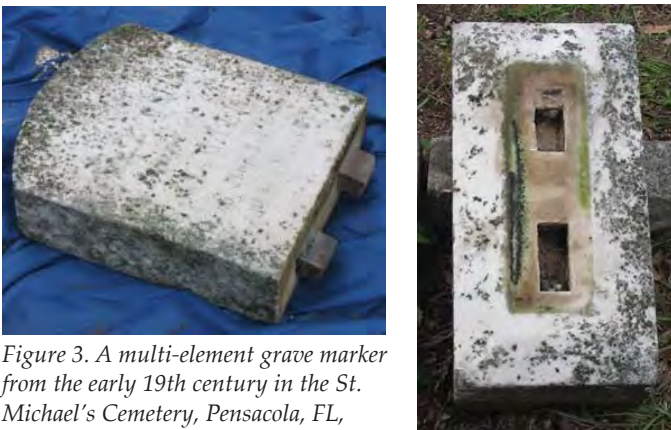
Figure 3. A multi-element grave marker from the early 19th century in the St. Michael’s Cemetery, Pensacola, FL, consists of a vertical element with tabs (left image) into a slotted base (right image). Photo: Fran Gale.

Multiple-element grave markers are found in a number of different forms (Fig. 3). In the most typical form, a grave marker would consist of two stones—an upper headstone placed on top of a base stone. The upper headstone may be secured in a number of different ways to the base. In the simplest of forms, the upper stone was placed on the base, set in a bed of mortar on top of the base, or joined with pins and mortar. With a “tab-and-

slot” grave marker, the tabbed upper stone was set in a slotted base. More common today, the upper headstone is secured with a technique that uses small spacers set on the base and a setting compound. This technique or one that uses an epoxy adhesive may be found on older markers where the stones have been reset.

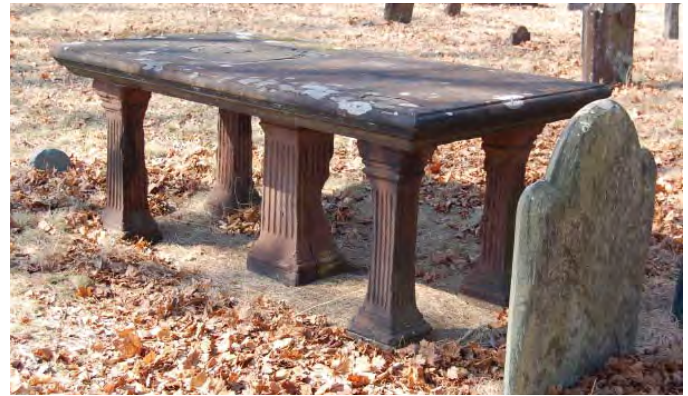
Figure 4. This sandstone table tomb, located in Cedar Grove Cemetery, New London, CT, is an engineered grave marker structure consisting of a horizontal stone tablet supported by four vertical table “legs” with and a central column,. Photo: Jason Church.

Grave markers can also be engineered structures. Examples of grave marker structures include masonry arches, box tombs, table tombs, grave shelters, and mausoleums (Fig. 4). The box tomb is a rectangular structure built over the gravesite. The human remains are not located in the box itself as some believe, but rather in the ground beneath the box structure. The table tomb is constructed of a horizontal stone tablet

supported by small corner supports or columns. Grave shelters, also called grave houses, can be simple or elaborate wooden structures built over the gravesite. Mausoleums are above-ground buildings with compartments for multiple burials. Engineered structures also include hillside and underground tombs.

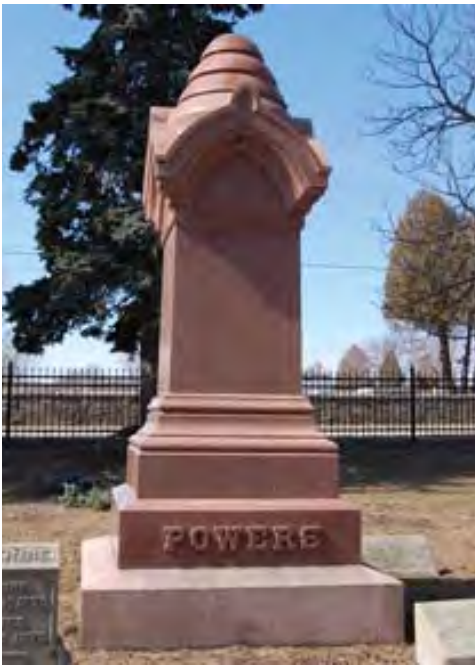
Figure 5. A variety of colors of natural stone are found in historic cemeteries, such as this pink granite marker in the Cedar Grove Cemetery, New London, CT. Photo: Jason Church.

Stone is a naturally occurring material with a wide range of properties and is available in a variety of colors (Fig. 5). Geologists classify stone according to the way in which it was formed with the three categories being igneous, sedimentary and metamorphic rock. Stone found in cemeteries is predominantly quarried, though the use of field stones is not uncommon. The mineralogy and chemical composition of stones vary. Some are composed primarily of silicate minerals; granites, sandstones, slate, and schist are examples. Other stones contain calcium carbonate with marble and limestone in this group. Mineralogy, chemical composition, and physical structure of the stone influence weathering and

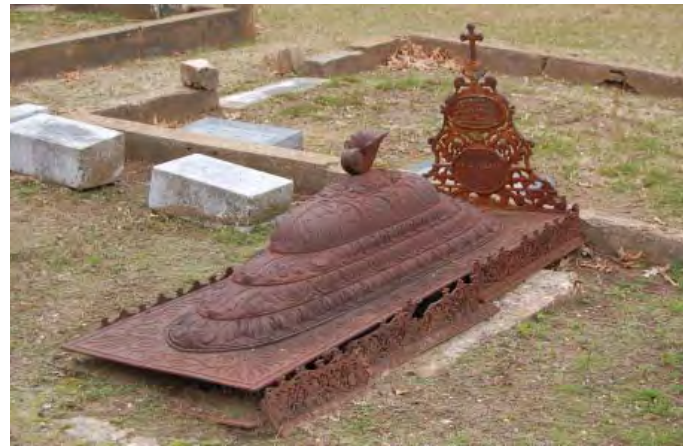
Figure 6. Decorative cast-iron grave markers like this late-19th century one in Oakland Cemetery in Shreveport, LA, are produced by heating the iron alloy and casting the liquid metal into a mold. Photo: Jason Church.

Metals are solid materials that are typically hard, malleable, fusible, ductile, and often shiny when new (Fig. 6). A metal alloy is a mixture or solid solution of two or more metals. Metals are easily worked and can be melted or fused, hammered into thin sheets, or drawn into wires. Different metals have varying physical

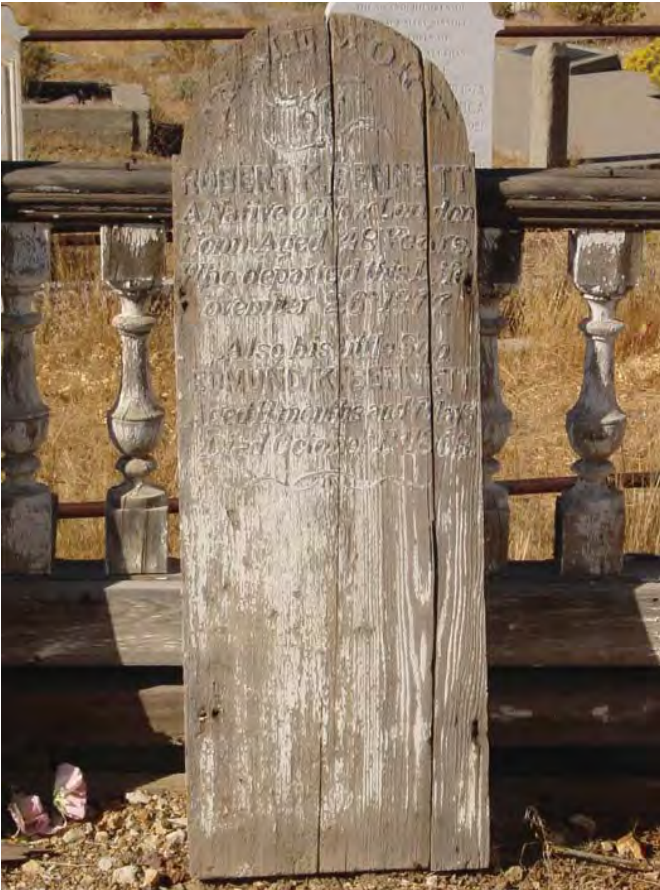
Figure 7. As shown by this 1877 marker in Silver Terrace Cemetery, Virginia City, NV, exposure to sunlight can damage wood grave markers, making the wood more susceptible to water damage and cracking. Photo: Jason Church.

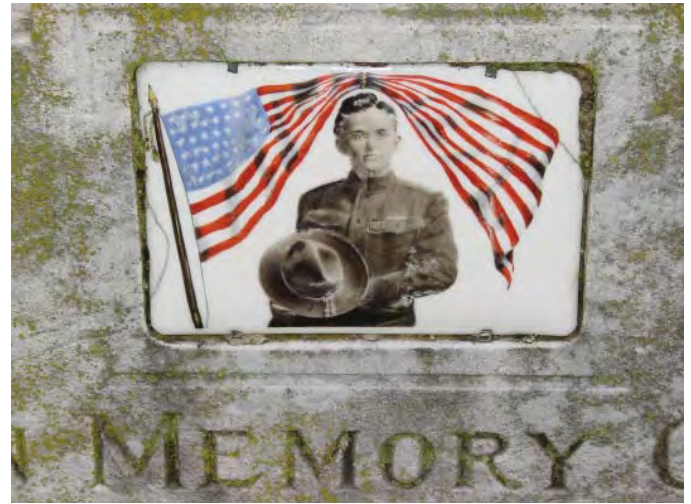
Figure 8. A fired ceramic, this cameo is set in a marble grave marker, located in Elmwood Cemetery, Memphis, TN. Different materials may require different conservation approaches. Photo: Mary Striegel.

Old cemeteries often include a wide variety of other materials not normally associated with contemporary grave markers, such as ceramics, stained glass, shells, and plastics (Fig. 8). As with masonry, metals, and wood, each has its own chemical and physical properties which affect durability and weathering. These materials

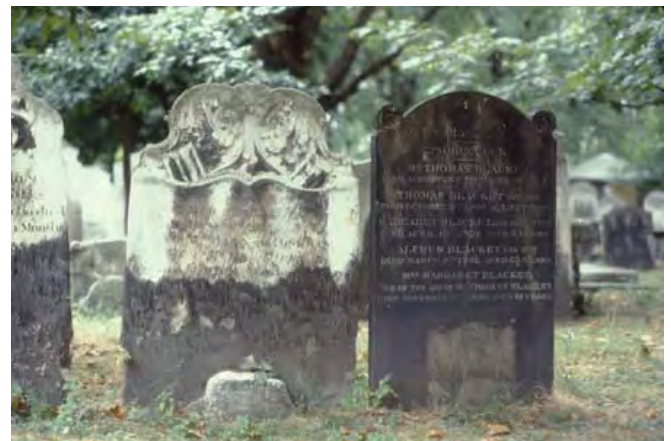
Figure 9. The limestone and sandstone grave markers in this historic cemetery have different weathering processes. On the left, the limestone shows surface loss in areas exposed to rainwater and gypsum crust formation below. The sandstone marker on the right displays uniform soiling, but surface hardening may be occurring. Photo: Fran Gale.

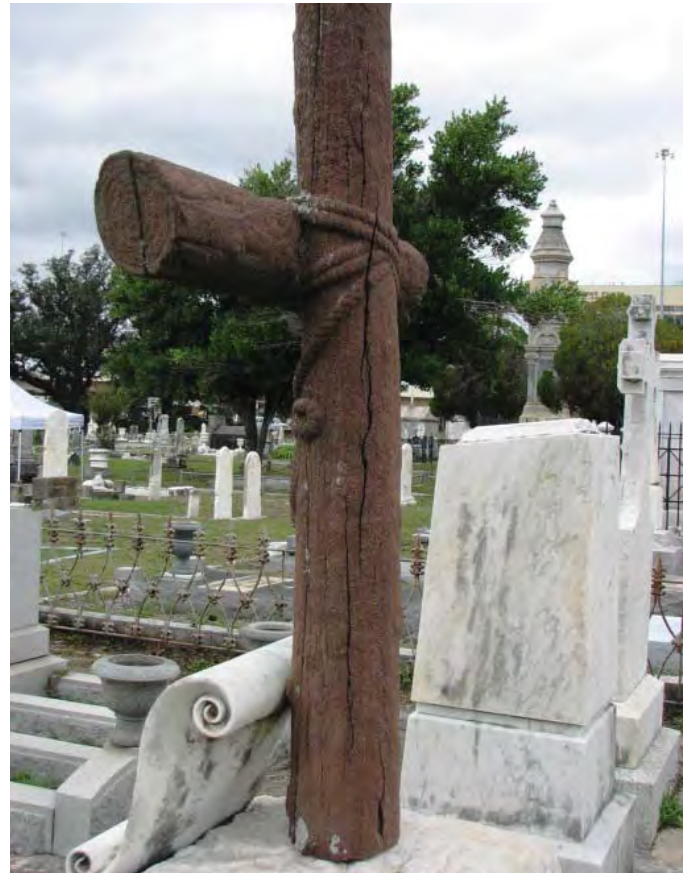
Figure 10. The sandstone cross (carved to look like wood) in this grave marker in St. Michael's Cemetery in Pensacola, FL, provides an example of inherent vice – the severe delamination affecting the sandstone has occurred along its natural bedding planes.

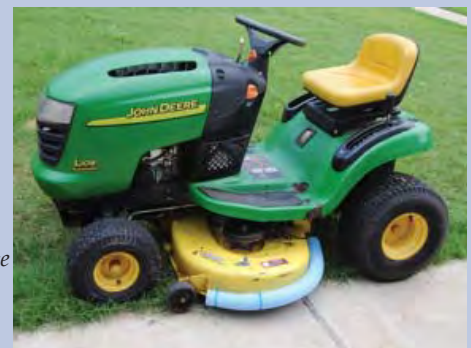
Figure B. A pool ‘noodle’ can be fitted to the deck of a lawnmower to prevent damage to grave markers. Photo: Debbie Dietrich Smith.

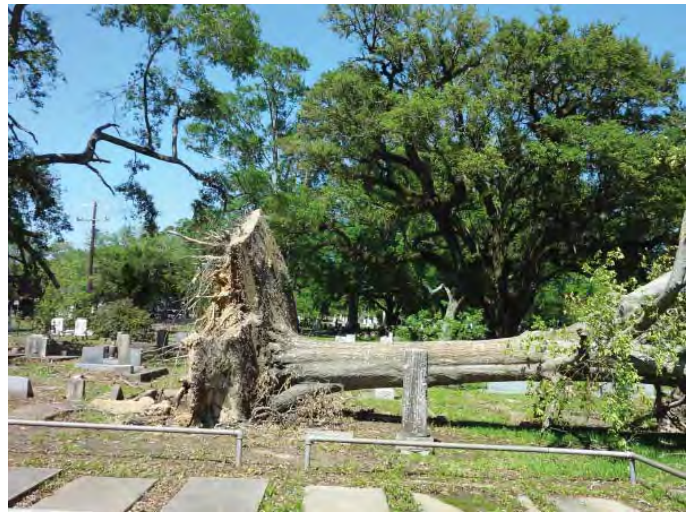
Figure 11. Woody vegetation can damage grave markers and pose a risk to visitors unless well managed and maintained. Photo: Jason Church.

Woody vegetation can damage grave markers in a variety of ways (Fig. 11). Trees, bushes, and vines can shade grave markers, extending the time that the markers are exposed to moisture. Tendrils and roots may burrow into mortar joints and openings, causing mechanical damage and large plants may lift up or shift markers. Even leaves and twigs, when allowed to collect on the ground near grave markers, can affect water drainage and evaporation (Fig. 12).

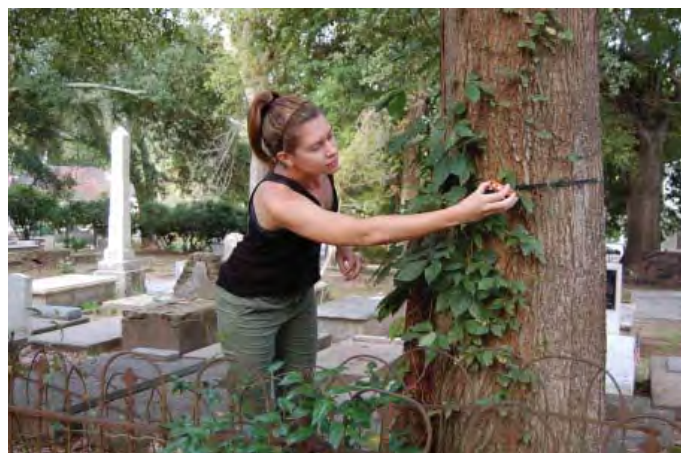
Figure 12. A cemetery professional undertakes a tree inventory in American Cemetery, Natchitoches, LA, to determine the health of trees in the cemetery. Management decisions for trimming or removal are based on the inventory. Photo: Debbie Dietrich Smith.

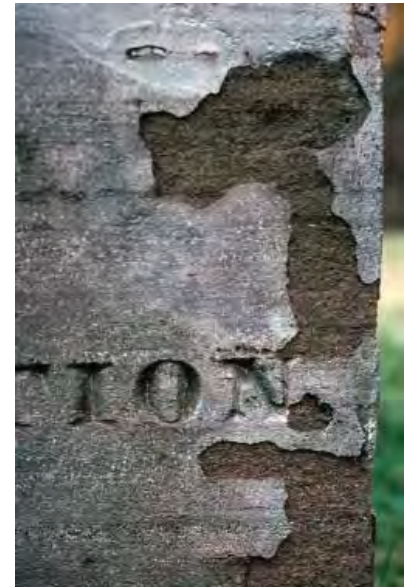
Figure 14. High-pressure water washing can damage grave markers. The photograph shows "wand marks" on the headstones produced by inappropriate pressure washing. Photo: Jason Church.

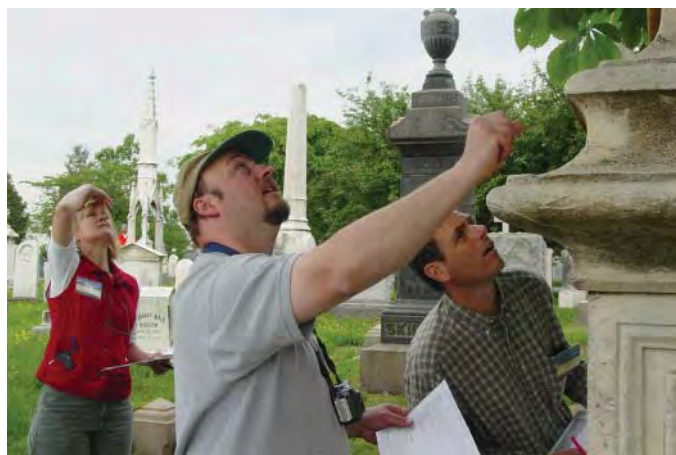
Figure 15a. Condition surveys are undertaken to document current conditions, determine safety issues, and plan both emergency stabilization and future treatment plans. There are a variety of survey forms available that can be tailored to the specific cemetery. Photo: Mary Striegel.

Depending upon the size of the cemetery and funding available, the initial assessment may be carried out by a team consisting of cemetery staff, a materials conservator, and, where necessary, an architect or structural engineer for cases involving large monuments and mausoleums (Figs. 15a and 15b). For smaller cemeteries without large monuments and mausoleums, and where funding is problematic, volunteers can be trained to prepare a condition assessment under the guidance of an experienced individual.

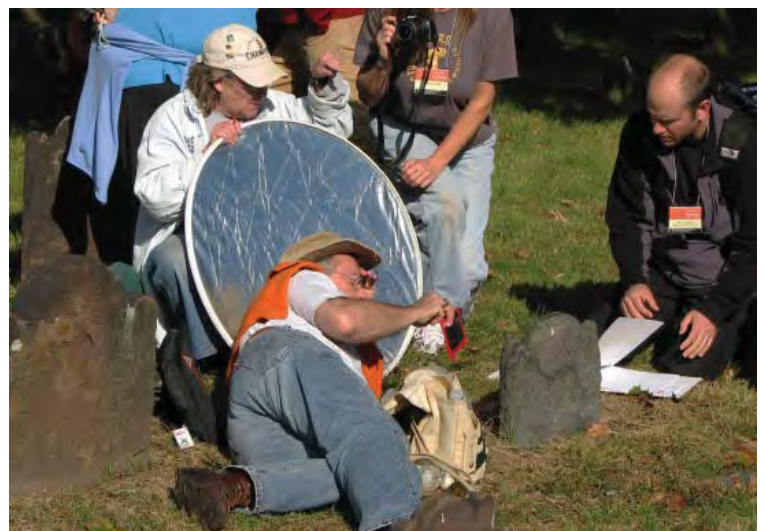
Figure 15b. Photographs are used to document the condition of the grave marker as part of a condition assessment. Photo: Fran Gale.

A tool kit for the condition assessment may include binoculars, digital camera, magnifying glass, measuring tape, clipboard, carpenter's rule, level, magnet, and flashlight. For large monuments, a ladder or aerial lift may be required. Photographs of each marker, including overall shots and close-up details, are an essential part of the documentation process. Photo logs are helpful for

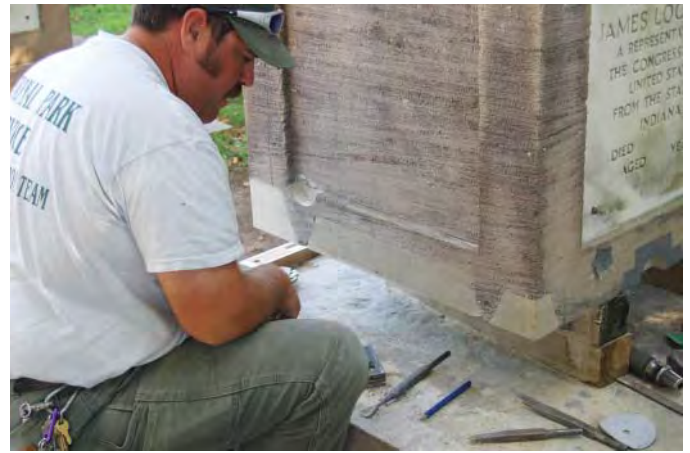
Figure 16. A professional mason works to insert a new piece of stone. Often referred to as a “dutchman”, this repair technique requires replacing the deteriorated stone section with a new finished piece of the same size and material. Photo: Jason Church.

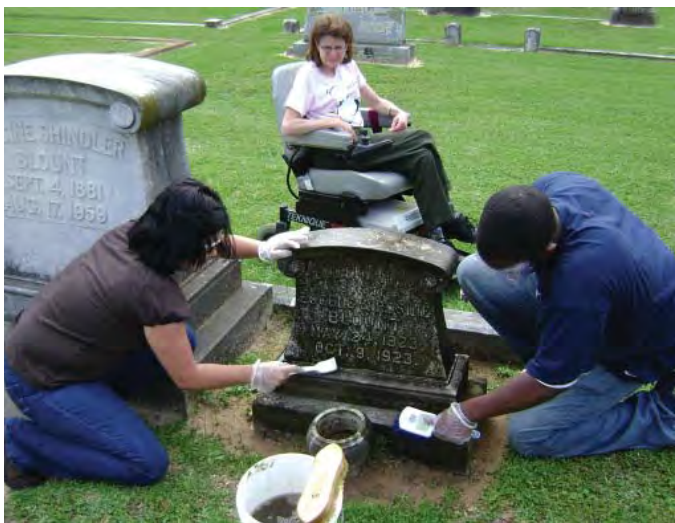
Figure 17. Volunteers can undertake cleaning of grave markers once they have received initial training. Cleaning methods may include wetting the stone, using a mild chemical cleaner, gently agitating the surface with a soft bristle brush, and thoroughly rinsing the marker with clean water. Photo: Jason Church.

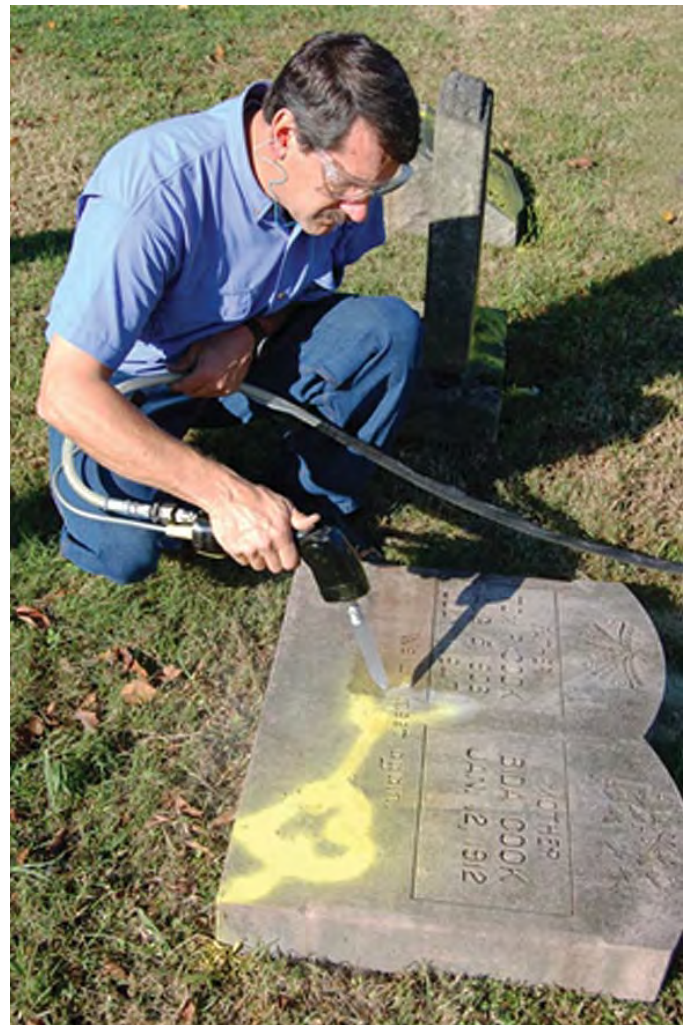
Figure 18. Graffiti is carefully removed using a low-pressure dry-ice misting instrument. Photo: Jason Church.

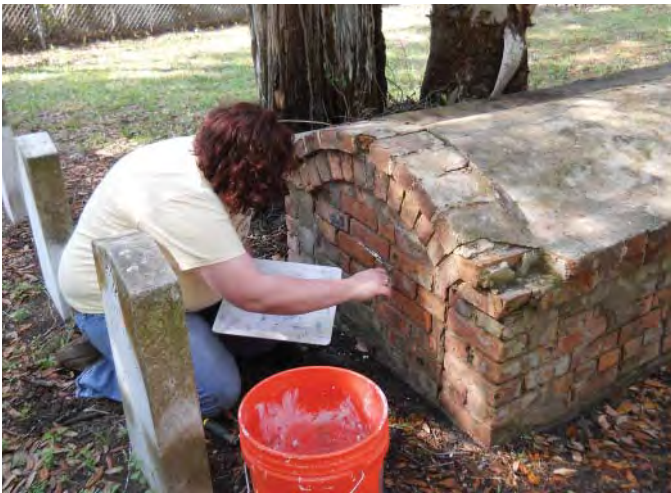
Figure 19. Masonry markers like this box tomb may require the repointing of mortar joints. It is important to use a mortar that is softer than the historic brick. In this case a conservator uses a lime putty-based mortar to repoint. Photo: Jason Church.

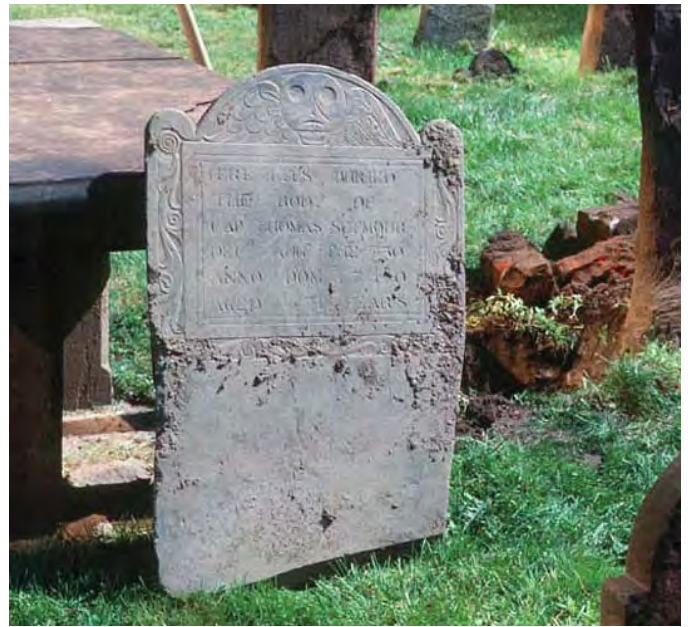
Figure 20a. This slate grave marker in the Ancient Burying Ground in Hartford, CT, is a ground-support stone. Resetting requires digging a hole that will hold the base of the stone and then compacting the soil at the bottom of the hole by hand. Photo: Fran Gale.

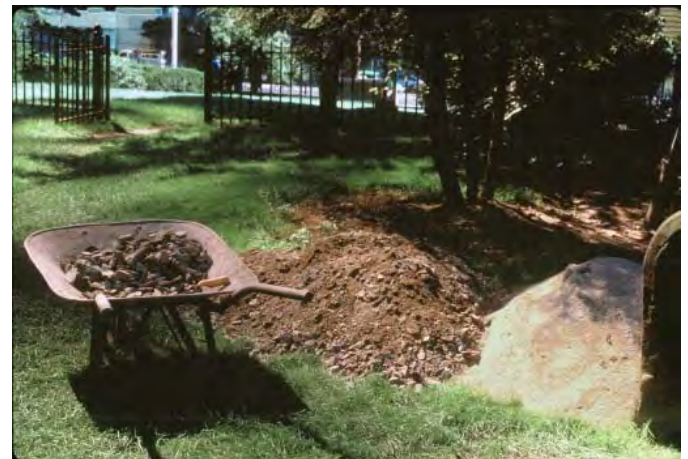
Figure 20b. To facilitate drainage, crushed stone, gravel, and sharp sand line the hole and are hand-tamped around the stone after placement. Photo: Fran Gale.

Resetting is recommended for grave markers when their foundations are unstable or out of plumb (Figs. 20a through 20c). This often complex activity involves lifting the grave marker, leveling its foundation, and returning the marker to its original upright position. Workers can be injured and the grave marker damaged if resetting is not carried out properly and safely.

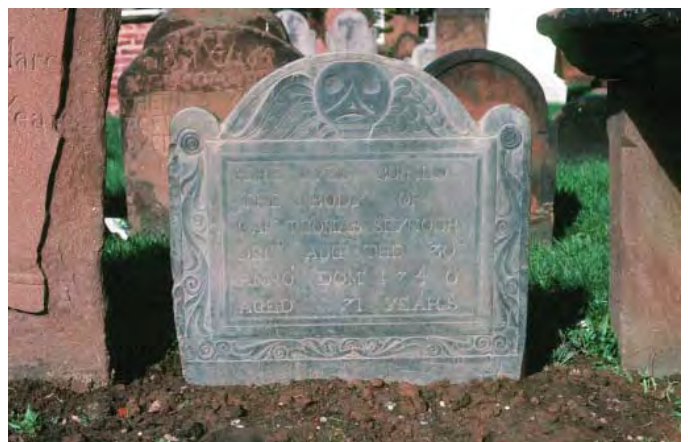
Figure 20c. The reset ground-supported grave marker should be level and plumb. Photo: Fran Gale.

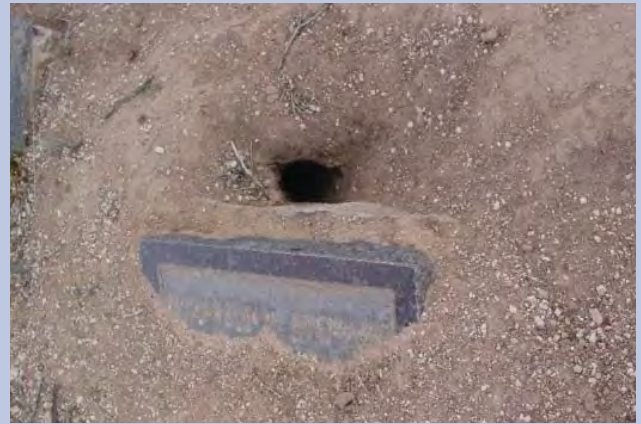
Figure C. Gophers and other burrowing animals produce uneven ground and holes that are trip and falling hazards to visitors and staff of historic cemeteries. Photo: Jason Church.

Trip and falling hazards include uneven ground, holes, open graves, toppled grave markers, fallen tree limbs, and other debris (Fig. C). Sitting, climbing, or standing on a grave marker should be avoided since the additional weight may cause

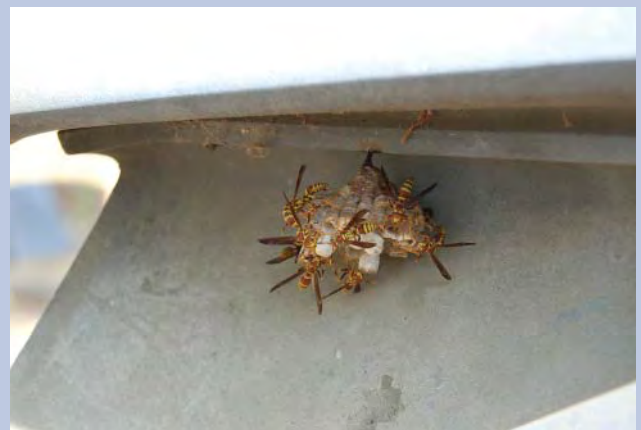
Figure D. Yellow jackets that are nesting below the projecting molding of this grave marker pose a hazard to visitors and staff because, if disturbed, they will vigorously defend their nest. Yellow jacket, paper wasp and hornet nests should be removed from grave markers by trained staff or specialists. Photo: Jason Church.

Snakes, wasps, and burrowing animals inhabit historic cemeteries (Fig. D). Snakes sun on warm stones and hide in holes and ledges, so it is important to be able to identify local venomous snakes. An appropriate venomous snake management plan should be in place, and

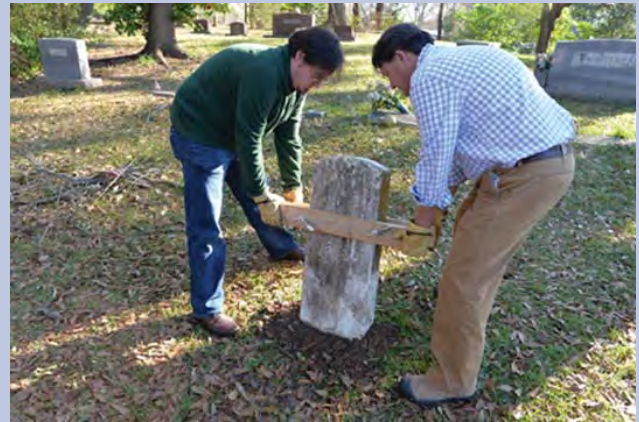
Figure E1. The simple wooden clamp system allows two people to safely lift a marble grave marker. Photo: Sarah Jackson.

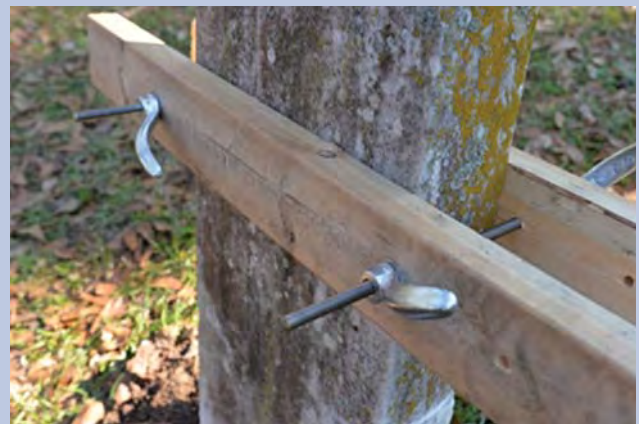
Figure E2. The clamp system is constructed from off-the-shelf wooden boards. Photo: Sarah Jackson.

lifting techniques. Lift equipment and ergonomically correct tools should be routinely used to lift heavy markers (for most people this includes markers that weight more than 50 pounds). For smaller grave markers, a simple wooden clamp system can be constructed for a two-person lift (Figs. E1 and E2).

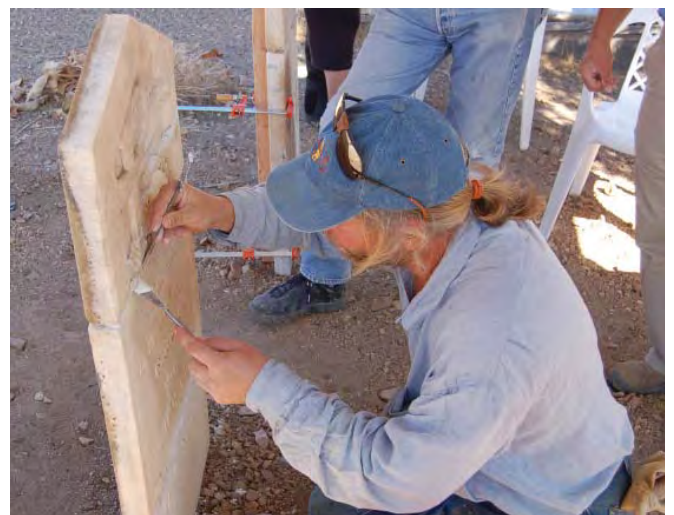
Figure 21. Cracks in a stone marker should be filled to keep water and debris out and prevent the crack from becoming larger. A patching mortar is designed to be used, in this case, with historic marble. Photo: Mary Striegel.

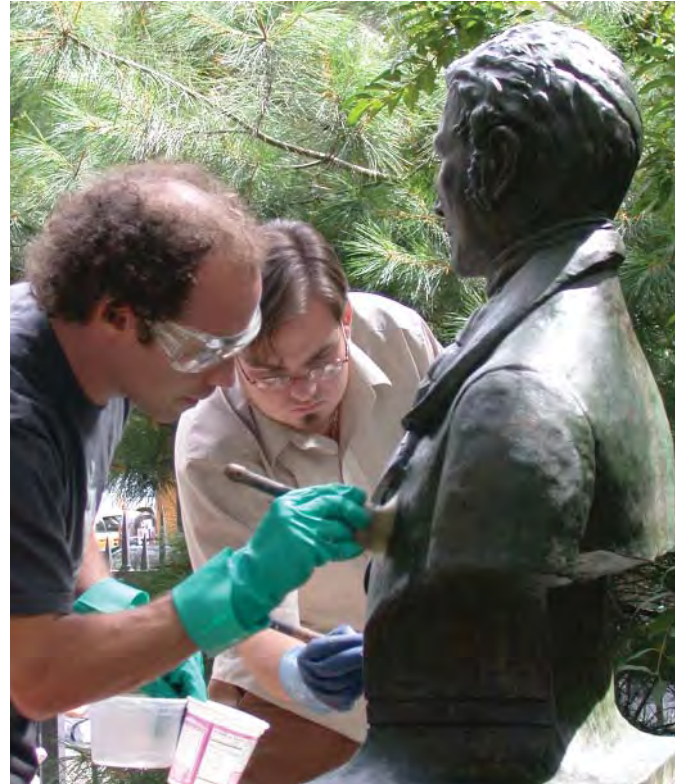
Figure 22. A protective coating must be maintained on metal elements. Wax or lacquer coatings help preserve the bronze patina and slow corrosion. Conservators apply a microcrystalline wax to this bust at St. Mark's Church in-the-Bowery, New York, NY. Photo: John Scott.

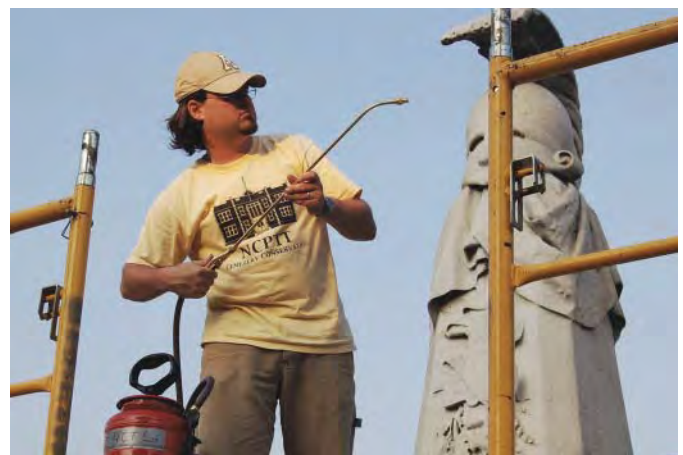
Figure 24. A severely deteriorating monument or grave marker can be treated with a stone consolidant. The treatment is usually applied using a spray system. The consolidant soaks into the stone and replaces mineral binders that hold the stone together. On-site and laboratory testing and evaluation are performed prior to using this non-reversible type of treatment. Photo: Lucas Flickinger.

When erosion is severe, consolidation treatments (e.g., ethyl silicate) have been used to replace mineral binders lost to weathering (Fig. 24). Because these treatments are not reversible, laboratory and on-site testing are essential. Application by a conservator or other experienced preservation professional is advised.
